Bus Bar Fault

Generator Step Up (GSU) Transformer, 25/500 kV, 784 MVA, FOA, Westinghouse, three phase, two pumps groups, shell form.

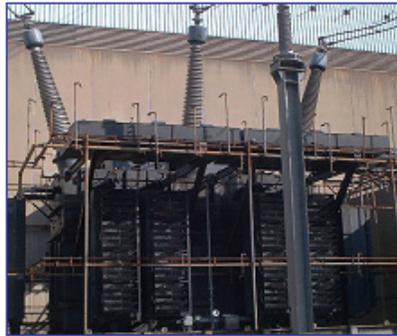
GSU Transformer

This unit started gassing the last month of 2001 after being in service for more than 20 years. Dissolved Gas Analysis (DGA) indicated the existence of overheating by all seven methods applied. The gas generation rate increased periodically, therefore, the decision was made to test this unit using Acoustic Emission (AE) with the objective of locating the gassing source(s) inside the transformer.

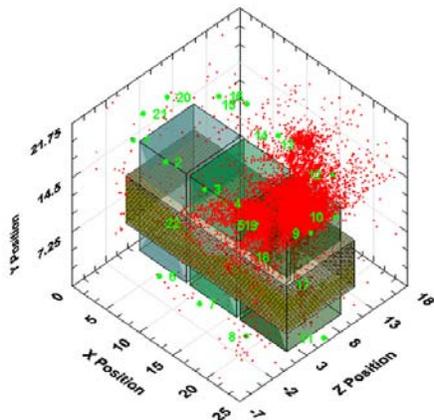
This transformer was tested continuously for 68 hours, while instrumented with 22 AE sensors. Many events were obtained over the course of the test with the event/time ratio changing dramatically. Post-test analysis indicated the existence of two clusters of events: Cluster 1 located close to H1 High Voltage Bushing and Cluster 2 located below the X1 Low Voltage Bushing. Most of the events and the highest peak amplitude were obtained in these clusters.

Analysis indicated that the number of events recorded was strongly related to pump operation. One pump group was running all the time and the second group was operating when it reached a pre-set temperature value. It is believed that these events were

Three-dimensional plot showing the location of two sources

triggered by a high temperature value in the faulted area that reached its critical value just before the operation of pump group #2 was ordered. As soon as pump group #2 started running, all of this activity was significantly reduced. This may be due to a drop in temperature in the fault area. This behavior, along with the DGA results, reinforced the belief that a thermal problem existed.

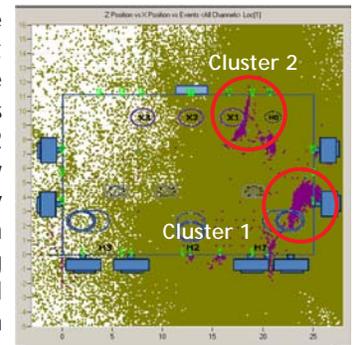
Location of the two sources in a two-dimensional plot (Top View)

The acoustic emission test indicated that the strongest acoustic activity was being detected on the upper part of the transformer. Therefore, an internal inspection was justified as the problem seemed to be located on the upper part of the core/connections area.

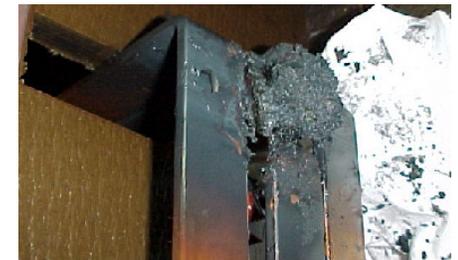
This unit remained in operation with DGA values being monitored periodically. Twelve weeks after the AE test was completed, an internal inspection was performed. Internal inspection revealed carbon build-up, due to severe overheating on one of the copper bus bars of the X1 Low Voltage bushing. This bar was also completely cracked with all of the current being carried by the other two bars (approximately 6000 A).

This fault was detected in the area where Cluster 2 was located.

Overheated bus bar with carbon build-up

The transformer was repaired on-site one week after copper bus bars were replaced. The customer estimated savings of 2 million dollars considering the time the plant would have been off-line.
