Bus Bar Fault

Generator Step Up (GSU) Transformer, 25/500 kV, 784 MVA, FOA, Westinghouse, three phase, two pumps groups, shell form.

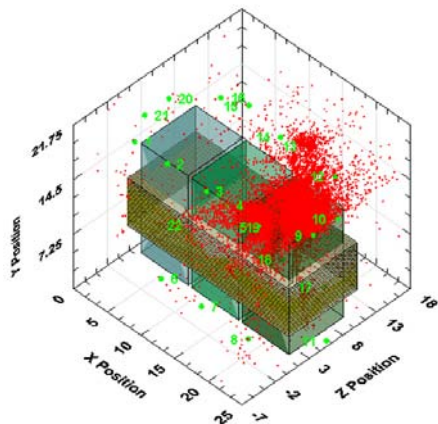
This transformer was tested continuously for 68 hours, while instrumented with 22 AE sensors. Many events were obtained over the course of the test with the event/time ratio changing dramatically. Post-test analysis indicated the existence of two clusters of events: Cluster 1 located close to H1 High Voltage Bushing and Cluster 2 located below the X1 Low Voltage Bushing. Most of the events and the highest peak amplitude were obtained in these clusters.

Three-dimensional plot showing the location of two sources

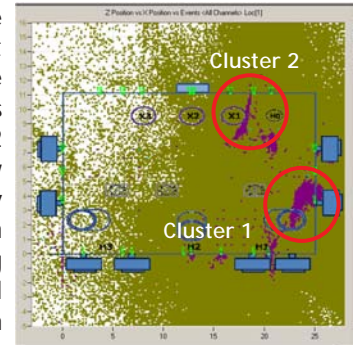
Location of the two sources in a two-dimensional plot (Top View)

The acoustic emission test indicated that the strongest acoustic activity was being detected on the upper part of the transformer. Therefore, an internal inspection was justified as the problem seemed to be located on the upper part of the core/connections area.

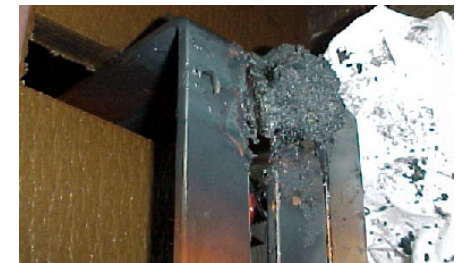
This unit remained in operation with DGA values being monitored periodically. Twelve weeks after the AE test was completed, an internal inspection was performed. Internal inspection revealed carbon build-up, due to severe overheating on one of the copper bus bars of the X1 Low Voltage bushing. This bar was also completely cracked with all of the current being carried by the other two bars (approximately 6000 A).

This fault was detected in the area where Cluster 2 was located.

Overheated bus bar with carbon build-up

The transformer was repaired on-site one week after copper bus bars were replaced. The customer estimated savings of 2 million dollars considering the time the plant would have been off-line.
