Case Study 75 - Bushing Degradation

Autotransformer, originally Westinghouse but repaired by GE in 1989. 138/69 kV, class OA/FA/FOA, 50/66/83/93 MVA, core form.

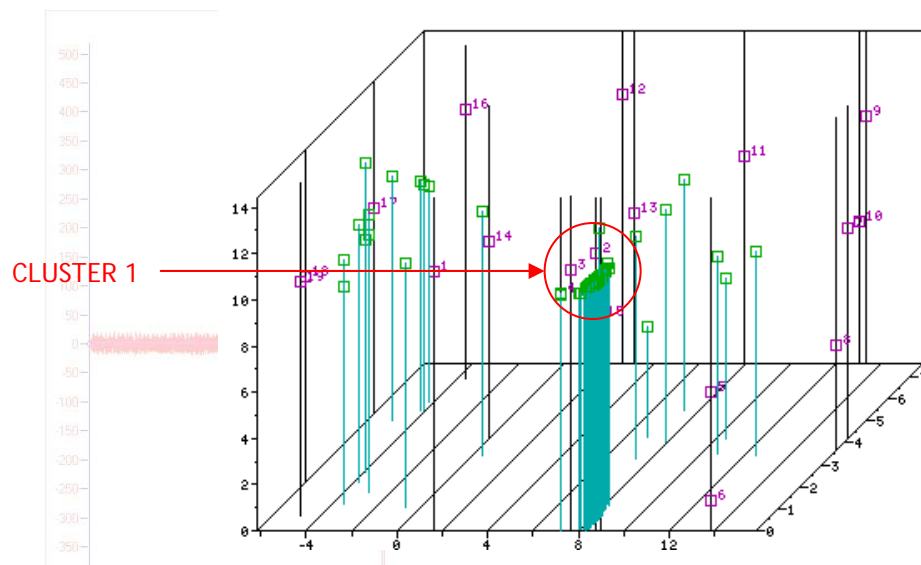
- AE Test performed in June 2003
- No acoustic activity was expected on the main tank because the gas in oil values indicate normal operation of the unit.

Cluster 1 was located a few inches from the high voltage (HV) wall, right in front of where the lower part of the H2 High Voltage bushing is located.
