Autotransformer's Degradation

In 2003, a bank of three single phase autotransformers, 500/230/13.8 kV, OA/FA/FA class, 146/194/243 MVA capacity, core type, was installed in a substation on the East Coast of the United States.

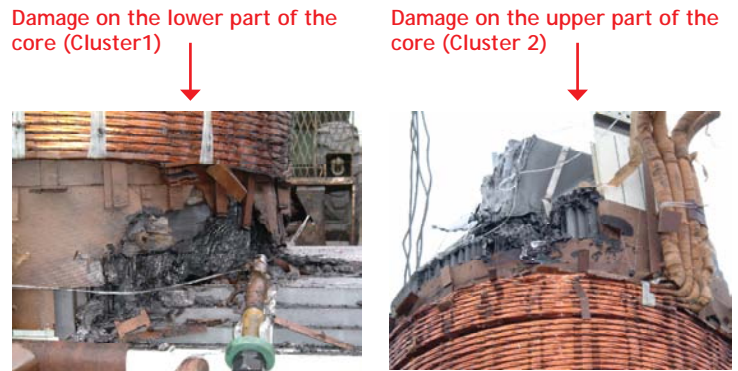
Figure 5 - Core Degradation

Once the unit failed, an internal inspection was performed and it was possible to verify the accuracy of the predicted location, see Figure 5, by detecting significant degradation on the core (upper and lower sections).

Fault investigations concluded that the catastrophic failure was due to excessive overheating and eventual melting of the silicone steel core laminations. It is suspected that particles coming from the defective core were slowly depositing on the tertiary winding and this eventually caused the fault of the unit.

Installing an Acoustic On-line Monitoring System at the end of this test could have prevented the failure of the autotransformer by detecting an increment on the intensity of the acoustic activity coming from the faulted areas.
