Autotransformer's Degradation

In 2003, a bank of three single phase autotransformers, 500/230/13.8 kV, OA/FA/FA class, 146/194/243 MVA capacity, core type, was installed in a substation on the East Coast of the United States.

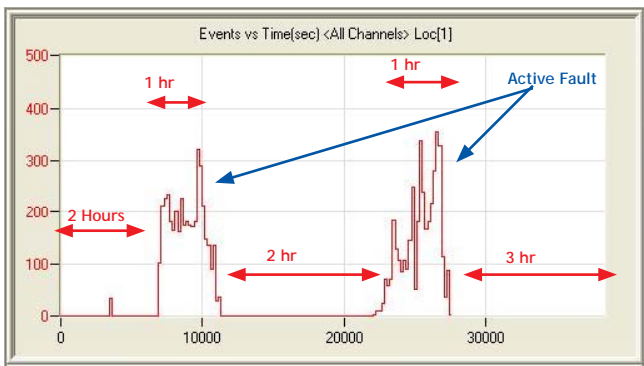
Figure 1 - Behavior of the acoustic activity detected on this unit.

During the AE monitoring, significant acoustic activity was detected, this activity presented the peculiarity of not being active all the time, as seen in Figure 1.

It can be seen that during the first 2 hours no acoustic activity was detected and suddenly there was a period of 1 hour and 13 minutes of significant activity. It was important to try to determine what was causing the changes in the amount of acoustic emission detected; therefore, the load current (monitored along with the AE) was analyzed.

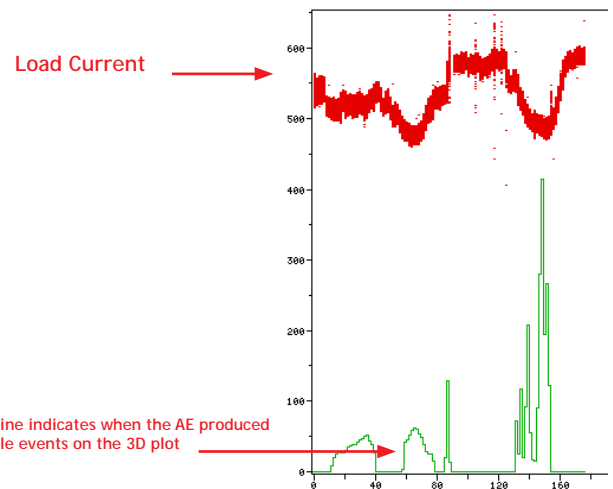
Figure 2 - Relation between load current (upper line) and AE (lower line).

It was noted that the amount of acoustic emission detected was higher when the load current was at its minimum value, see Figure 2. This behavior suggested that the fault was ONLY active when the voltage was at its maximum level. To confirm this hypothesis, we requested the voltage profile of the unit, for the period of time that it was monitored. This can be seen in Figure 3 and it shows that this assumption was correct.

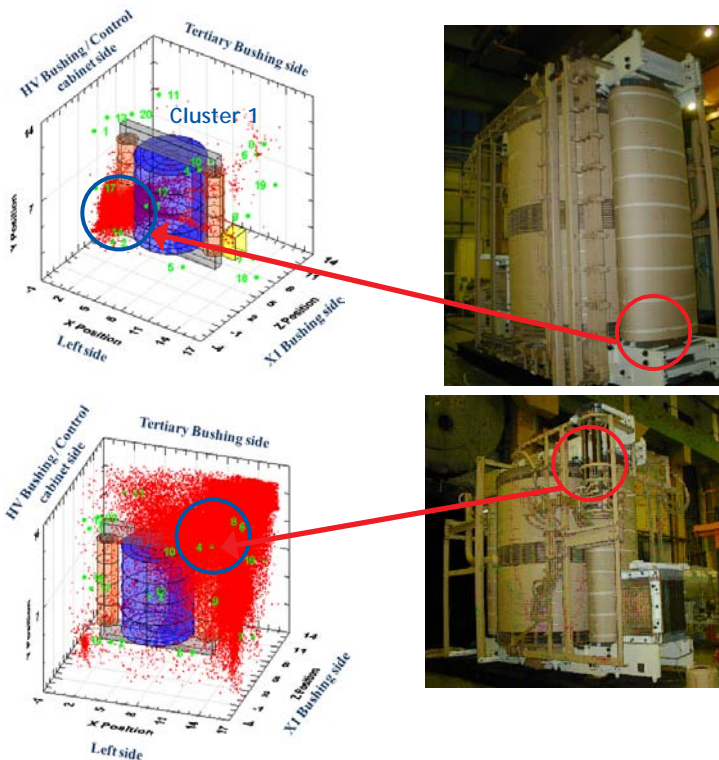
Figure 4 - Predicted location of the faults using the three-dimensional algorithm and its relative location on the transformer.

During all the AE monitoring time, the three-dimensional location algorithm was applied and as seen in Figure 4, where different locations were identified as the areas where the acoustic activity was concentrated. These areas correspond to the lower part of the core (Cluster 1) as well as the upper part of the core (Cluster 2).

Using the grading system to determine the intensity of the fault [1], "C" grades were given to both clusters and an overall grade "C" was given to the transformer (due to the low TDCG value). Based on these grades, a follow up was recommended.

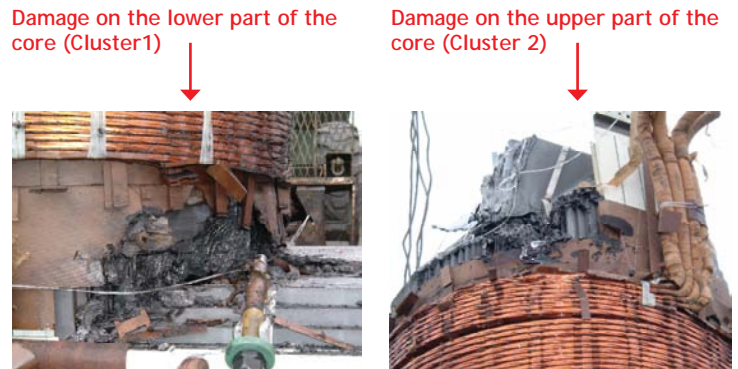
Figure 5 - Core Degradation

Once the unit failed, an internal inspection was performed and it was possible to verify the accuracy of the predicted location, see Figure 5, by detecting significant degradation on the core (upper and lower sections).

Fault investigations concluded that the catastrophic failure was due to excessive overheating and eventual melting of the silicone steel core laminations. It is suspected that particles coming from the defective core were slowly depositing on the tertiary winding and this eventually caused the fault of the unit.

Installing an Acoustic On-line Monitoring System at the end of this test could have prevented the failure of the autotransformer by detecting an increment on the intensity of the acoustic activity coming from the faulted areas.
