# CASE STUDY 8032004 - LOOSE BOLTS

- Waukesha transformer  
115/13.8 kV, 54/72/90 MVA,  
OA/FA/FA, Manufactured in 2001
- Brand new Generator Step Up  
(GSU) transformer installed after  
catastrophic failure of unit  
previously installed.
- Power plant personnel requested  
AE test to determine the  
condition of the unit.

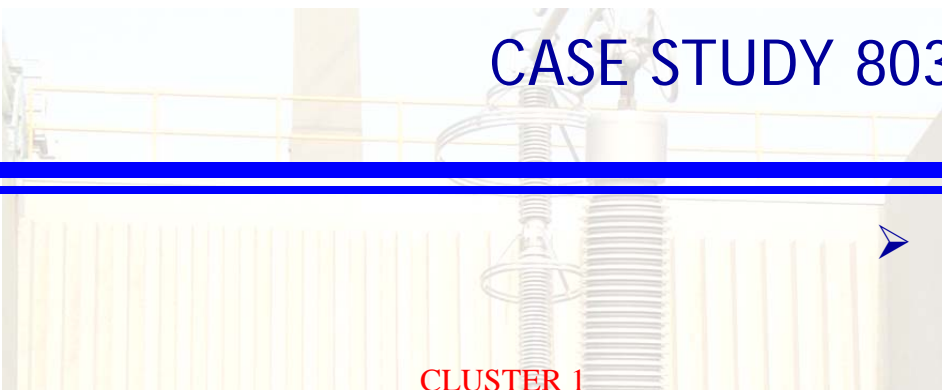
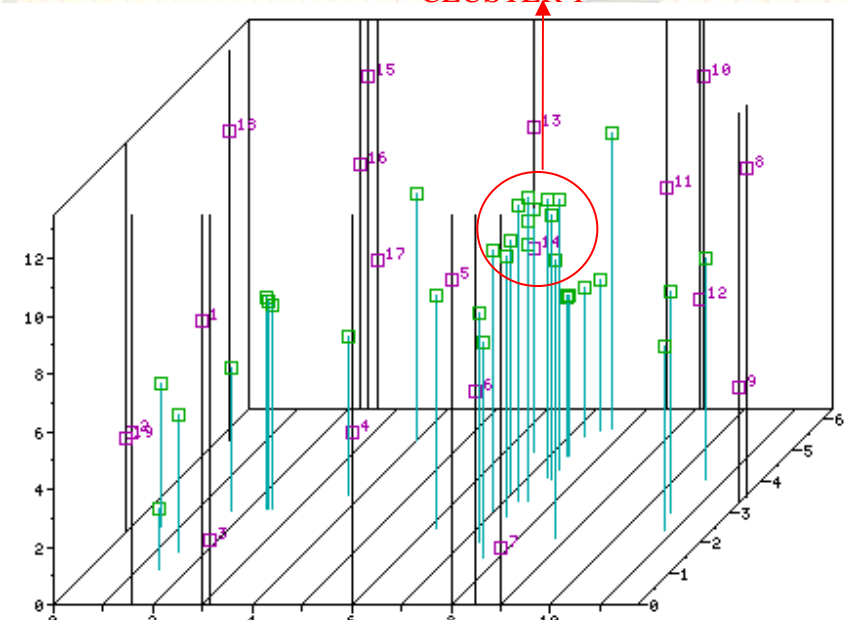
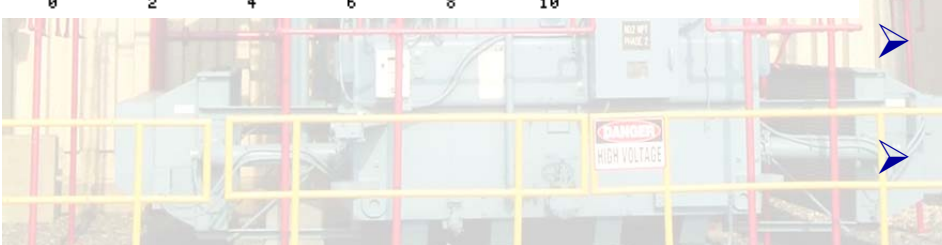
- Dissolved Gas Analysis sample before the AE test indicated a positive trend in CH<sub>4</sub> & C<sub>2</sub>H<sub>6</sub> gases.
- An infrared scan did not find any hot spots/overheating.
- 1 Cluster of events obtained in lower part of LV bushings X1 or X2
- Internal inspection revealed a few loose bolts on one of the low voltage bushings.
- Bolts were tightened.
- Unit is in service. No increase on Gas Concentrations has been observed.
