Case Study 2062006

Transformer On-line monitoring

Physical Acoustics Corporation

CASE STUDY 2062006

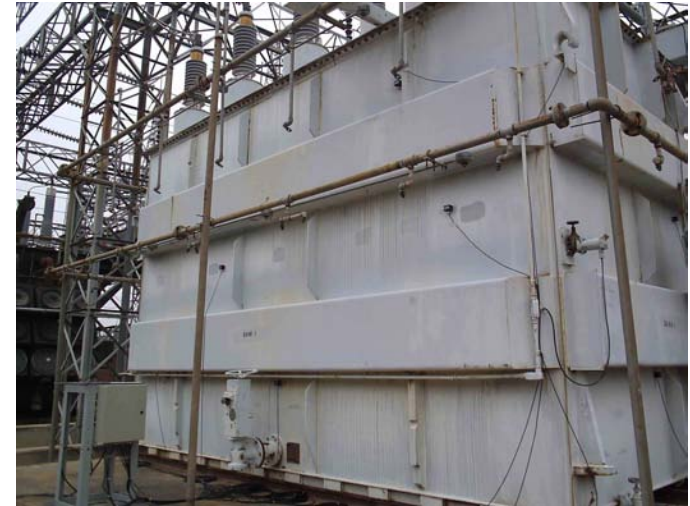
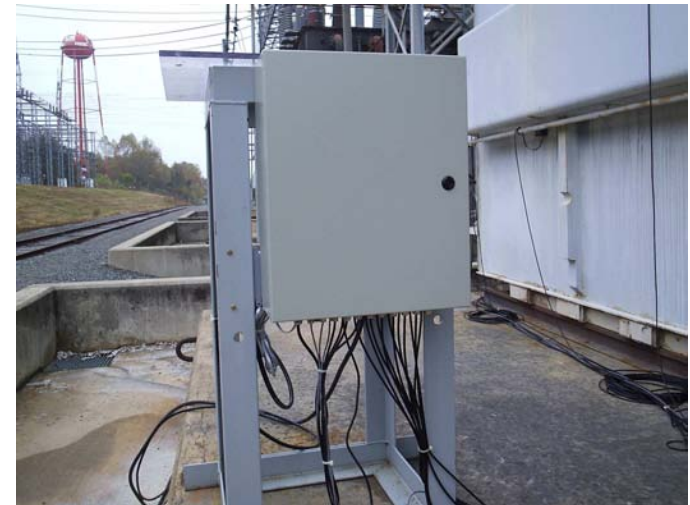
ON-LINE MONITORING

- On-line monitoring started in October 2006
- The same two areas of activity detected in June 2006 were detected during the entire monitoring period (Clusters 1 & 2).
- An on-line multiple combustible gases monitor was also installed
- No changes in TDCG were detected by the DGA monitor
- The two areas of acoustic activity corresponded to:
 - Middle section of Phase A coil
 - Upper part of Phase C coil
- The on-line system collected data from October 2006 – April 2007

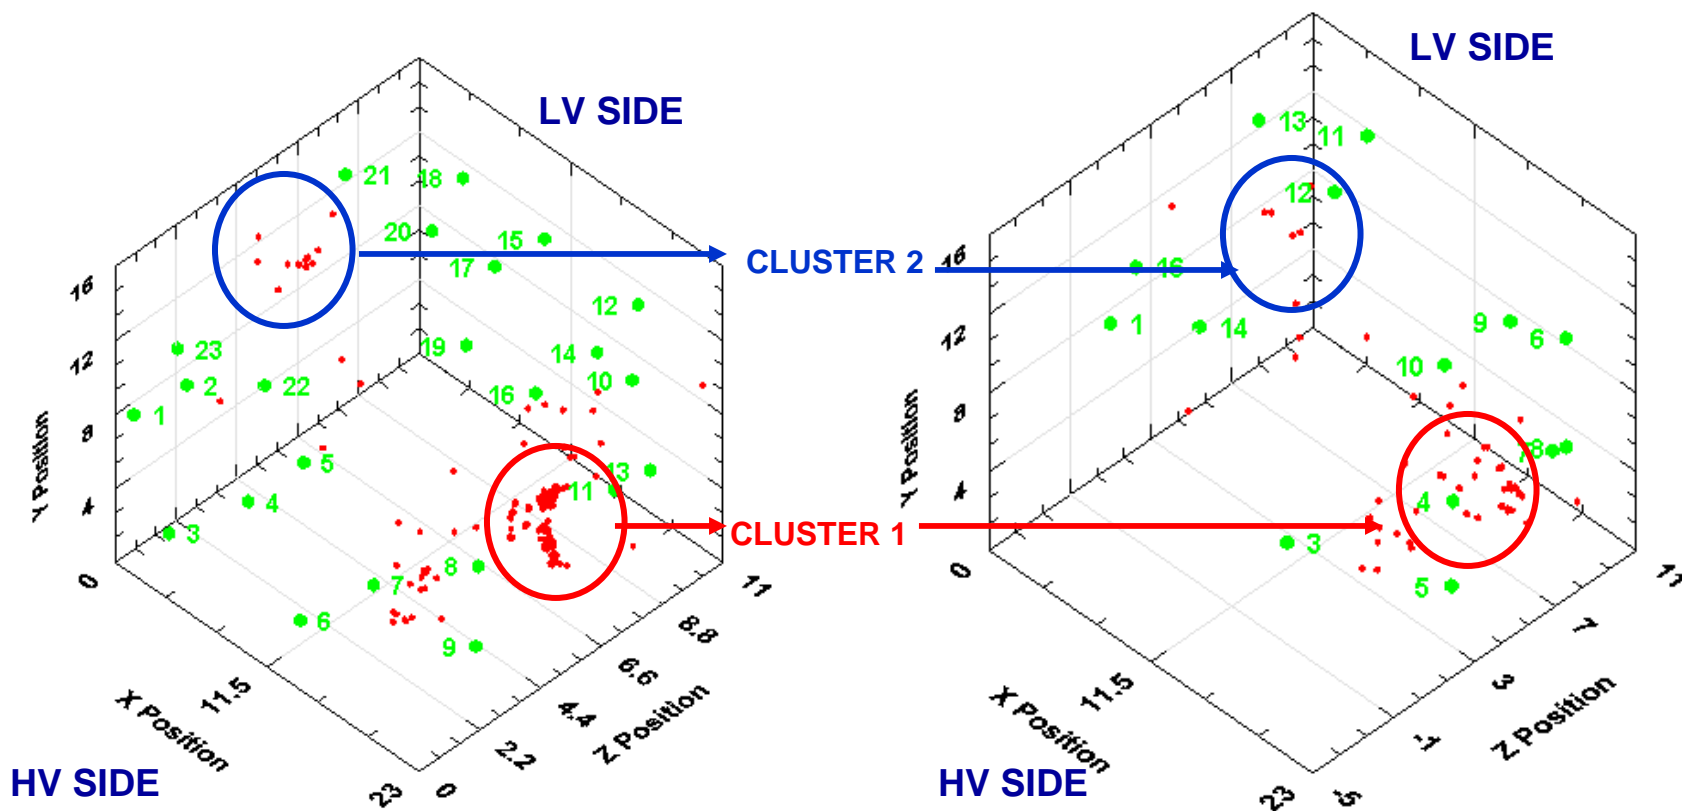
3D LOCATION PLOT

- Two areas of acoustic activity were detected (Clusters 1 & 2).

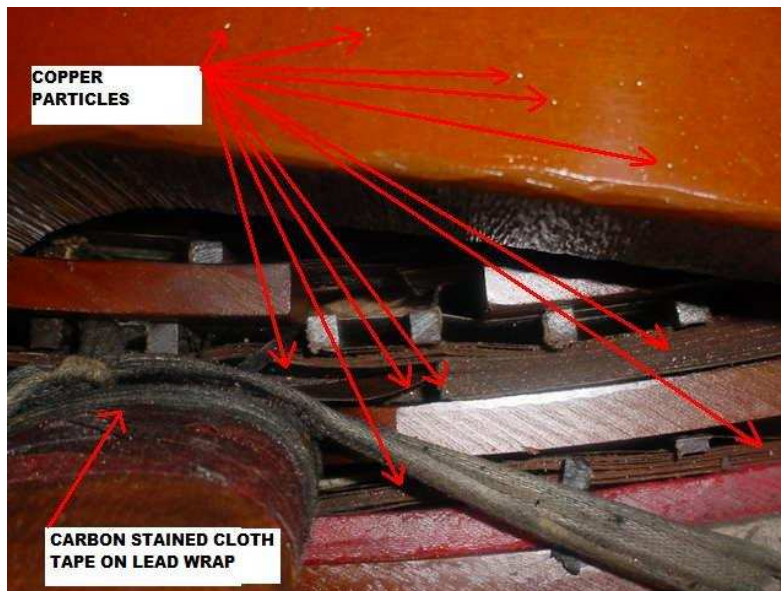
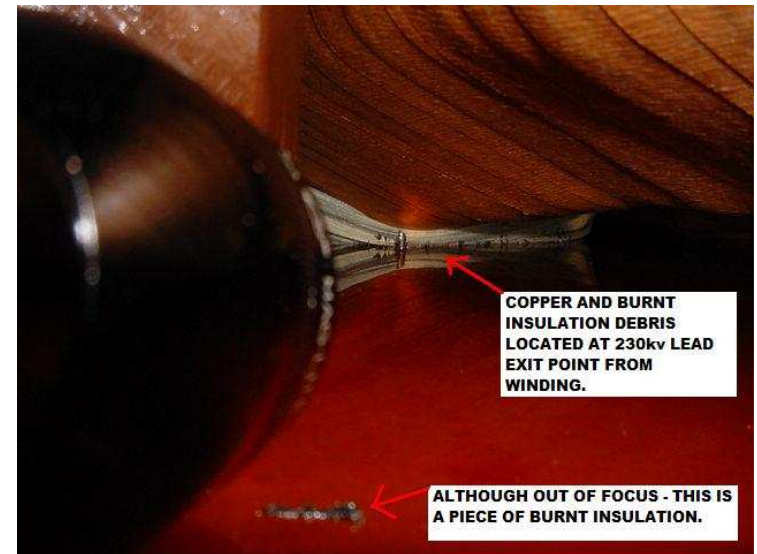
ON-SITE OVERHAUL (April 2007)

1. The general vicinity of the H3/X3/Y3 winding assembly was noted as being considerably littered with dark/carbonaceous paper.
2. This unit by design incorporates the direct flow cooling system; speculation is that this material most likely originated from the inner layers of this winding assembly with the oil flow providing the vehicle for spreading this debris.

3. There is also considerable coverage of copper particulate in and around the top of this winding. This material ranges in size from “dust” to pieces similar in stature to that of a “pinhead” with a small percentage of larger “BB” size pieces found.

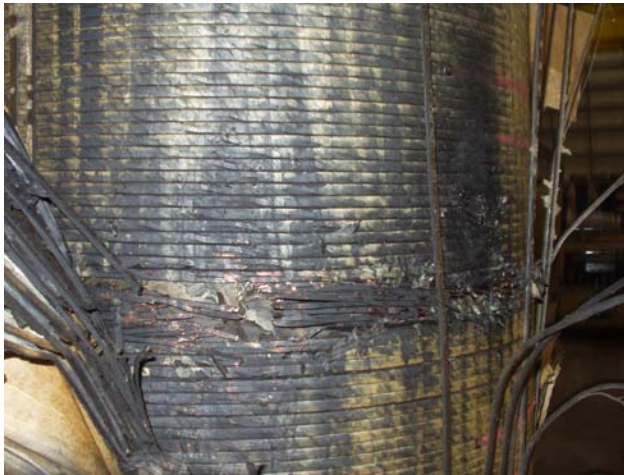
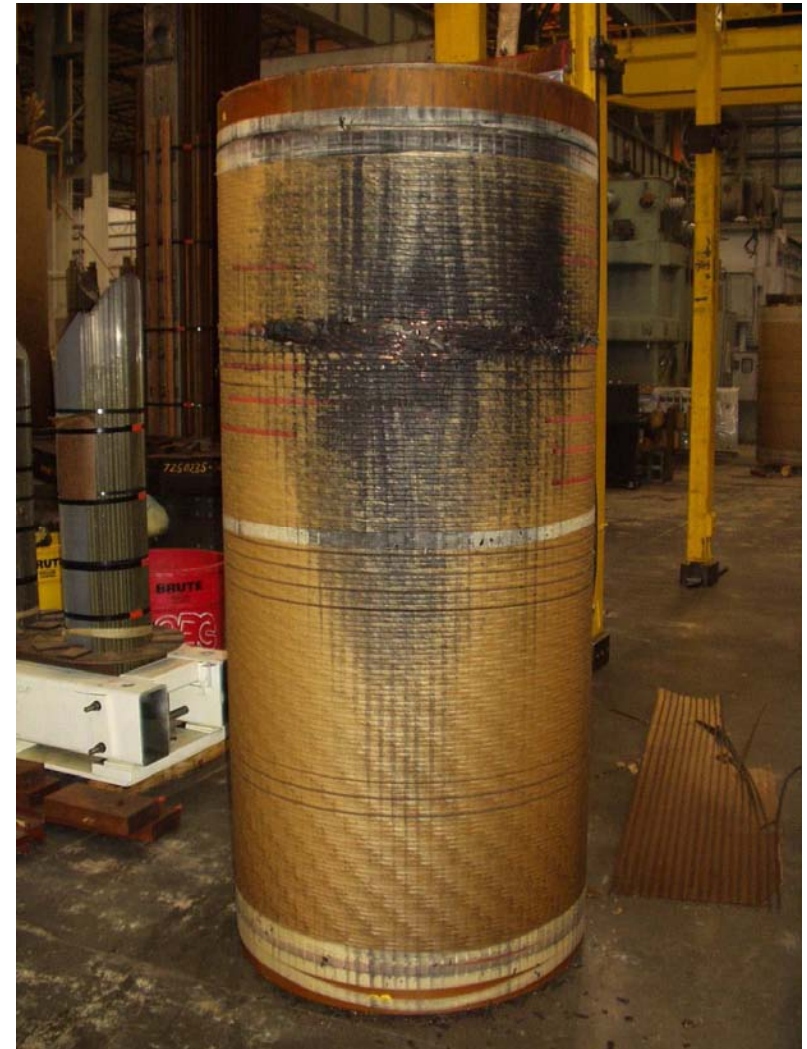
OPENED @ FACTORY (NOVEMBER 2007)

- Factory inspection indicated that the failure mode at the fault location was turn to turn in the layer winding.
- The unit remained in operation for several months under these conditions; it is possible the fault could have opened up the delta an C phase and the TV could have been running open delta.
