CASE STUDY 8032004 - LOOSE BOLTS

- Waukesha transformer
115/13.8 kV, 54/72/90 MVA,
OA/FA/FA, Manufactured in 2001
- Brand new Generator Step Up
(GSU) transformer installed after
catastrophic failure of unit
previously installed.
- Power plant personnel requested
AE test to determine the
condition of the unit.

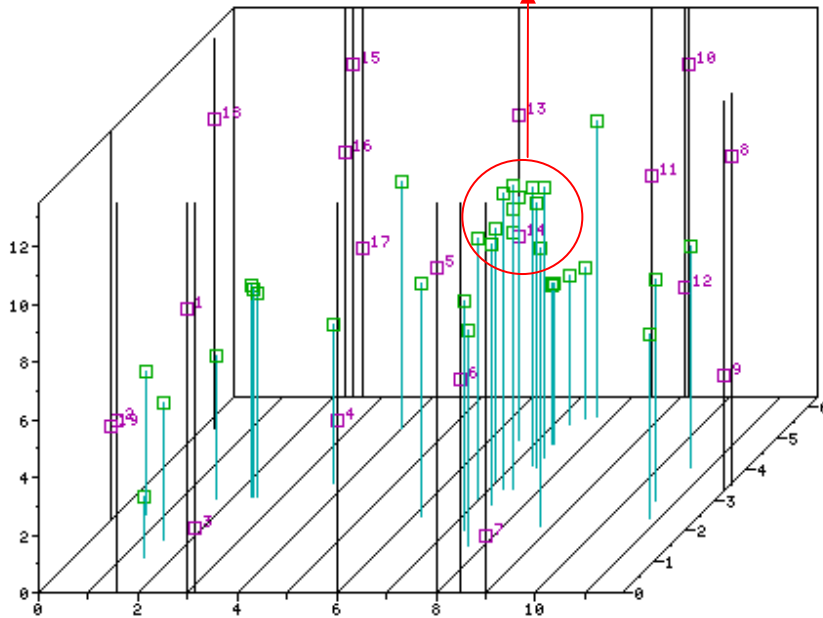
CLUSTER 1

- Dissolved Gas Analysis sample before the AE test indicated a positive trend in CH₄ & C₂H₆ gases.
- An infrared scan did not find any hot spots/overheating.
- 1 Cluster of events obtained in lower part of LV bushings X1 or X2
- Internal inspection revealed a few loose bolts on one of the low voltage bushings.
- Bolts were tightened.
- Unit is in service. No increase on Gas Concentrations has been observed.
