Case Study: Ultrasonic Phased Array Inspection of Stainless Steel Piping for Stress Corrosion Cracking

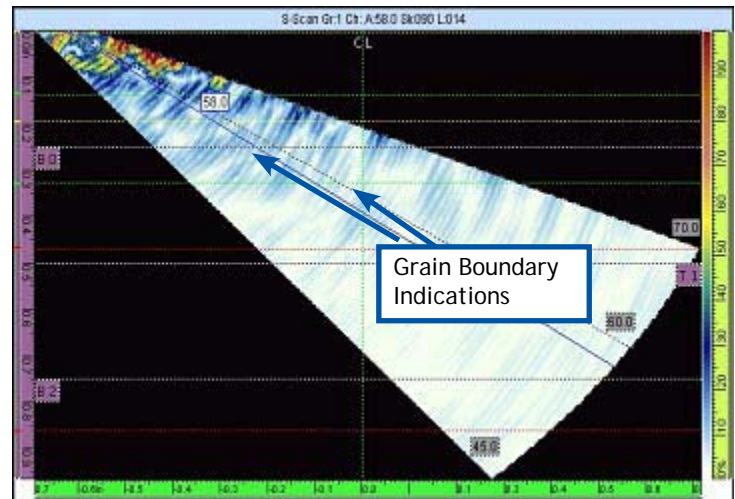
General reflections from grain boundary as captured in the sector scan for the base metal and verified under a microscope.

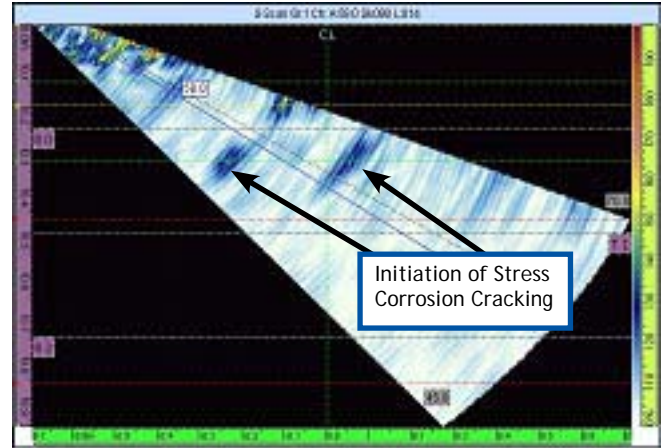
Typical responses from a cracked specimen are shown. The figure above shows the initiation of stress corrosion cracking on the ID of the piping.

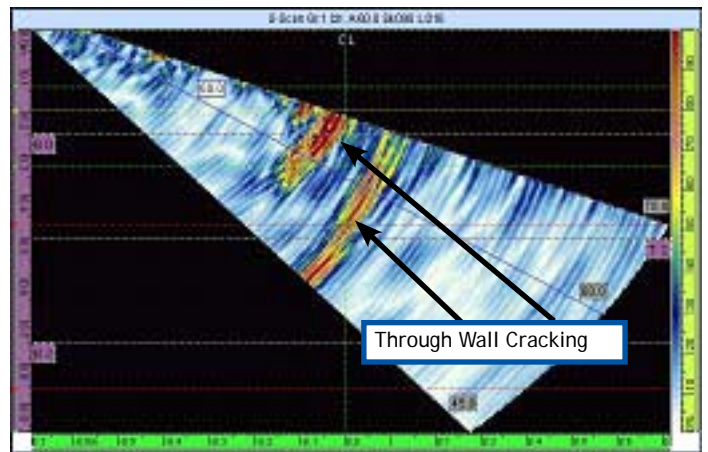
The figure below shows the through-wall indication going from the root to the cap on the second leg of the scan. The coarseness of the grain structure is obvious from the distortion in the reflected signal. Focusing of the beam has greatly minimized this distortion.
