ACTUAL PLANT EXPERIENCE RESULTS OF AN ACOUSTIC MONITORING SYSTEM (AMS) FOR HRSG'S EARLY TUBE LEAK DETECTION

Presented at USA HRSG Forum on 09/24/2021.

(Tham) Thamarai P. Chelvan

UNIT 12 HRSG's FIRST TUBE LEAK EVENT (FEB. 4, 2013) INDICATED BY HIGH MAKE-UP WATER USE AT HP ECON 2-1 AFTER ABOUT 3 YEARS FROM COMMERCIAL OPERATION & ITS IMMEDIATE SHUT DOWN & REPAIR

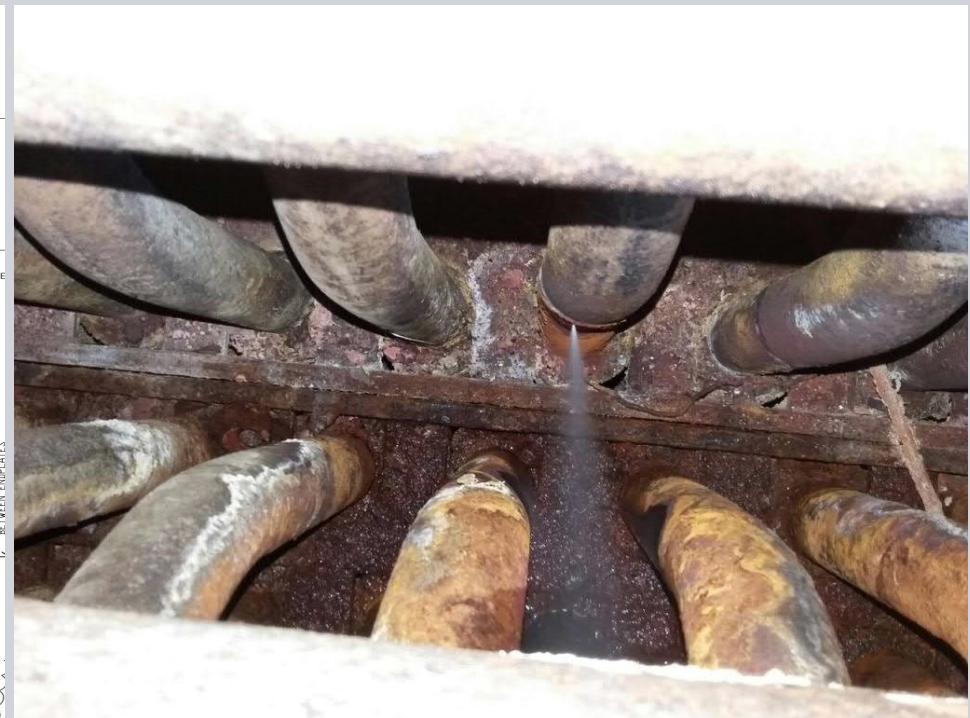
(VIDEO SHOWS THE LEAK BY FAC AT CONDENSATE PREHEATER 2 LHS MODULE – OCCURRED DURING OCTOBER 2016 – SEE THE RED DOT)

- High Sound Level of the Leak
- How the Leak Jet impinges to the adjacent tube row causing erosion & corrosion (see the discoloration at bottom 3 tubes due to wide spray angle water jet impingement during HRSG operation)

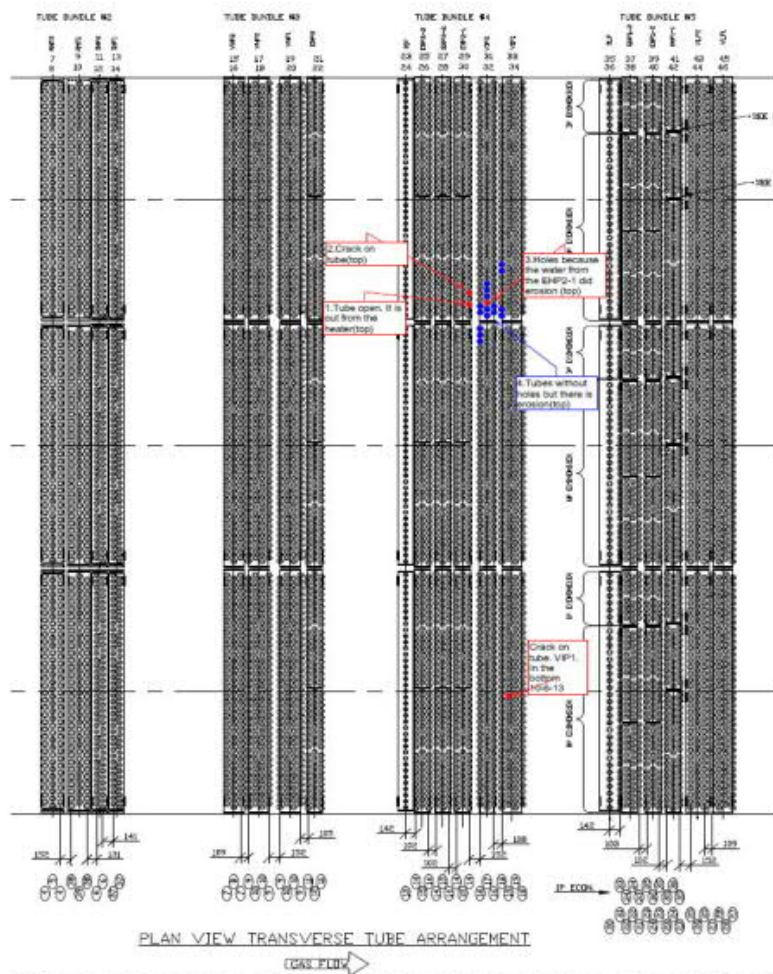
UNIT 12 HRSG's ADDITIONAL TUBE LEAKS DUE TO FEW MONTHS OF CONTINUED OPERATION WITH LEAK (FOUND ON 6/10/2013) - PRIMARY TUBE LEAK CRACKS & SECONDARY WATER JET EROSION & CORROSION DAMAGE TO ADJACENT ROW TUBES

1. Full Circumference Cracked Tube No. 3 (Red) & 2. Partially Cracked Tube No.5 (Red) at Tube Joint on Header 29 as Primary Source of Water Jet Leak

3. Hole on VIP2 tube (Red) Due to HP2-1 Tube Leak Water Jet Erosion

4. Erosion & Corrosion Damage on VIP2 Tubes (Blue) Due to HP2-1 Tube Water Jet Leak

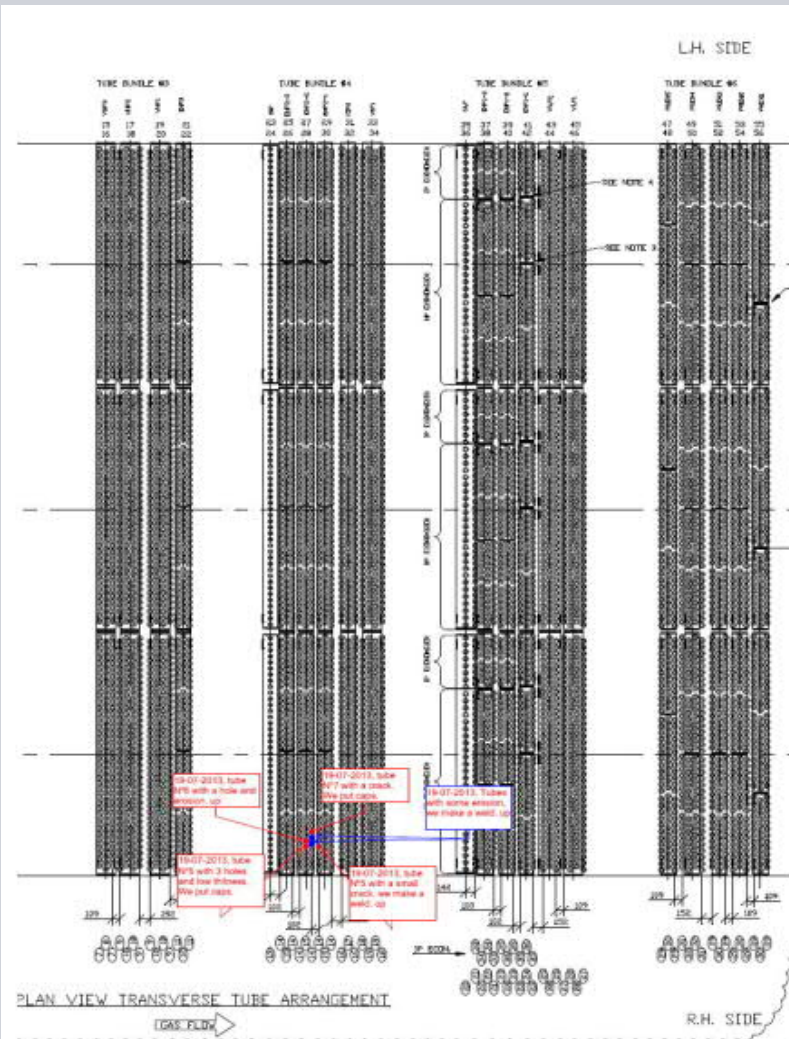
UNIT 11 HRSG's PRIMARY & SECONDARY TUBE LEAKS FOUND ON JULY 19, 2013, AFTER FINDING PRIMARY & SECONDARY TUBE DAMAGES IN UNIT 12.

Enlarged View of the Damaged Tubes Section

Primary Leak Source - Crack Facing Header 27 at Front Row Tube No. 5 Joint of Header 29 – See Water Jet Leak Area Marks

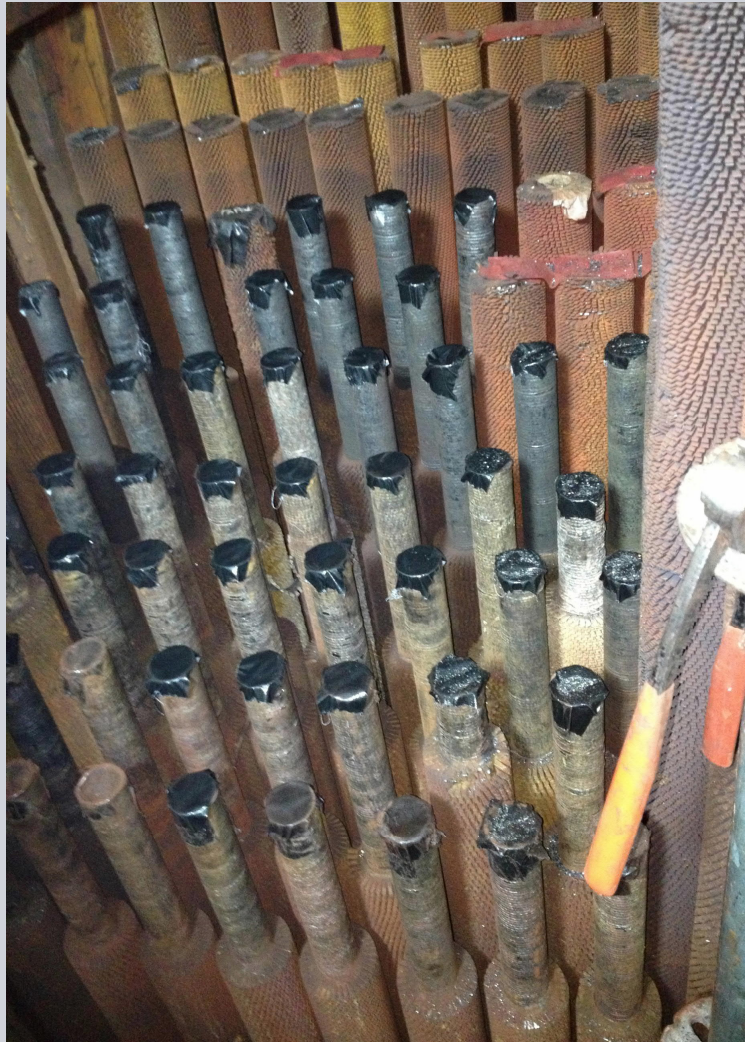
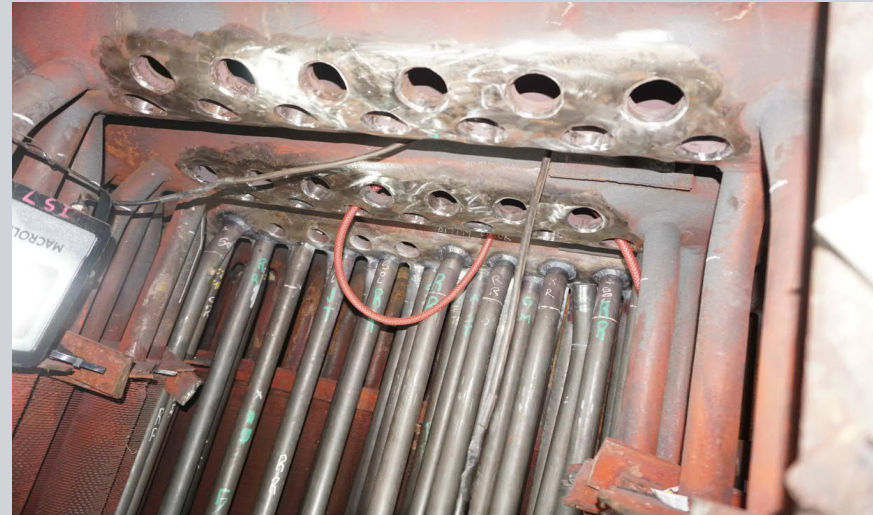
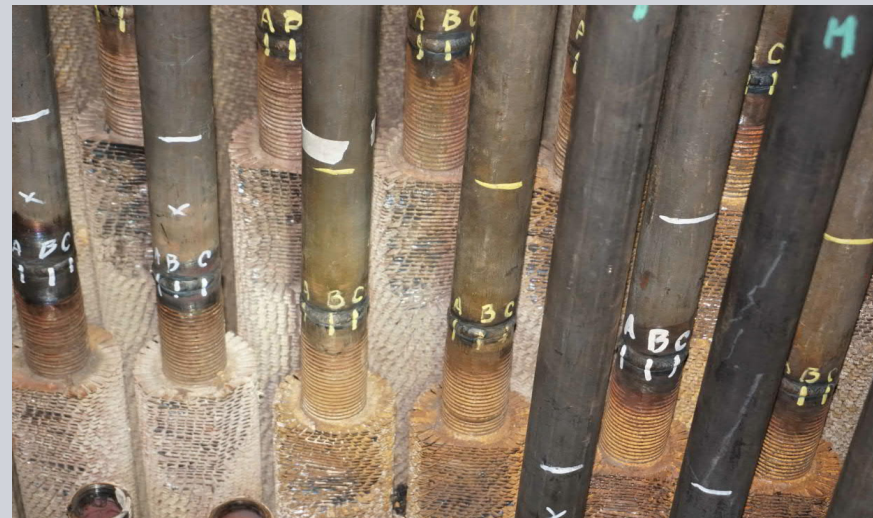
UNIT 11 HRSG's PRIMARY & SECONDARY TUBE LEAKS FOUND ON JULY 19, 2013 & REPAIRS PERFORMED PHOTOS

Tube No: 5 & 6 on Header 27 with Holes & Low Thickness Due to Erosion & Corrosion

Tube No: 7 on Header 27 with a Crack & Tube Plug with Header Window Cutting Method

Erosion & Corrosion Damage (Blue) on Header 27 Due to HP2-1 Tube No: 5 Water Jet Leak

**PRIMARY & SECONDARY TUBE DAMAGES RESULTED IN EXPENSIVE
& EXTENSIVE MULTIPLE ROWS OF TUBE CUTTING FOR ACCESS AND
REPAIR WELDING WITH NEW REPLACEMENT PLAIN TUBE SECTIONS
(SPENT >\$1.5 MILLION US\$ FOR TWO MODULES REPAIR, ONE IN EACH UNIT)**

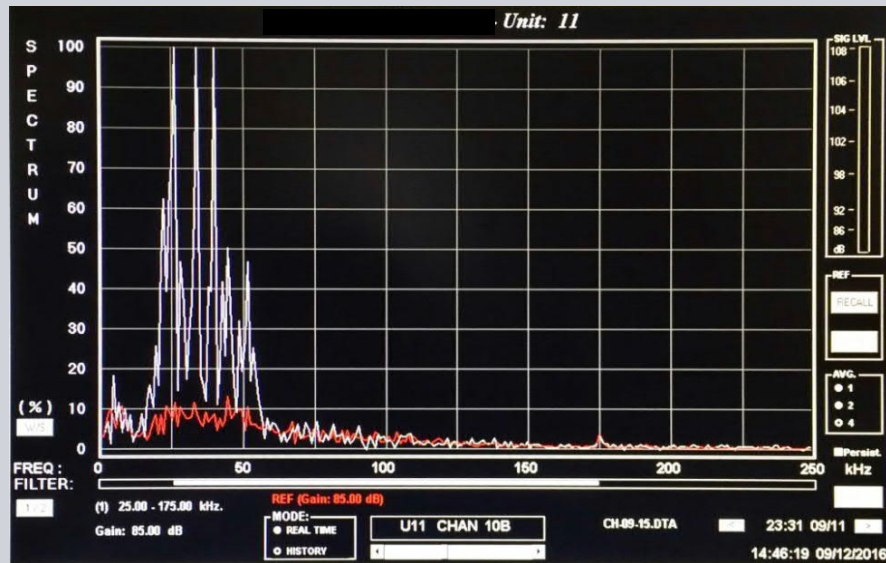
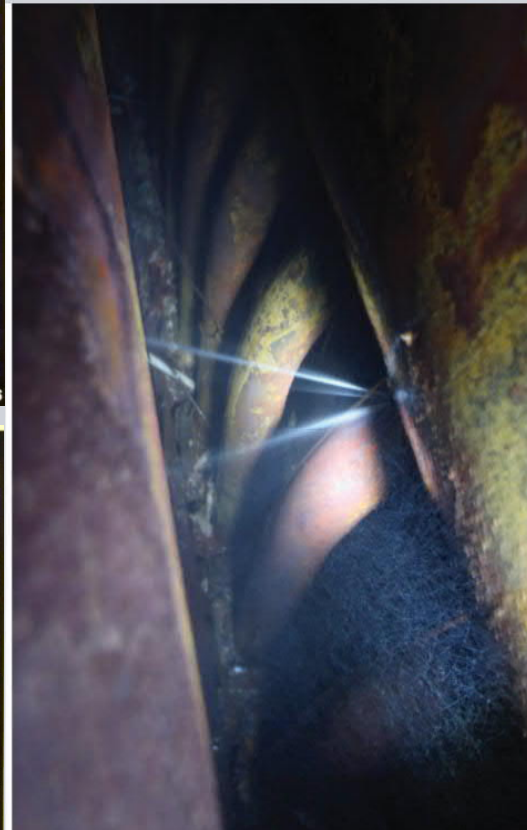
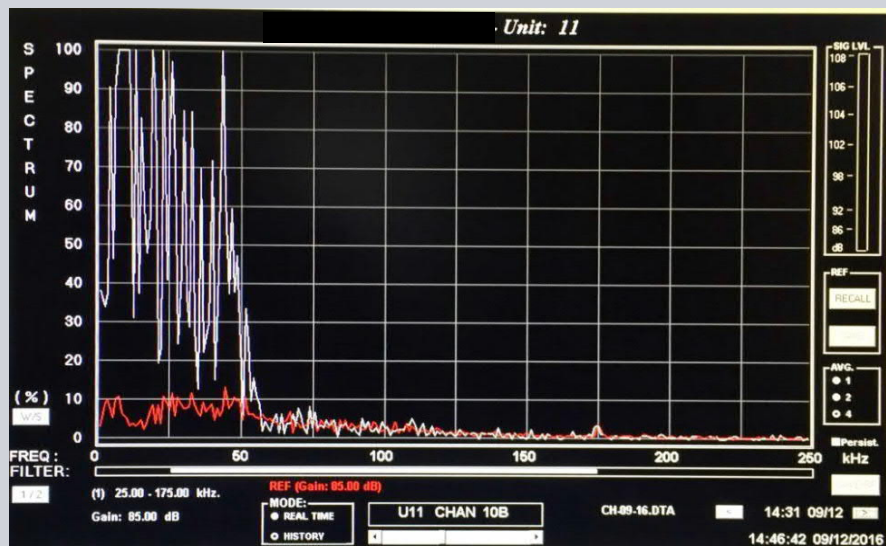
FREQUENCY DISTRIBUTION OF THE ENERGY FOR AFTER THE LEAK SIGNALS (9/12/2016 HP ECON 2-1 ACTIVE TUBE LEAK LOCATION PHOTO)

9/12/2016 – Found Leak Jets at HP Econ 2-1
Tube No. 5 Front Row of Top Header 29 - LHS
Module - Channel 10 B Area

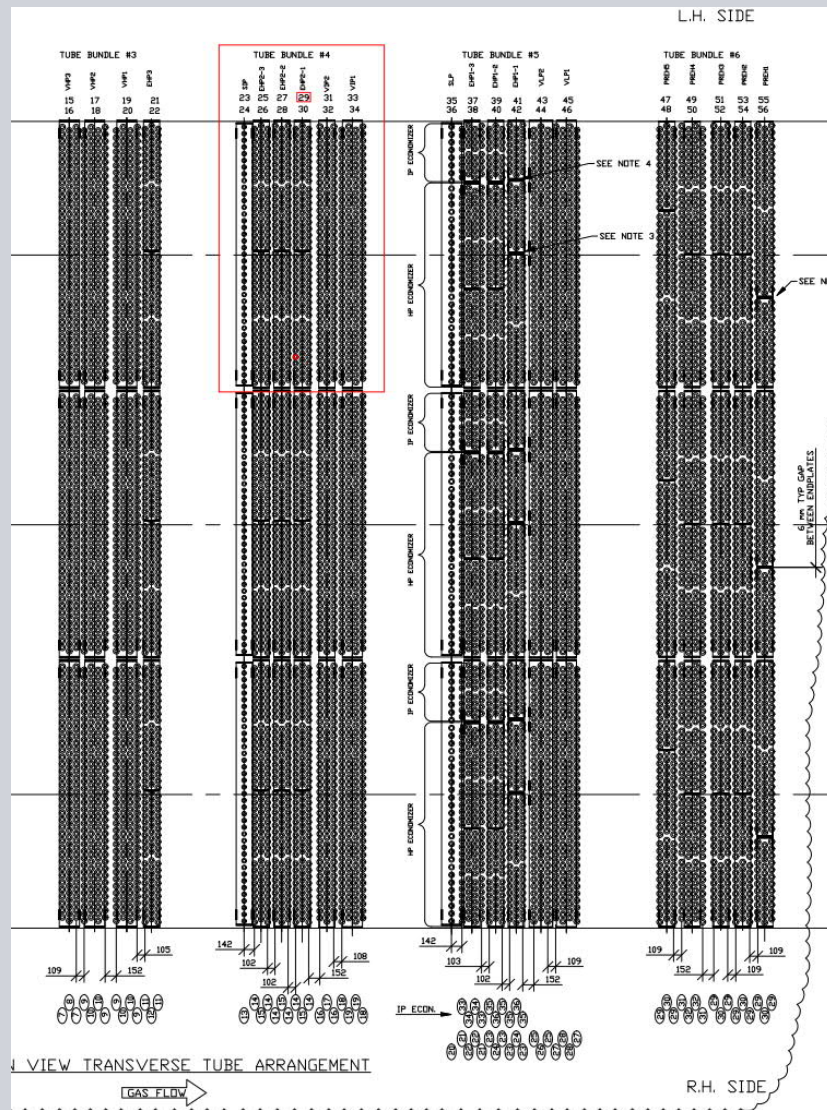
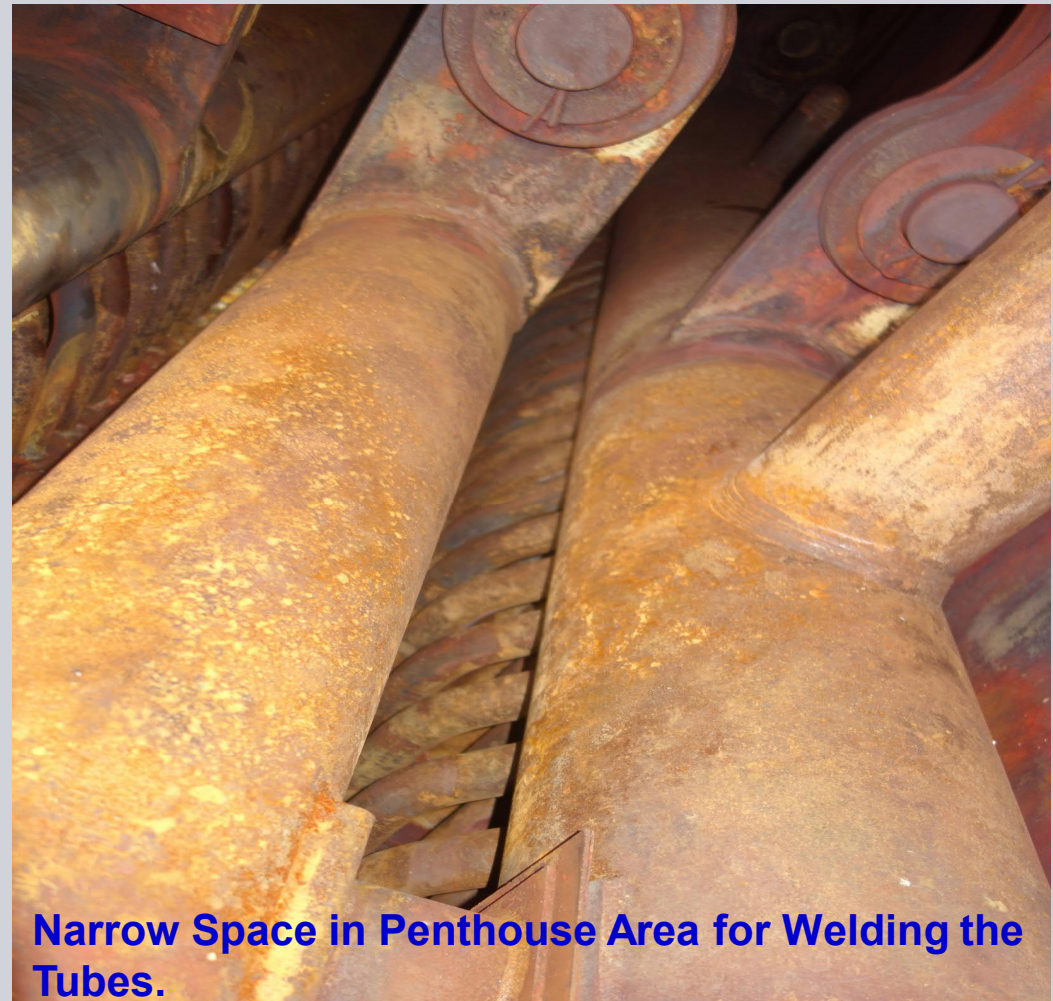
1ST TUBE LEAK DETECTION BY AMS AFTER 2 MONTHS OF ITS INSTALLATION AT SUBJECT PLANT (9/12/2016 HP ECON 2-1 TUBE NO. 5 FRONT ROW ON TOP HEADER 29 LOCATION & PHOTO OF NARROW AVAILABLE PENTHOUSE AREA SPACE FOR WELDING ACCESS)

Narrow Space in Penthouse Area for Welding the Tubes.

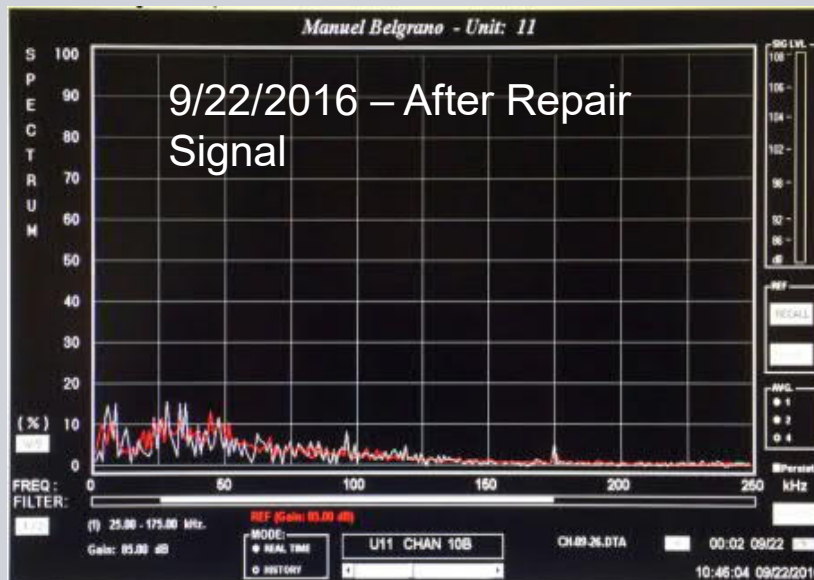
9/12/2016 HP ECON 2-1 TUBE NO. 5 TOP HEADER - AFTER REPAIR WELDING PHOTOS & AFTER REPAIR SIGNALS TREND

After Repair Signals Went Back To Normal Level

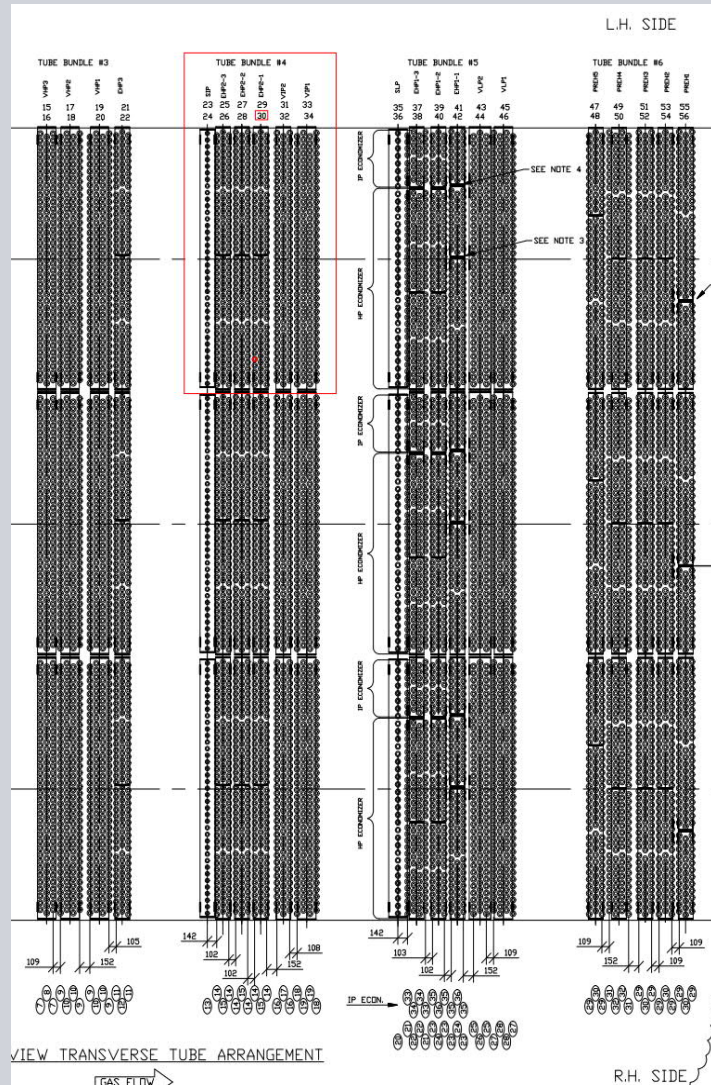
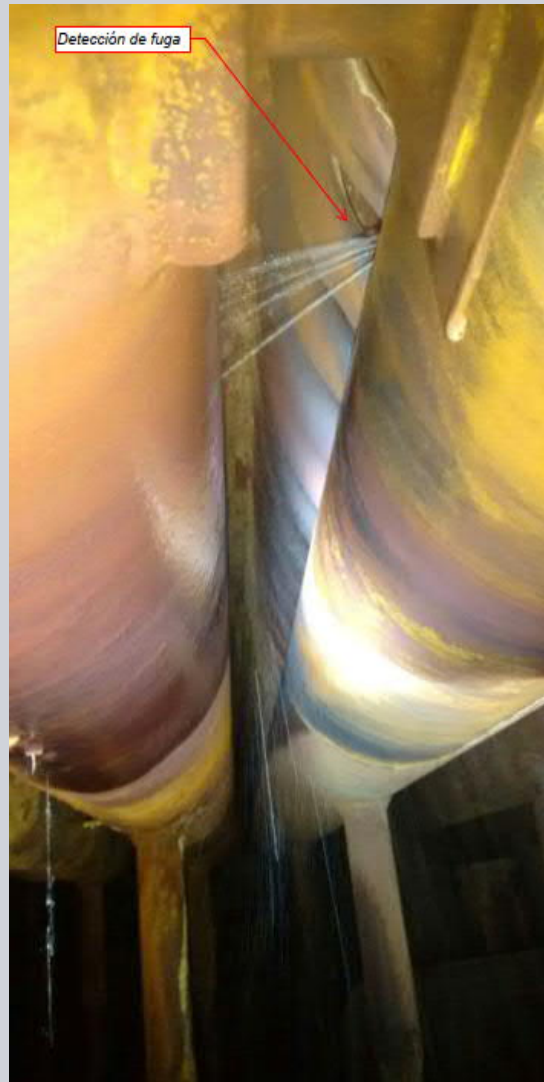
2ND TUBE LEAK DETECTION BY AMS (01/15/2017 HP ECON 2-1 TUBE NO: 5 FRONT ROW AT BOTTOM HEADER 30 LHS MODULE - LEAK LOCATION & REPAIR PHOTO)

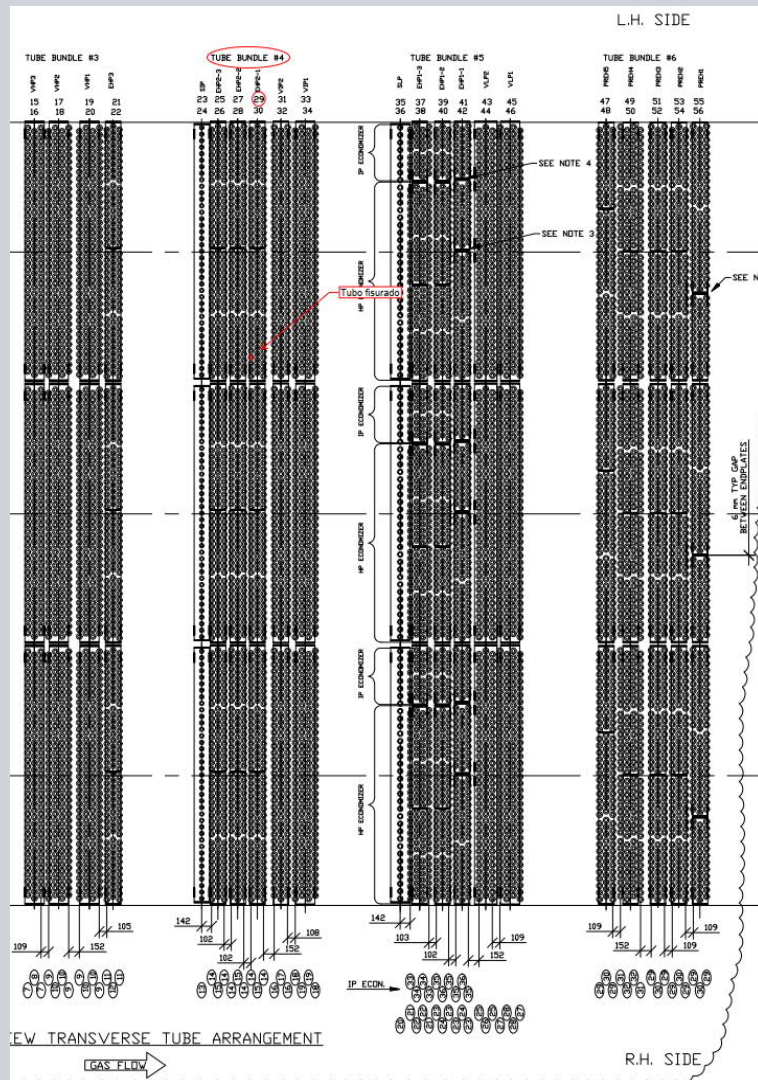
3RD TUBE LEAK DETECTION BY AMS (10/19/2017 HP ECON 2-1 TUBE NO. 4 FRONT ROW ON HEADER 29 LHS MODULE- TUBE LEAK LOCATION & REPAIR PHOTOS)

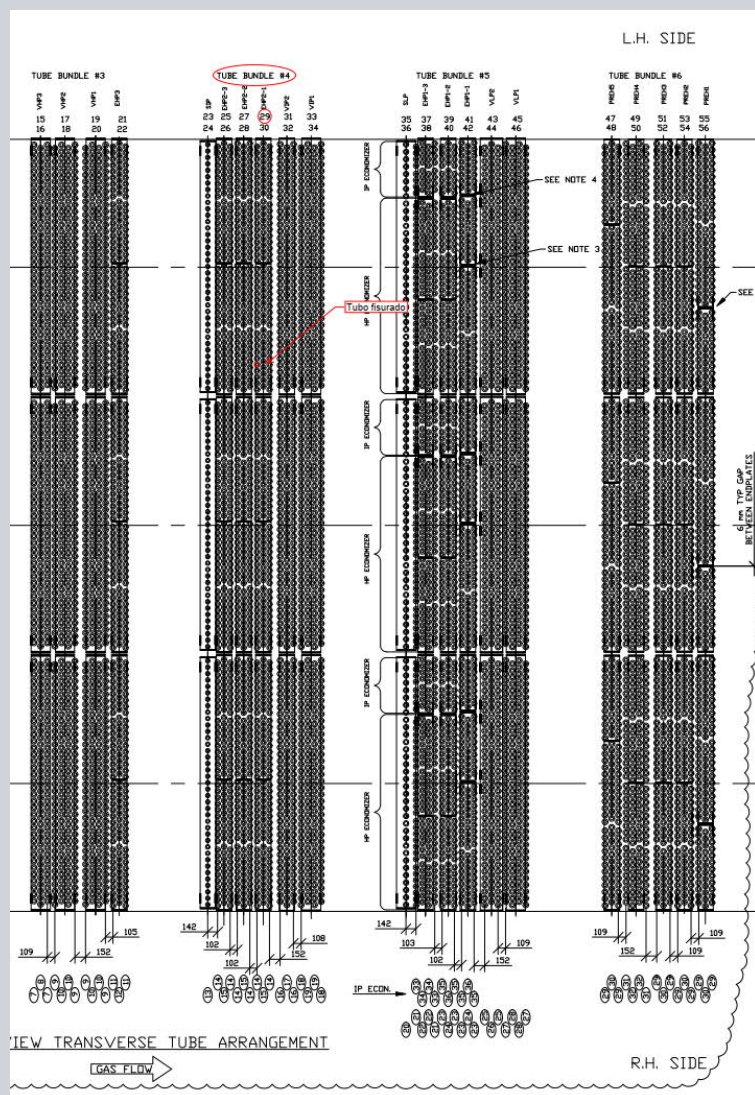
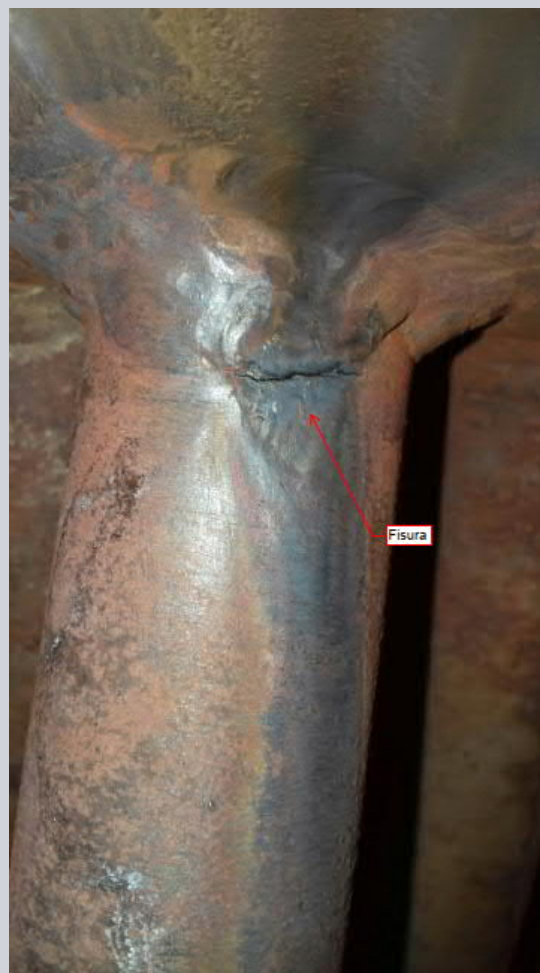
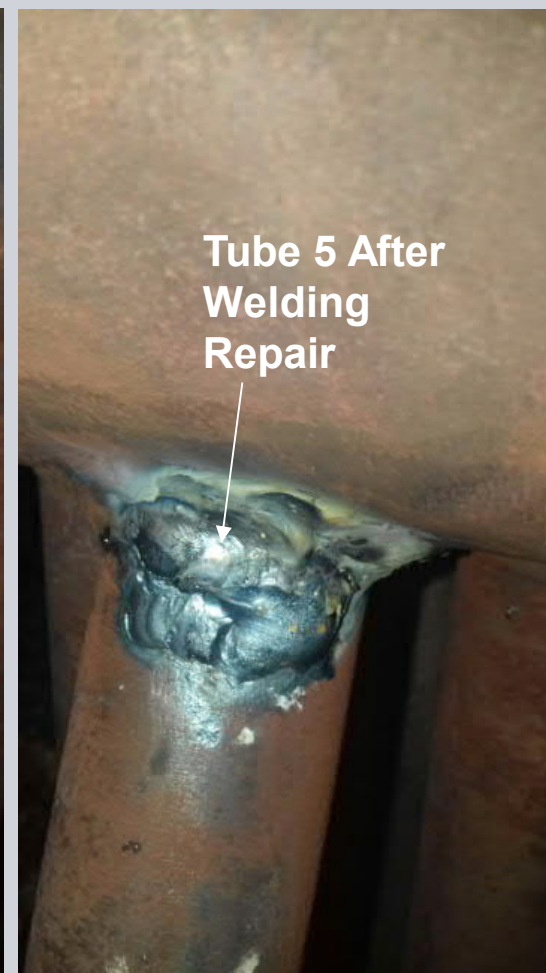
3RD TUBE LEAK DETECTION BY AMS (10/19/2017 HP ECON 2-1 TUBE NO. 5 FRONT ROW ON HEADER 29 LHS MODULE – TUBE LEAK LOCATION & REPAIR PHOTOS – CRACK AT THE SAME WELD OF THE 1ST TUBE LEAK REPAIR)

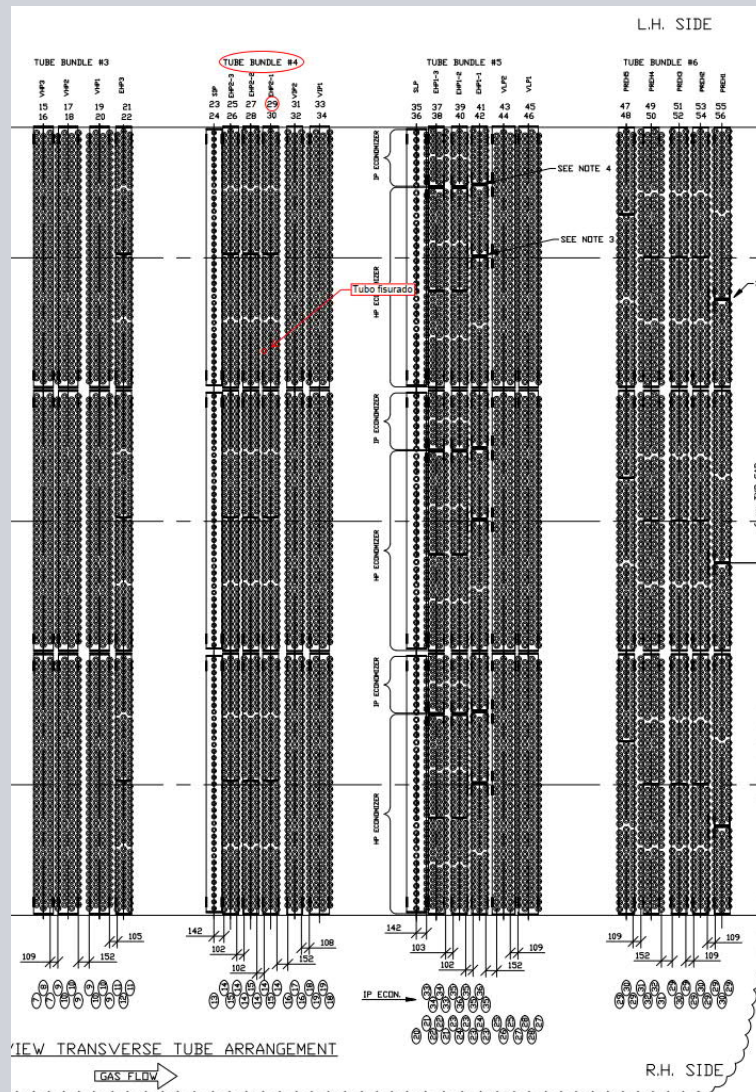
4TH TUBE LEAK DETECTION BY AMS (03/10/2018 HP ECON 2-1 TUBE NO: 6 FRONT ROW ON HEADER 29 LHS MODULE – LEAK LOCATION & REPAIR PHOTOS)

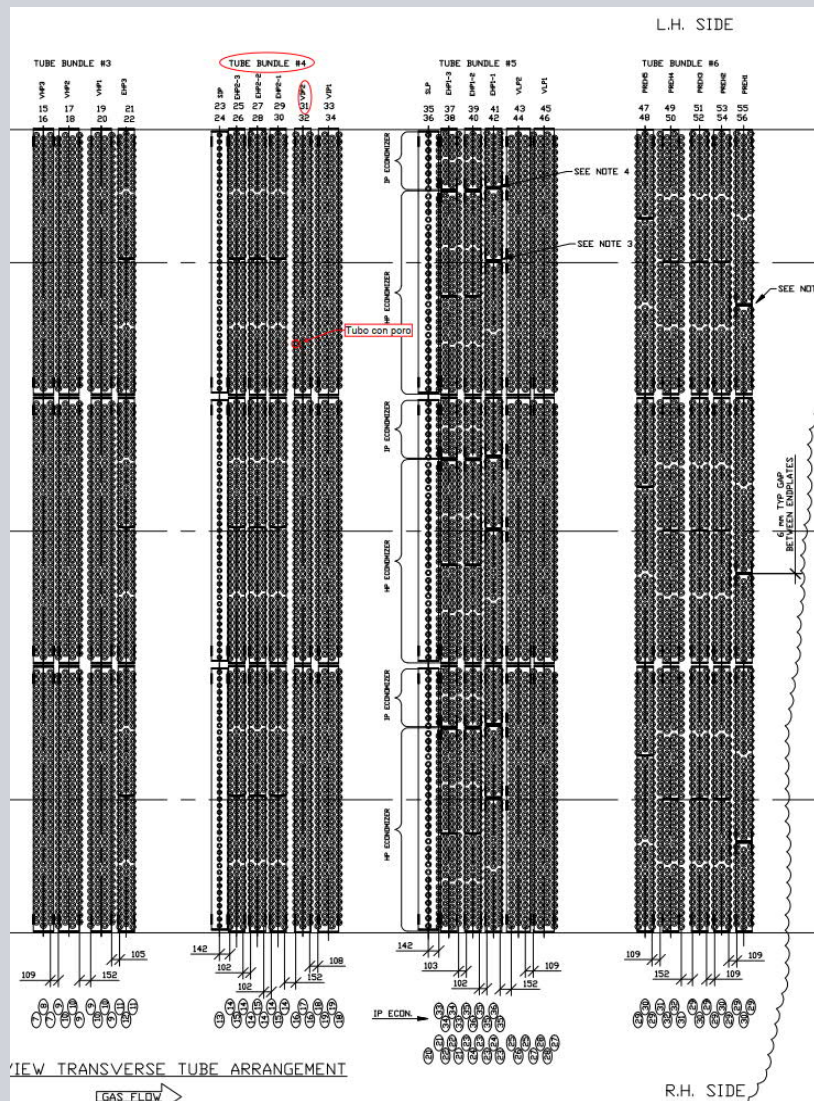
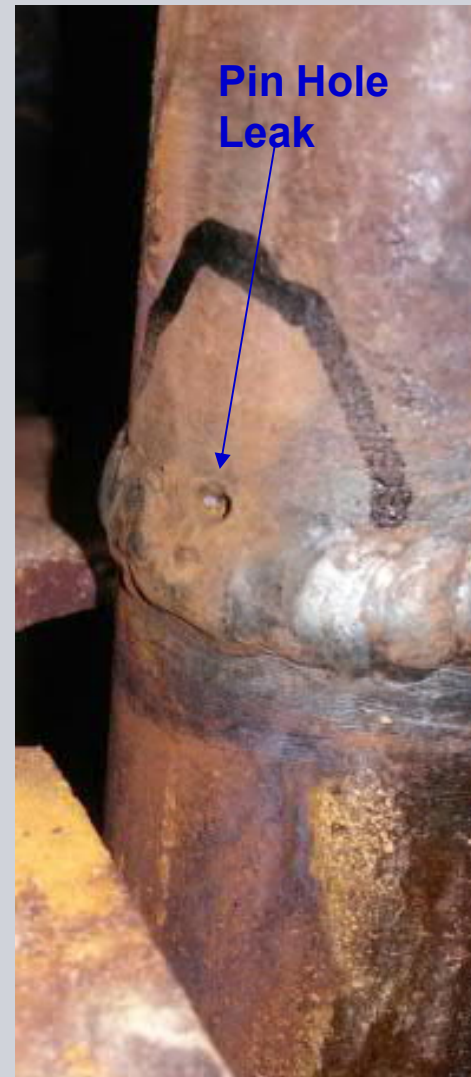
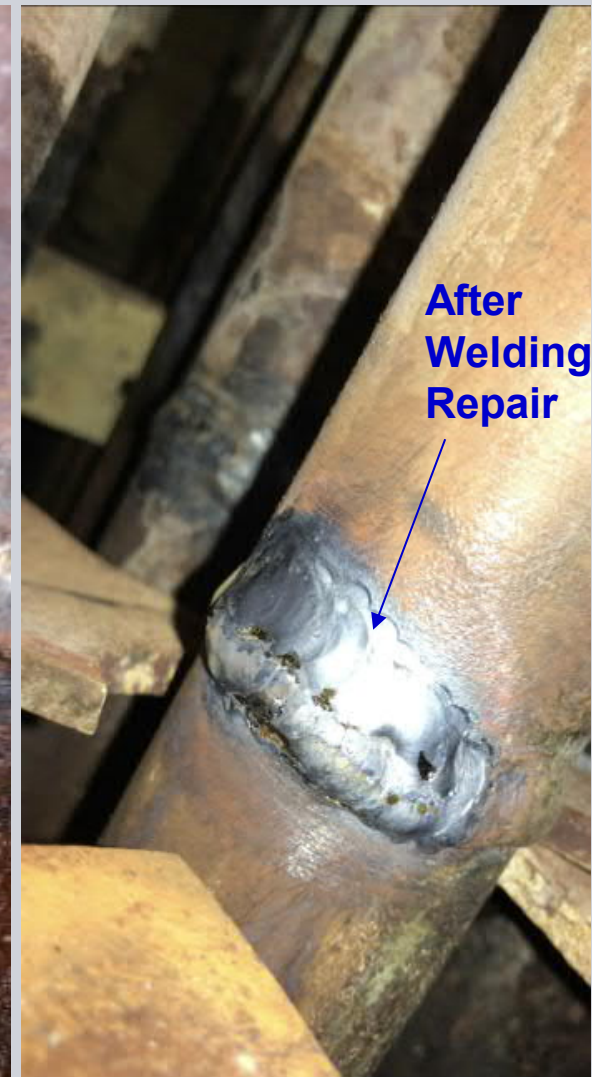
5TH TUBE LEAK DETECTION BY AMS (11/05/2018 IP EVAPORATOR PIN HOLE TUBE LEAK – LEAK LOCATION & AFTER REPAIR PHOTOS)

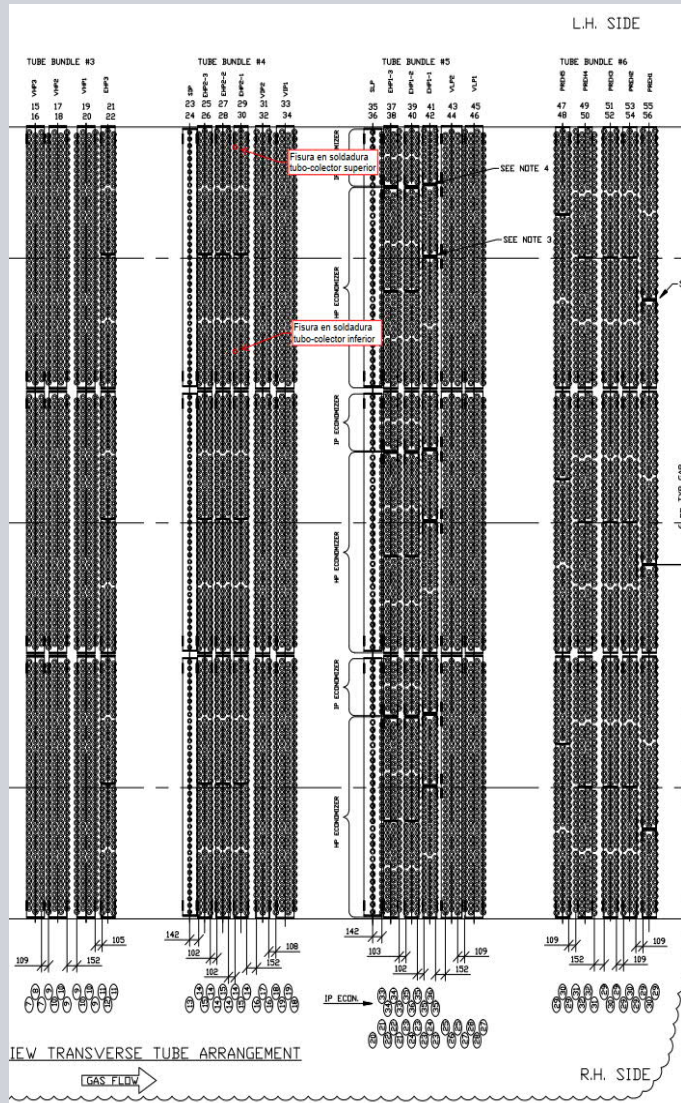
6TH TUBE LEAK DETECTION BY AMS (HP ECON 2-1 TUBE NO: 5 BOTTOM HEADER NO: 30 & TUBE NO: 37 AT TOP HEADER 29 FRONT ROW TUBES – LHS MODULE (01/06/2020) – LEAK LOCATION & REPAIR PHOTOS)

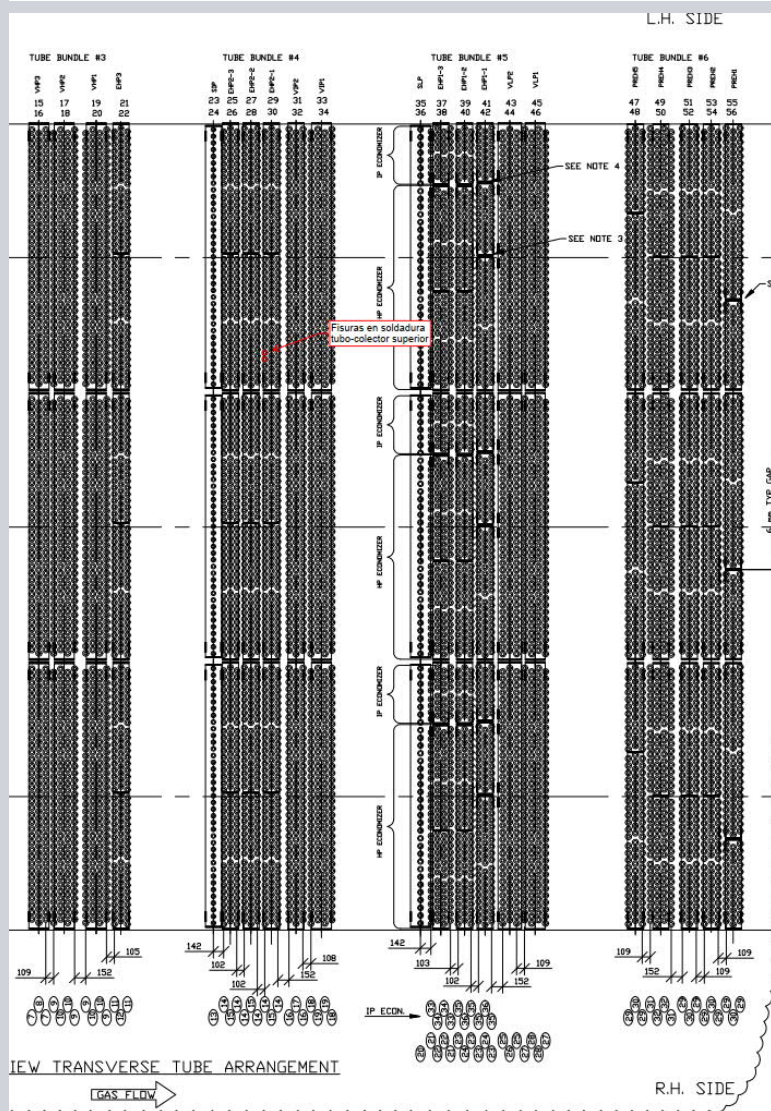
7TH TUBE LEAK DETECTION BY AMS (HP ECON 2-1 TUBE NO: 5 & 6 FRONT ROW OF TOP HEADER 29 LHS MODULE (02/08/2020) – LEAK JET LOCATION & REPAIR PHOTOS – SAME TUBES OF 3RD & 4TH INCIDENCE WELD REPAIRS

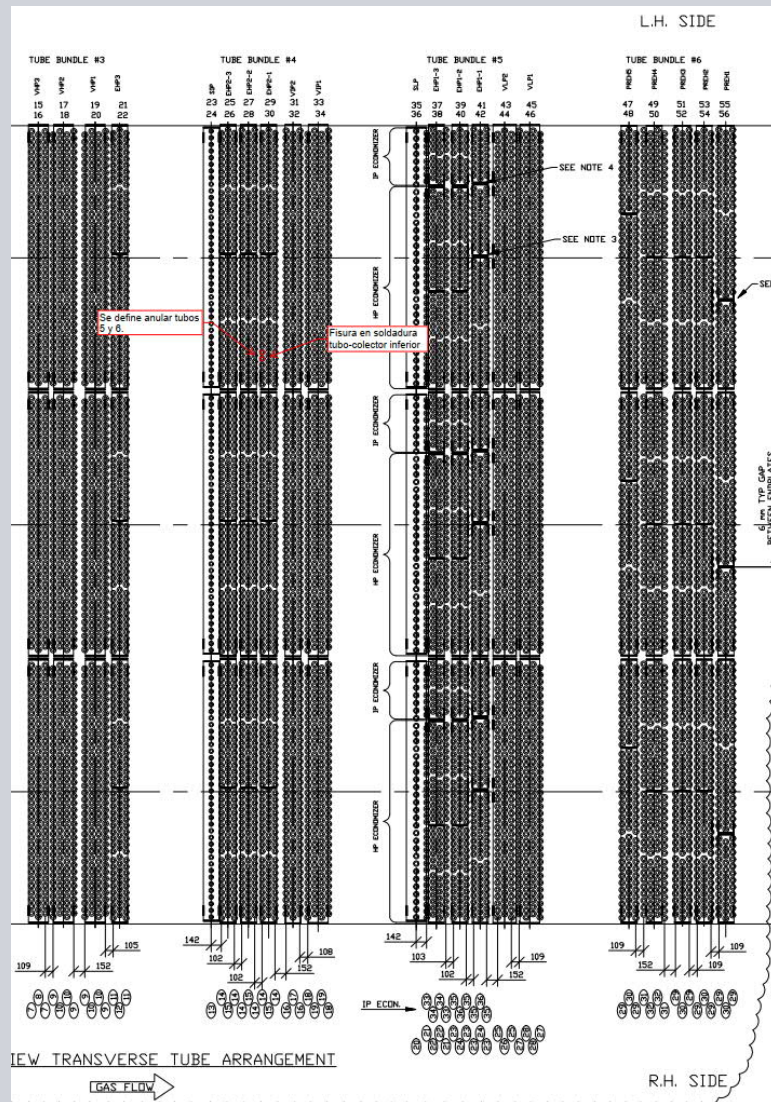
8TH TUBE LEAK DETECTION BY AMS (HP ECON 2-1 TUBE NO: 5 FRONT ROW OF BOTTOM HEADER 30 HAD REPEAT CRACK LEAK ON 02/20/2020 – SAME LOCATION AS THE 2ND INCIDENT) – LEAK LOCATION & REPAIR PHOTO)

Tube No. 5 Bottom Header Repeat Crack

DUE TO REPEAT LEAKS AT THE SAME TUBES, BOTH TUBES 5 & 6 WERE PLUGGED AT BOTH TOP & BOTTOM ENDS.

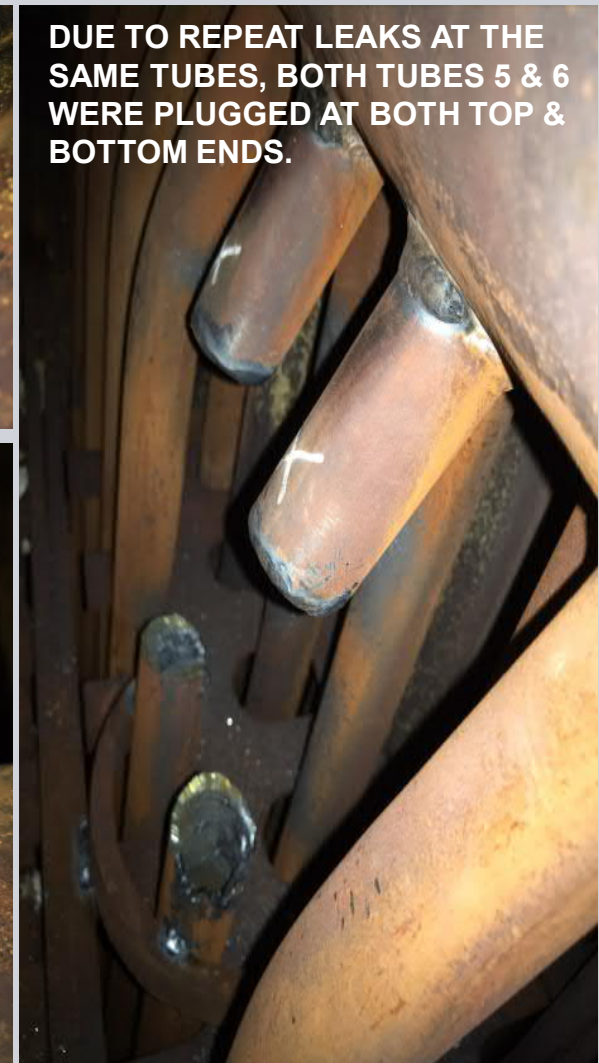
Tube No. 5 Bottom Header After Crack Weld Repair & Plug Welding

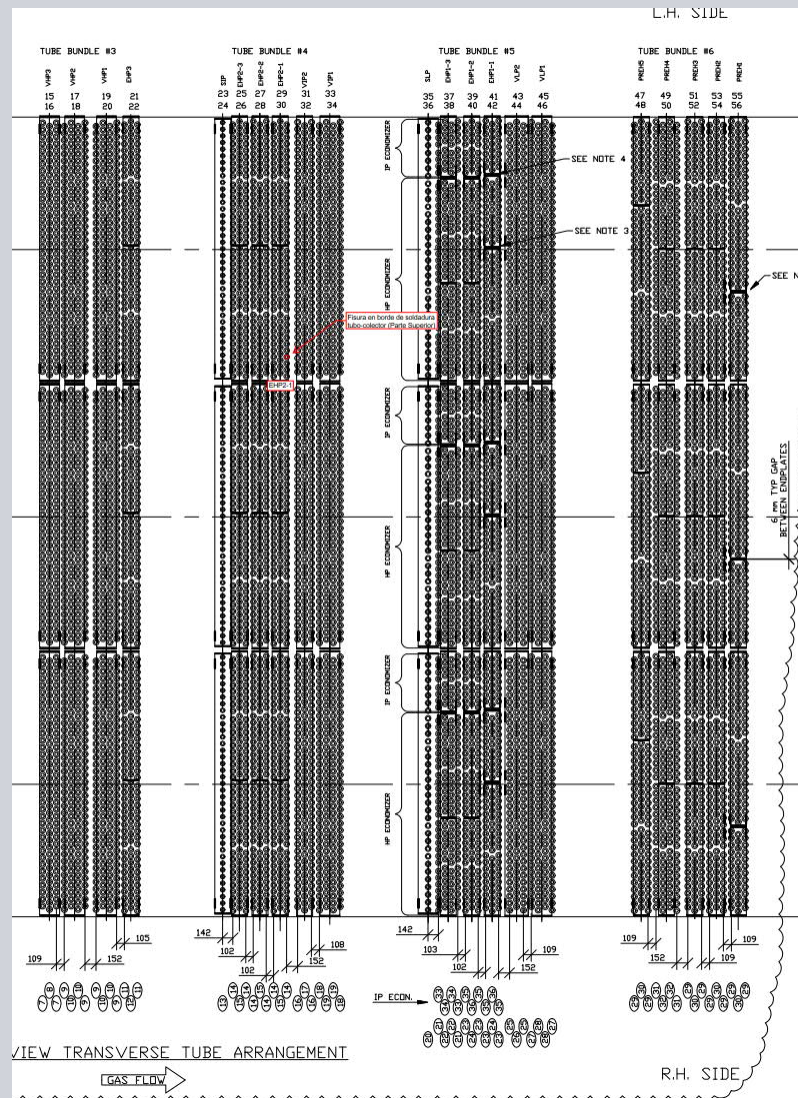
9TH TUBE LEAK DETECTION BY AMS (HP ECON 2-1 TUBE NO: 4 REAR ROW OF TOP HEADER 29 LHS MODULE (10/08/2020) – LEAK LOCATION & REPAIR PHOTOS)

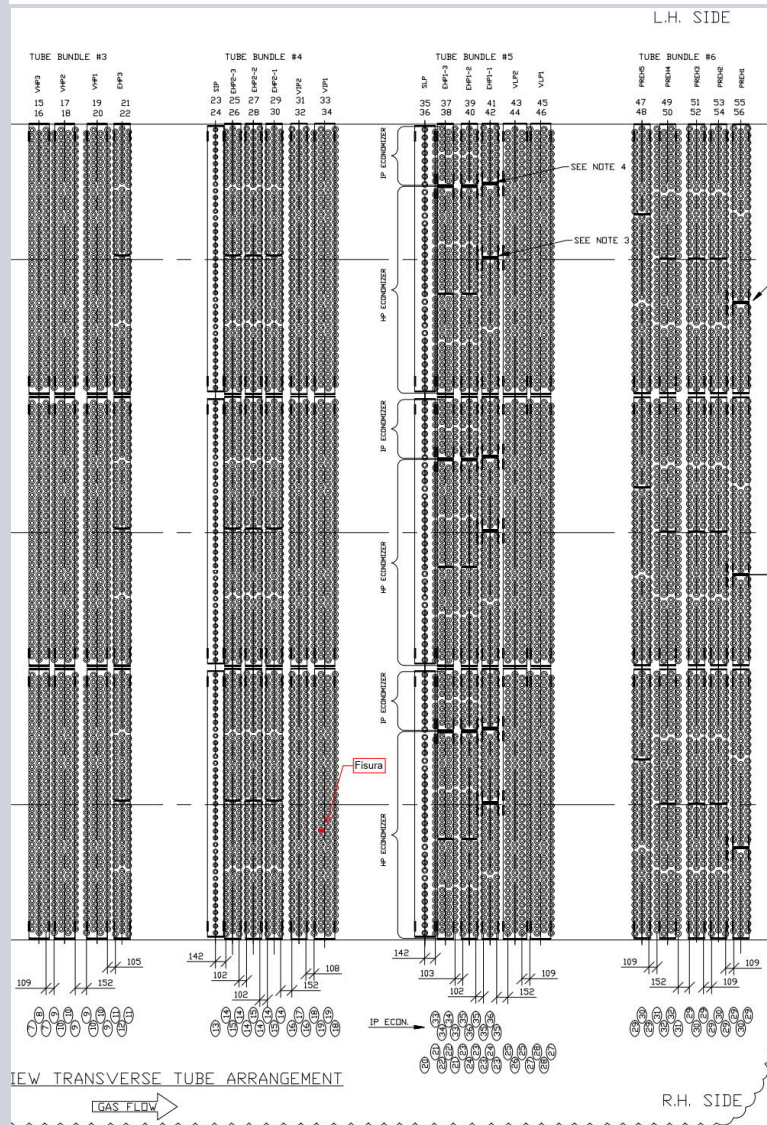
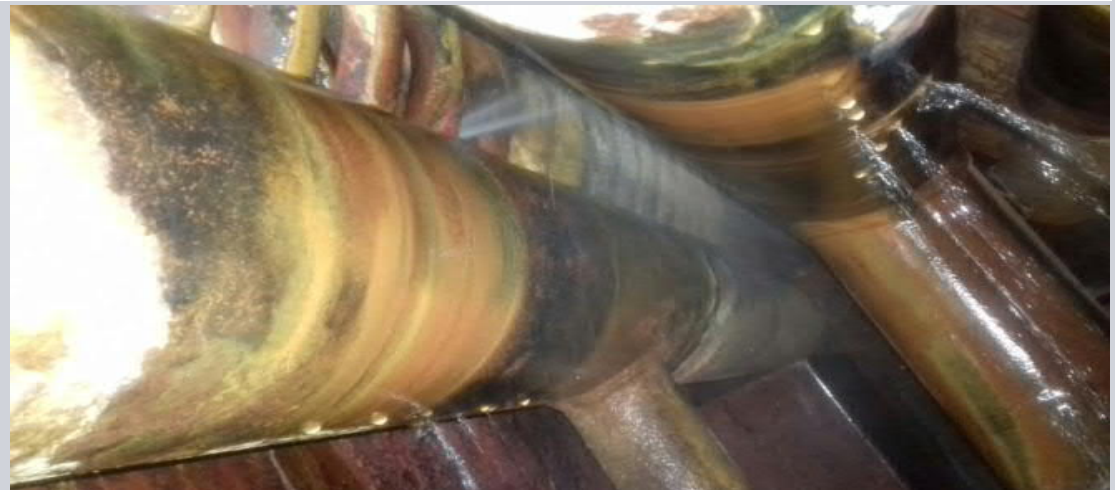
1ST TUBE LEAK DETECTION BY AMS IN UNIT 12 (IP EVAPORATOR 1 TUBE NO:15 FROM RHS OF BOTTOM RHS MODULE HEADER 34 (08/15/2017)– LEAK & REPAIR PHOTOS)

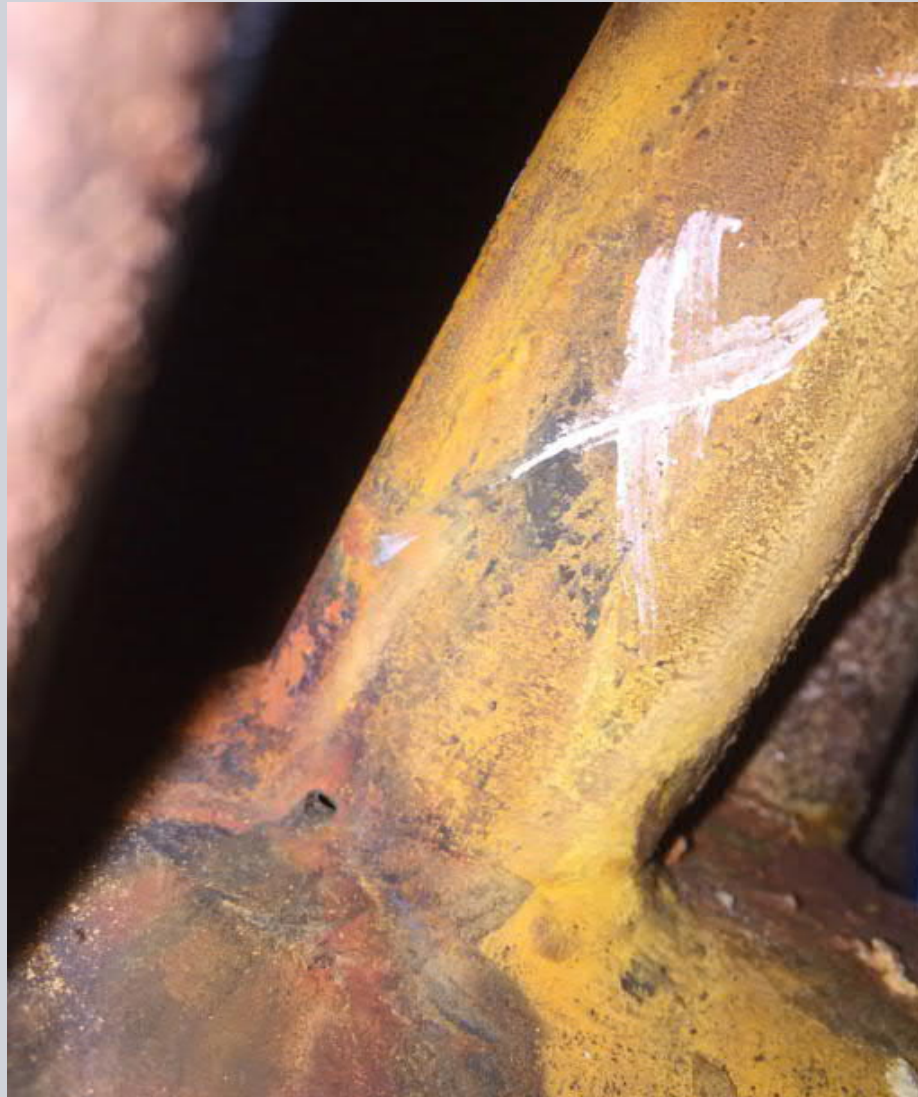
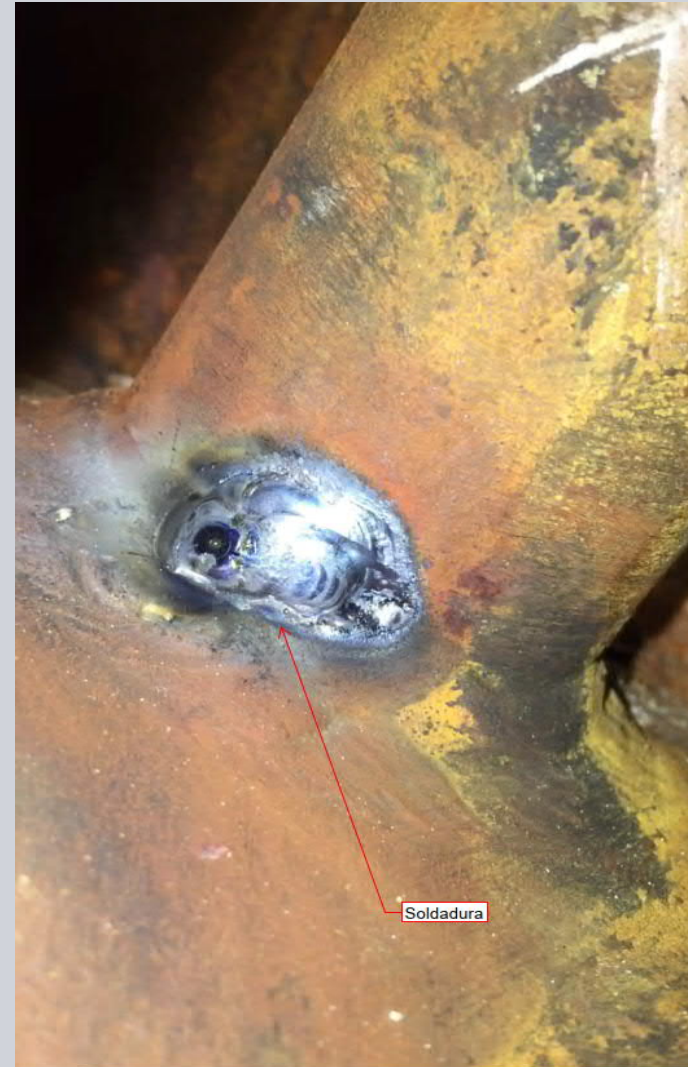
**1ST TUBE LEAK DETECTION BY AMS IN UNIT 12 (IP
EVAPORATOR 1 TUBE NO:15 FROM RHS OF BOTTOM RHS
MODULE HEADER 34 (08/15/2017)– PIN HOLE & REPAIR PHOTOS)**
