JANUARY 2026
VOL. 65, NO. 1

MMP MATERIALS PERFORMANCE

Laboratory Examination Methodology for Internal Pipeline Crack

SUDHAKAR MAHAJANAM, *Mistras Group, Inc., La Porte, Texas, USA*

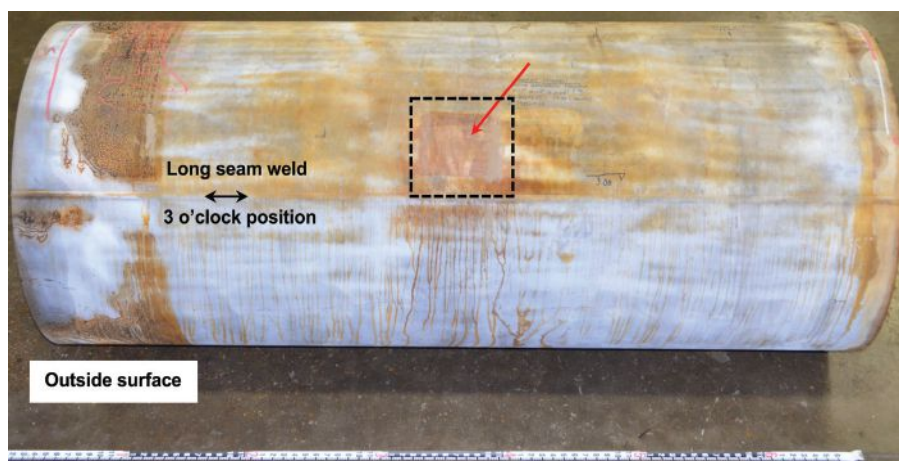
Figure 1 shows an as-received photograph of the 6-ft 3-in. (1.91-m)-long pipe sample that was provided for laboratory examination. The reported anomaly was located close to the long seam weld, approximately between the 2 and 3 o'clock positions as per how the pipe was oriented in service. Wall thickness readings were

FIGURE 1 As-received photograph showing the location of the anomaly. Scale divisions are inches.

taken at one end of the pipe, with the average value being 0.324 in (0.8 cm). The WFMP inspection performed on the outside surface of the pipe did not show any indications. A window containing the internal feature was flame cut (dotted box in Figure 1) for further examination.

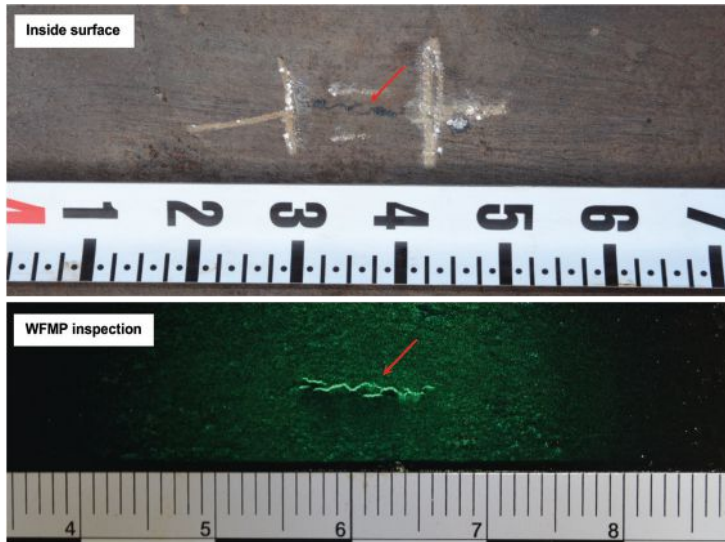
The WFMP inspection was also performed on the inside surface of the pipe as shown in Figure 2. A linear, longitudinal

indication about 1 in long was observed.

FIGURE 2 Photographs of pipe inside surface at crack location. Scale divisions are inches.

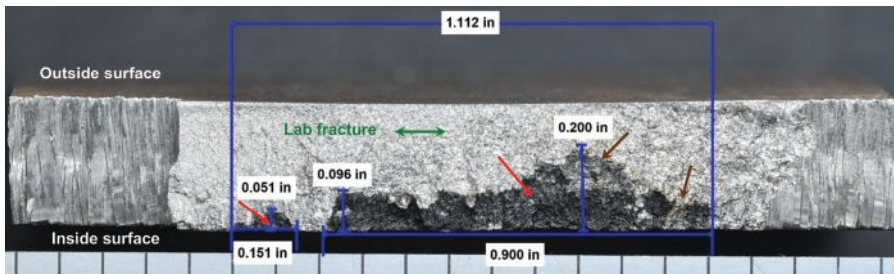
The indication was broken open after chilling in liquid nitrogen to allow for examination of the fracture surfaces. Figure 3 shows a macro-photograph of the fracture surface following lab break-open procedures. A distinct crack surface with black corrosion product was observed. Within the region of the crack, two visually distinct zones were observed: a darker region

FIGURE 3 Photograph showing one half of the crack surface. Scale divisions are 0.1 in (2.5 mm).

marked by red arrows (likely original, pre-existing crack) and a lighter region marked by brown arrows (likely crack growth). Crack length and depth dimensions were also determined and appeared to confirm the field PAUT measurements.

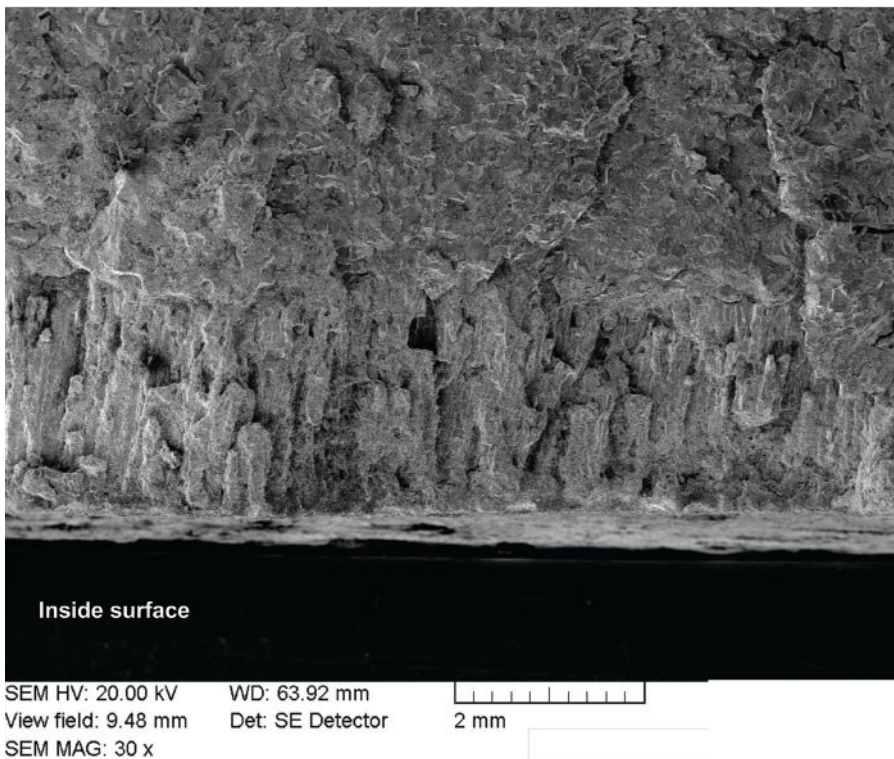
FIGURE 4 SEM image of crack surface showing columnar grains close to the inside surface.

SEM imaging of the crack surface was performed both before and after ultrasonic cleaning. Prior to cleaning, EDS analysis of the crack surface indicated the presence of iron, oxygen, and sulfur, which are typical of oilfield corrosion products. After cleaning, SEM fractography revealed columnar fracture morphology close to the inside surface, as shown in Figure 4. No distinct transgranular or intergranular features were identifiable on the crack surface. The mid-wall regions appeared to contain corroded cleavage facets. Additional SEM images can be found in AMPP paper no. 20700.⁹

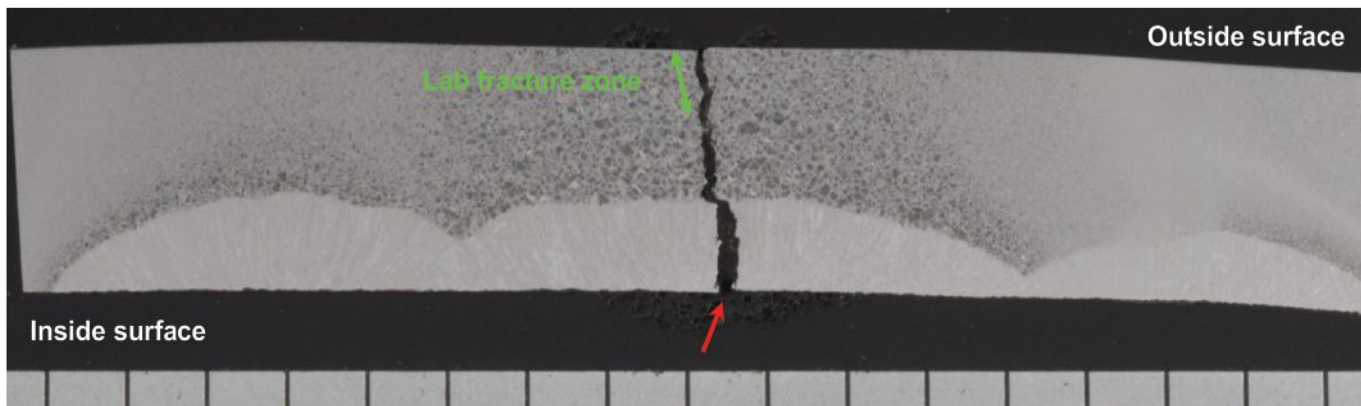
A matched fracture mount was prepared for metallographic examination, as shown in Figure 5. Three distinct weld passes were located, with the crack bisecting the middle weld pass. Higher magnification light micrographs taken in the vicinity of the crack are presented elsewhere.⁹ The region close to the outside surface consisted of acicular/Widmanstatten ferrite and pearlite. The region close to the inside surface also consisted of acicular/Widmanstatten ferrite and some pearlite. Such microstructures are typically formed from fast, non-equilibrium cooling rates. The pipe base material consisted of polygonal ferrite and pearlite, typical of low-carbon steel.

FIGURE 5 Macro-graph of crack cross-section. Scale divisions are 0.1 in. Etchant: Nital.

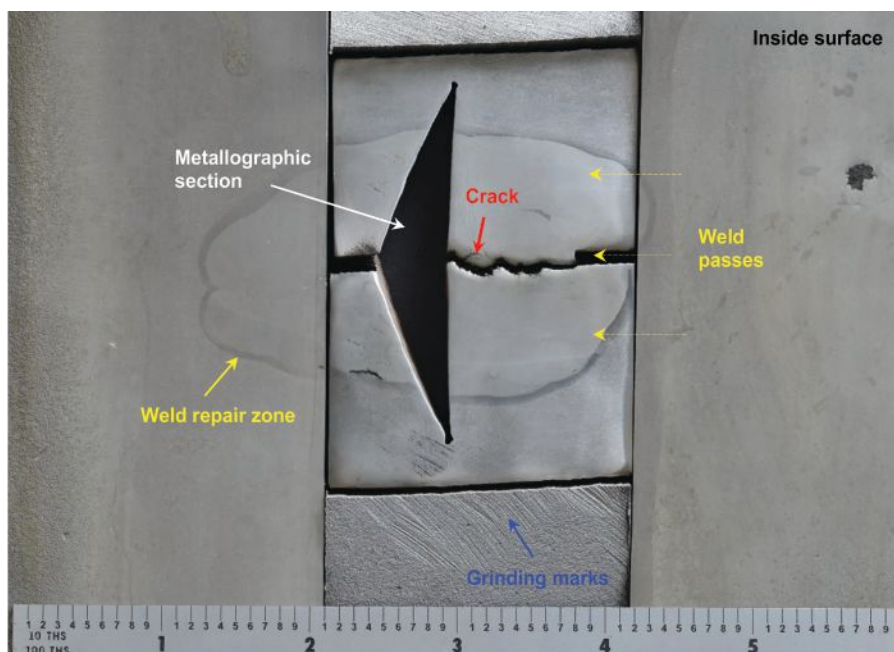
Given the SEM and metallographic findings, the inside surface of the pipe sample in the vicinity of the crack was examined further. The inside surface was lightly sandblasted to prepare for macro-etching of the crack region with Nital. Grinding marks were observed close to the crack, along with a distinctly etching region. An expanded macro-etch was then performed, as shown in Figure 6, to include the areas containing the grinding marks. The expanded mac-

ro-etch revealed the entire extent of the weld zone region surrounding the crack, and indicated the presence of a weld repair of a pre-existing defect using three weld passes. The repair welding likely was performed around the time of installation.

FIGURE 6 Macro-etching performed in the vicinity of the crack. Scale divisions are inches. Etchant: Nital.
