Composite Impact & Porosity Characterization with Pocket UT™

Introduction

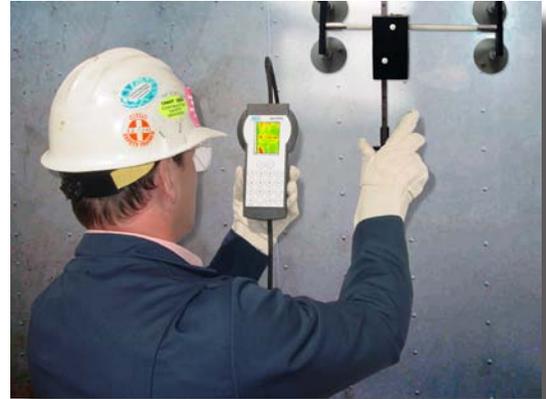
*Composite Inspection Performed with
Pocket UT™ and X-Y Scanner*

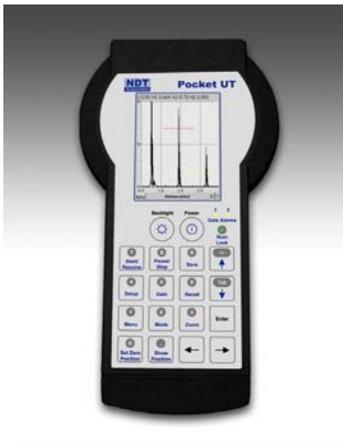
***Pocket UT™: Hand-Held
Ultrasonic Full C-Scan System***

The Pocket UT™ is an innovative hand-held, battery powered C-scan system which can map the damaged area using manual or motorized X-Y scanners. The system runs on Windows CE™ and Pocket UT Win™ for data acquisition, analysis, and archiving. It also has the capability to perform A, B, and C-scans, placing the unit in a class by itself. The inner workings of the two pound instrument includes a 20MHz bandwidth amplifier and a 1kHz pulser/receiver board that is powered by a 7.2V NiMH battery giving the instrument 4 hours of continuous use. Thickness, amplitude and waveform data is stored on a 1 Gb (or higher) compact flash card, that can be transferred to a laptop computer using the USB port.

The Pocket UT™ can interface with 2 axes of motion, whether motorized or manual. The open architecture allows the instrument to interface with any 2 axis encoded scanner or to control stepper motor scanners. Resolution is limited only by the scanner, with typical scans taken at .020".

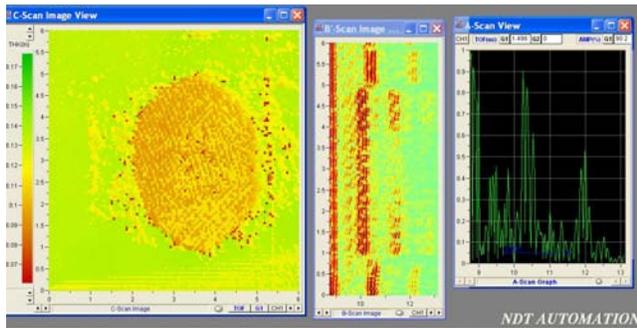
Delamination can be seen clearly in both the C-Scan and B-Scan.

Several inspections were performed for two different aerospace applications, impact damage and porosity. The impact damage was in an area of a composite fuselage approximately 10" x 10". The area was scanned with a manual X-Y scanner with resolution set at .150". The minimum damage area was established to be .500". The specification stated that a minimum damaged area of interest must be seen in three consecutive scan lines. The results were gathered and displayed in a C-scan plot within a few minutes. The same test using conventional means would have taken several hours.

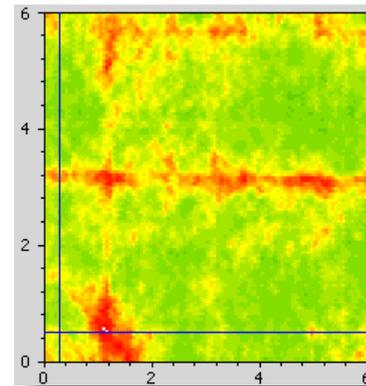
This C-Scan shows a large amount of porosity in red

The second inspection was to find areas of porosity that caused a significant loss of the back wall of the ultrasonic signal. This condition causes the area to be very weak. The test was performed using an automated X-Y scanner at .050" resolution. The resulting C-scan displayed the areas of porosity very easily and repairs were scheduled.
