MONOPILE JACKING POINT INSPECTION

Application Brief

Non Destructive Testing (NDT) Inspection of Monopile Jacking Point Welds

MISTRAS conducted inspection and testing of jacking points located within the base of offshore wind turbine transition pieces at the monopile / transition piece interface below the air tight deck.

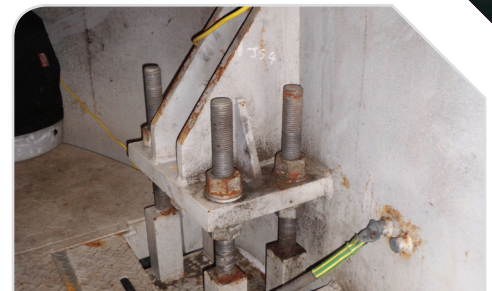
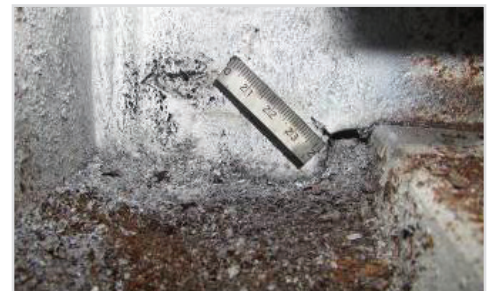
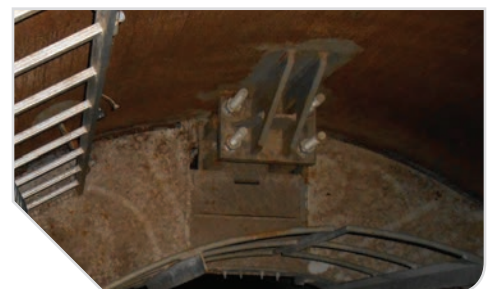
A photographic survey provided a representation of the general condition and specific defects at jacking point locations.

The photographs were annotated with the client's turbine and jacking point location details to facilitated accurate reporting of features / defects.
