Inspection Engineering Journal

Successful Volumetric Examination of a Modified Storage Tank Corner Weld

VOLUME 28, ISSUE 3

MAY | JUNE 2022

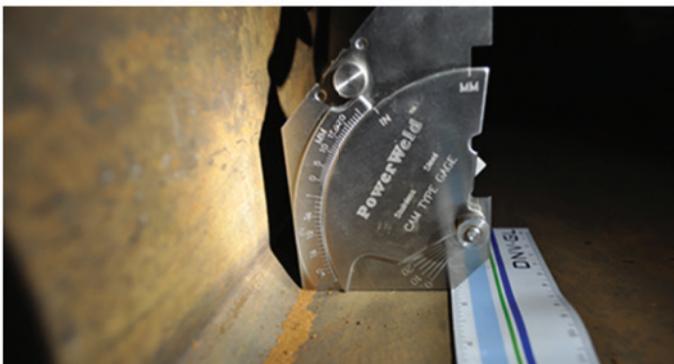
Figure 3. Corner-weld as-built view [4].

The tank owner specified and included this weld design in the 20-year nonintrusive inspection strategy to increase tank reliability, exceeding code requirements related to weld sizing and non-destructive examination. The as-built weld final dimensions were as per code with full penetration and a nondestructive volumetric weld examination, in addition to the code surface examination. The conceptual weld design is presented in Figure 2, and a view of the as-built weld is presented in Figure 3.

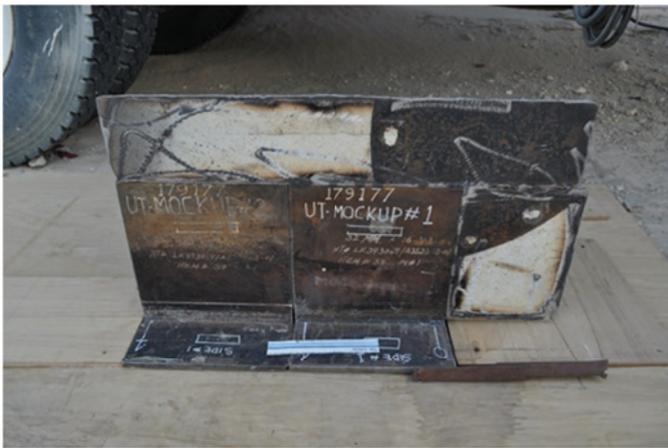
Figure 5. As-built mock-up for PAUT scan plan and calibration [4].

- Review of technical procedure background, operating methodology, data quality checks, and system performance: detection ability and sizing accuracy of indications
- Evaluation of significant UT parameters and their variability
- Confirmation of personnel experience, training, and certifications
- Consideration of the following variables:
 - Welding procedure
 - Corner-weld geometry
 - Base materials
 - Actual wall thickness
 - Root and final weld set-up
 - PAUT channel set-up
 - Calibration blocks and as-built mock-up (Figure 5)
 - Reference reflectors
 - Temperature effects
 - Data acquisition and processing
