Acoustic Emission Inspection for Bridge Applications

Application Solutions

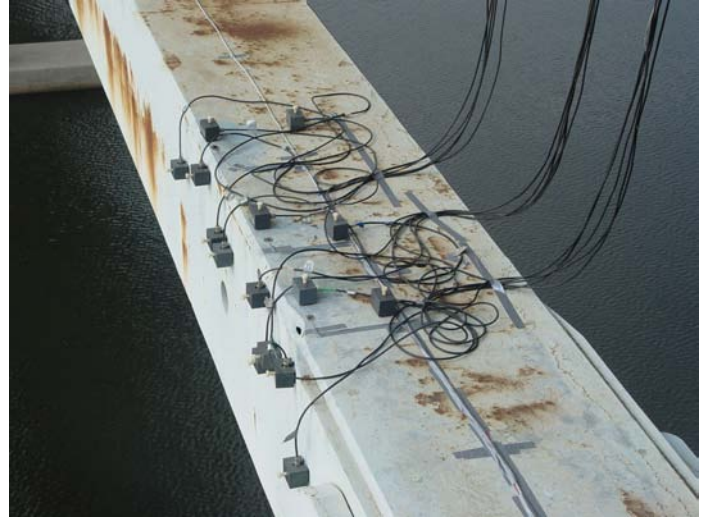
Figure A1: Box beam instrumented for AE monitoring.

A box beam (Figure A1) was instrumented and monitored with AE for two hours during normal traffic loading. The beam contained cracks in the longitudinal weld such as the surface breaking crack shown in Figure A2. Retrofits (repairs) of the cracks include grinding, drill stop holes and peening of the cracks.

When the retrofits were replaced and tightened, there were no locatable emissions indicating that the retrofit was doing the job that it was designed for.

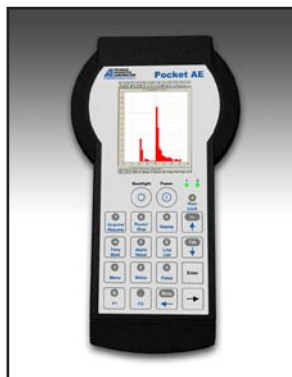
Figure B1: Pocket AE.

The Pocket AE™ computerized hand-held Acoustic Emission system (Figure B1), has been used to screen existing cracks on bridges for identifying and ranking each location from worst to best. In some cases where cracks were found in unexpected locations, representative locations from adjacent stringers were also checked (though no surface crack was detected) to see if there was any possible subsurface

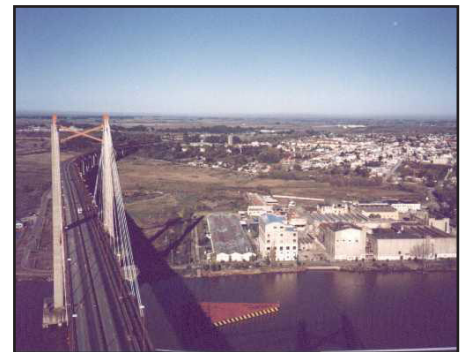
Figure D1: Cable-stayed bridge in Brazil.

A cable-stayed bridge located in Brazil was suffering from failures in the cable-stay supports as a result of corrosion. This bridge (shown in Figure D1) is located over a salt marsh and experiences heavy traffic loading as well as steady breezes and warm temperatures.

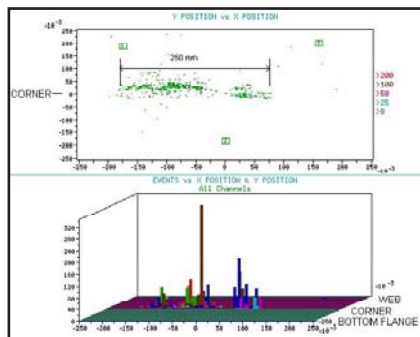
Figure E1: Planar location of crack-like defect in a box beam.

Motorway trails in the UK led to the detection of an active AE source located in a box beam. It was located below the end of a diagonal bracing connection at the bottom of the flange. Continuous monitoring of this crack-like defect produced AE events that could be located using source location algorithms. The results are shown in Figure E1 indicating a 250 mm long defect.

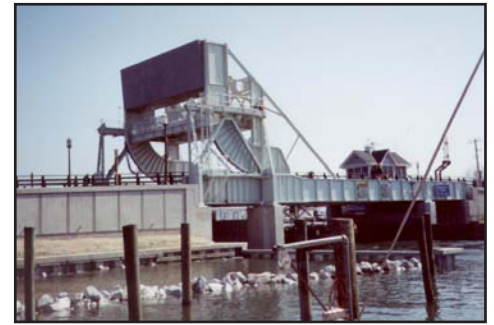
Figure F1: Bascule bridge that was monitored with AE during operation

There is one example of a bascule bridge (see Figure F1) that was producing audible sounds when it was operated. The non-moving structure was instrumented with AE sensors and monitored during operation.

The bridge was opened and closed several times until sufficient data was collected. Location analysis was used to isolate the source of the sound which proved to be an area where there was interference between the moving and nonmoving parts of the bridge.

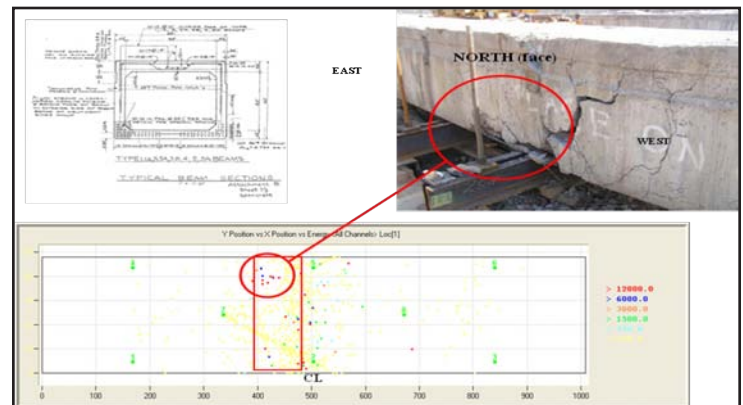
Figure G1: Location of AE events shows rupturing of prestressing strand.

We worked with a university on the testing of two adjacent concrete box beam girders that were removed from a section of bridge that failed in December of 2006. Each beam was monitored with AE during cyclic loading up to failure. While AE could easily pick out cracking and fretting in the concrete, the major interest was the detection of rupturing prestressing strand in the reinforcement (see Figure G1).
