Touch Point Corrosion™ Inspection

MISTRAS Group Inc. Integrated Solution

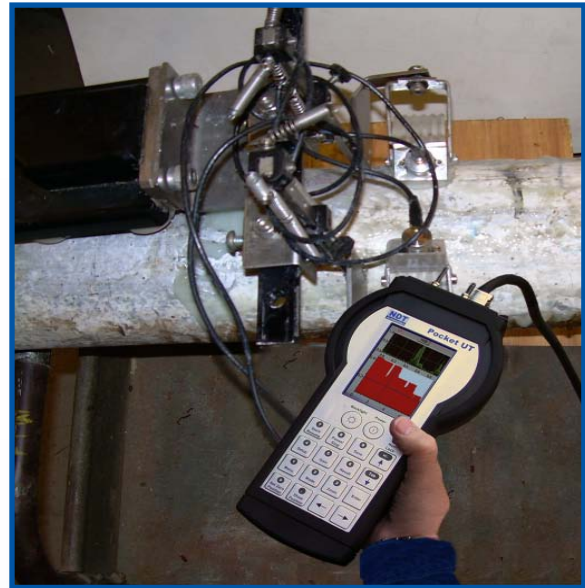
Figure 1. MISTRAS designed and manufactured Pocket UT System with portable flexible Bridge Assembly to fit many pipe sizes used for Touch Point Corrosion™ Inspection

The follow up inspection is performed using a Pocket UT System developed and manufactured by our sister company, NDT Automation (Figure 1.). An ultrasonic

attenuation study is performed utilizing the Pocket UT System. The ultrasonic data from the inspection is interpreted using a proprietary calculation developed by our in-house engineering staff and programmed into the Pocket UT Instrument. The equation considers a combination of factors including pipe length, amplitude loss, the cross sectional affected area and other factors in order to estimate a percent (%) wall loss. The wall loss then leads to an A-D Grade of the area in question. (Figure 2.)

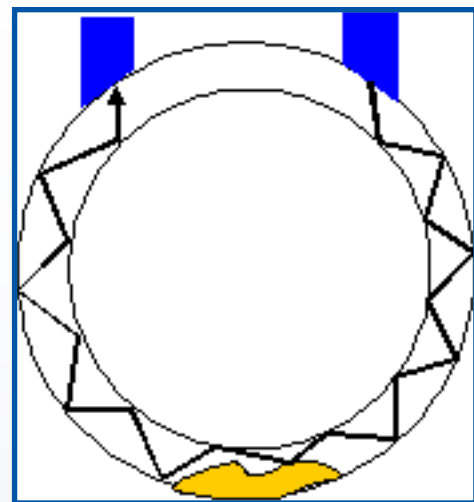
Figure 3 Schematic of Ultrasonic Touch Point Corrosion™ Inspection Method
