Bus Bar Fault

Generator Step Up (GSU) Transformer, 25/500 kV, 784 MVA, FOA, Westinghouse, three phase, two pumps groups, shell form.

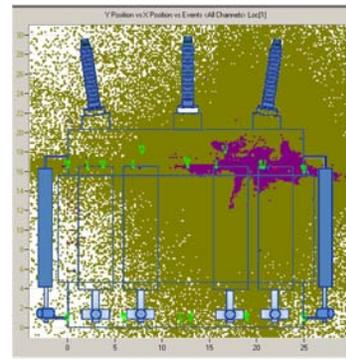
The acoustic emission test indicated that the strongest acoustic activity was being detected on the upper part of the transformer. Therefore, an internal inspection was justified as the problem seemed to be located on the upper part of the core/connections area.

This unit remained in operation with DGA values being monitored periodically. Twelve weeks after the AE test was completed, an internal inspection was performed. Internal inspection revealed carbon build-up, due to severe overheating on one of the copper bus bars of the X1 Low Voltage bushing. This bar was also completely cracked with all of the current being carried by the other two bars (approximately 6000 A).

This fault was detected in the area where Cluster 2 was located.

The transformer was repaired on-site one week after copper bus bars were replaced. The customer estimated savings of 2 million dollars considering the time the plant would have been off-line.
