Bus Bar Fault

Generator Step Up (GSU) Transformer, 25/500 kV, 784 MVA, FOA, Westinghouse, three phase, two pumps groups, shell form.

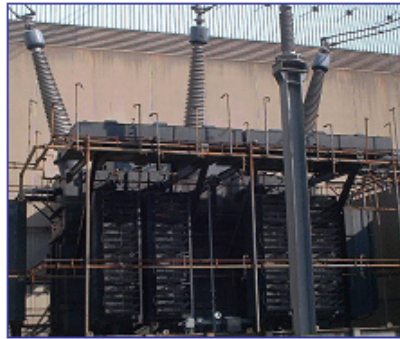
GSU Transformer

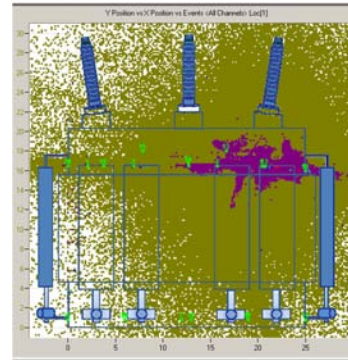
This unit remained in operation with DGA values being monitored periodically. Twelve weeks after the AE test was completed, an internal inspection was performed. Internal inspection revealed carbon build-up, due to severe overheating on one of the copper bus bars of the X1 Low Voltage bushing. This bar was also completely cracked with all of the current being carried by the other two bars (approximately 6000 A).

This fault was detected in the area where Cluster 2 was located.

The transformer was repaired on-site one week after copper bus bars were replaced. The customer estimated savings of 2 million dollars considering the time the plant would have been off-line.
