ACTUAL PLANT EXPERIENCE RESULTS OF AN ACOUSTIC MONITORING SYSTEM (AMS) FOR HRSG'S EARLY TUBE LEAK DETECTION

Presented at USA HRSG Forum on 09/24/2021.

(Tham) Thamarai P. Chelvan

UNIT 12 HRSG's FIRST TUBE LEAK EVENT (FEB. 4, 2013) INDICATED BY HIGH MAKE-UP WATER USE AT HP ECON 2-1 AFTER ABOUT 3 YEARS FROM COMMERCIAL OPERATION & ITS IMMEDIATE SHUT DOWN & REPAIR

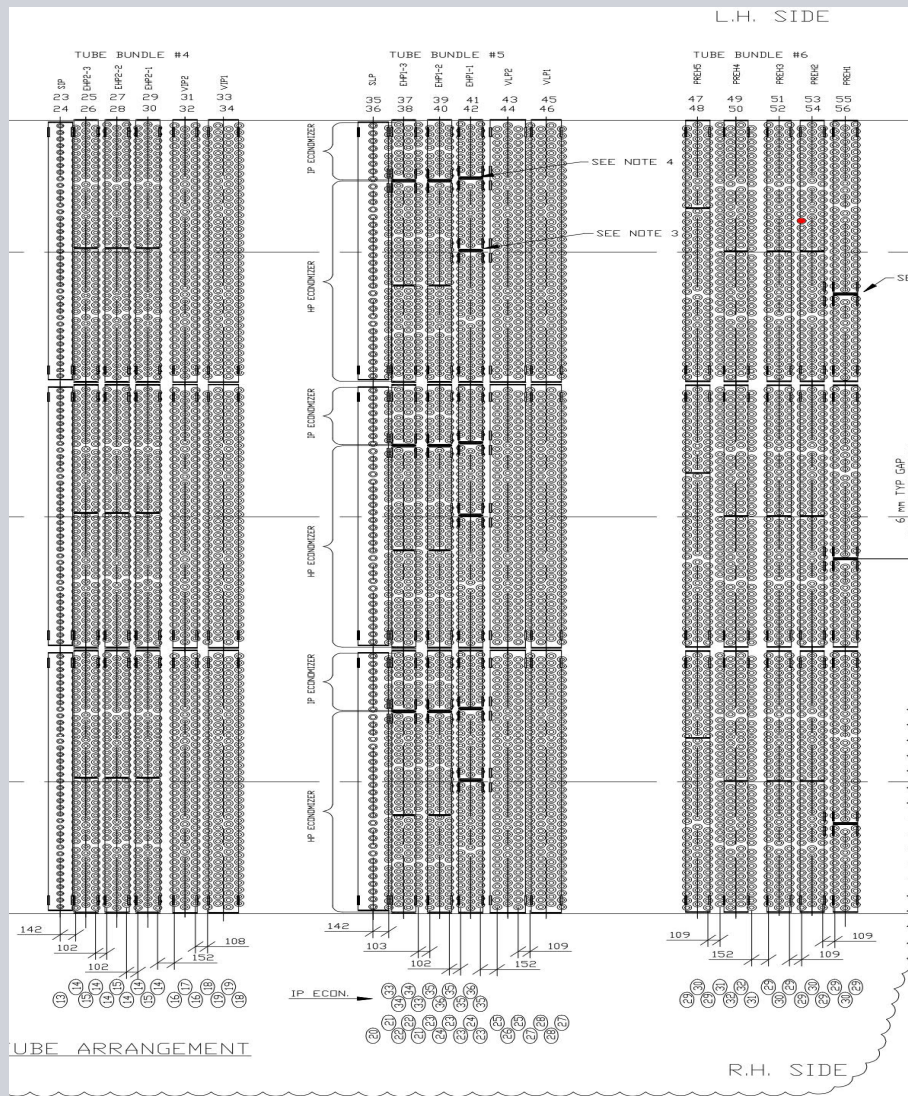
(VIDEO SHOWS THE LEAK BY FAC AT CONDENSATE PREHEATER 2 LHS MODULE – OCCURRED DURING OCTOBER 2016 – SEE THE RED DOT)

- High Sound Level of the Leak
- How the Leak Jet impinges to the adjacent tube row causing erosion & corrosion (see the discoloration at bottom 3 tubes due to wide spray angle water jet impingement during HRSG operation)

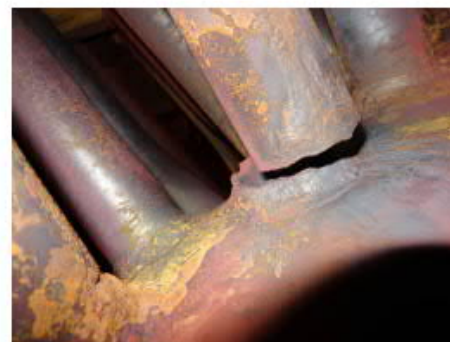
1. Full Circumference Cracked Tube No. 3 (Red) & 2. Partially Cracked Tube No.5 (Red) at Tube Joint on Header 29 as Primary Source of Water Jet Leak

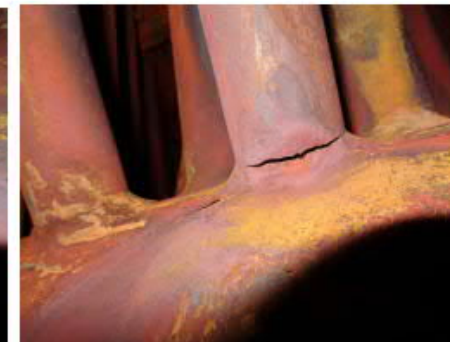
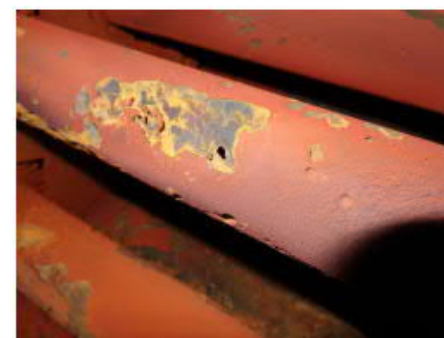
3. Hole on VIP2 tube (Red) Due to HP2-1 Tube Leak Water Jet Erosion

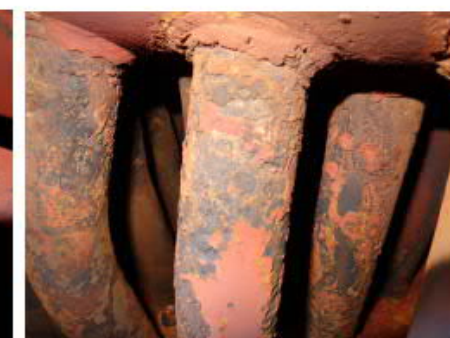
4. Erosion & Corrosion Damage on VIP2 Tubes (Blue) Due to HP2-1 Tube Water Jet Leak

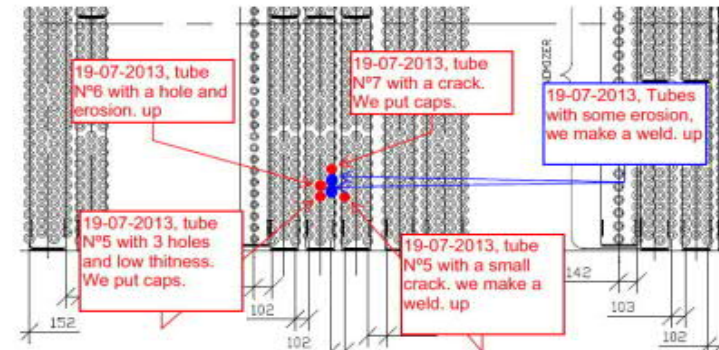
Enlarged View of the Damaged Tubes Section

UNIT 11 HRSG's PRIMARY & SECONDARY TUBE LEAKS FOUND ON JULY 19, 2013, AFTER FINDING PRIMARY & SECONDARY TUBE DAMAGES IN UNIT 12.

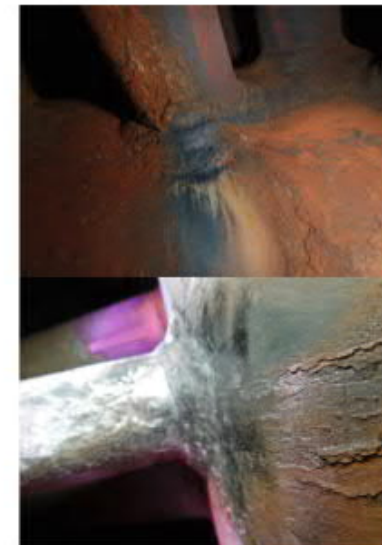
Primary Leak Source - Crack Facing Header 27 at Front Row Tube No. 5 Joint of Header 29 – See Water Jet Leak Area Marks

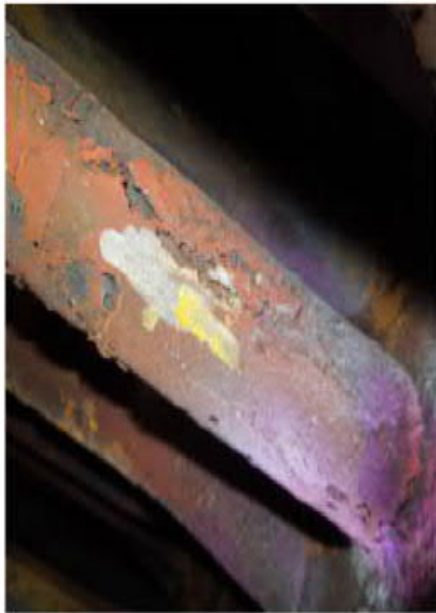
FOTOGRAFIA 2

Tube No: 5 & 6 on Header 27 with Holes & Low Thickness Due to Erosion & Corrosion

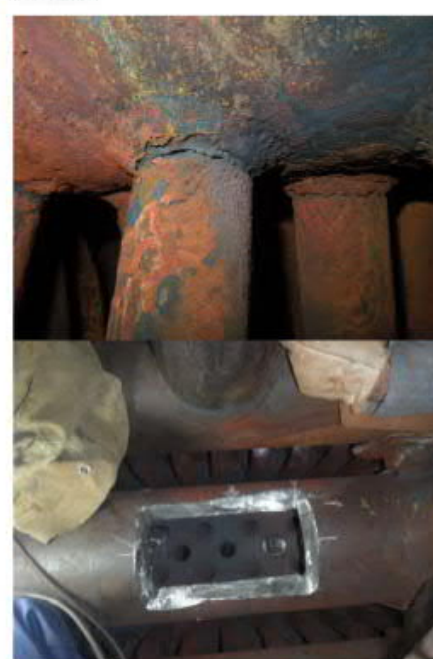
FOTOGRAFIA 1

Tube No: 7 on Header 27 with a Crack & Tube Plug with Header Window Cutting Method

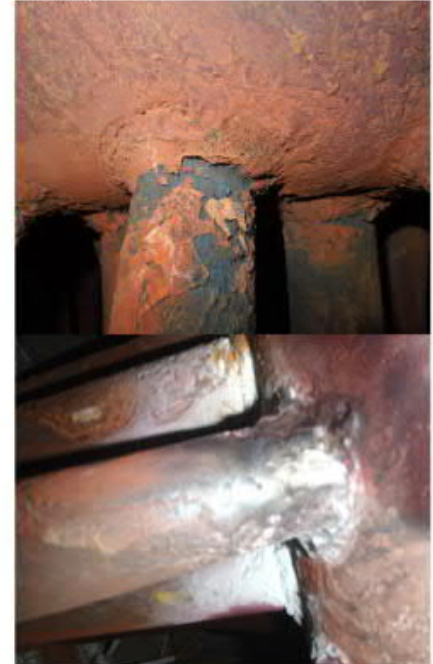
FOTOGRAFIA 5

Erosion & Corrosion Damage (Blue) on Header 27 Due to HP2-1 Tube No: 5 Water Jet Leak

**PRIMARY & SECONDARY TUBE DAMAGES RESULTED IN EXPENSIVE
& EXTENSIVE MULTIPLE ROWS OF TUBE CUTTING FOR ACCESS AND
REPAIR WELDING WITH NEW REPLACEMENT PLAIN TUBE SECTIONS
(SPENT >\$1.5 MILLION US\$ FOR TWO MODULES REPAIR, ONE IN EACH UNIT)**

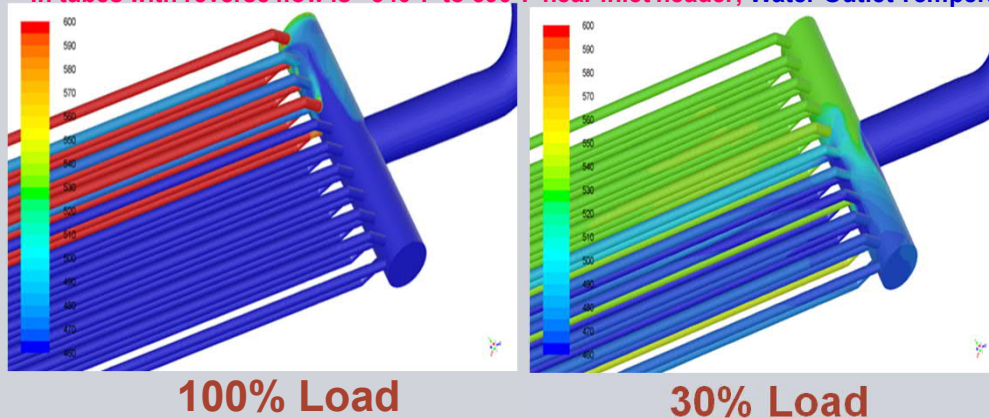
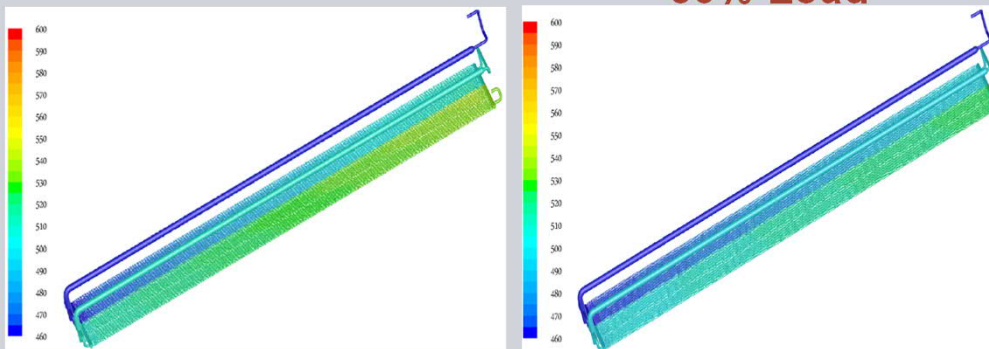
Siemens Energy, Inc. (SEI) Measured Extensive Tube Metal Temperatures & Performed 3D Plexiglass Physical & CFD Flow Modeling Studies. Based on these Studies, **the Primary Root Cause Result:** “Reverse Flow” in downward water flow pass from insufficient pressure head to overcome the “Upward Buoyancy Forces” created by “Water Density Differences”. **Recommended Modifications to Eliminate HP Econ 2-1 Tube Leaks:** Modify “Feed Pipes” for upward flow in all 4 passes of the same row header.

Measured Temperature Data Calibrated CFD Model's Predicted Temperature Distribution in Existing Arrangement:
In tubes with reverse flow is ~540°F to 590°F near inlet header; Water Outlet Temperature: 480°F

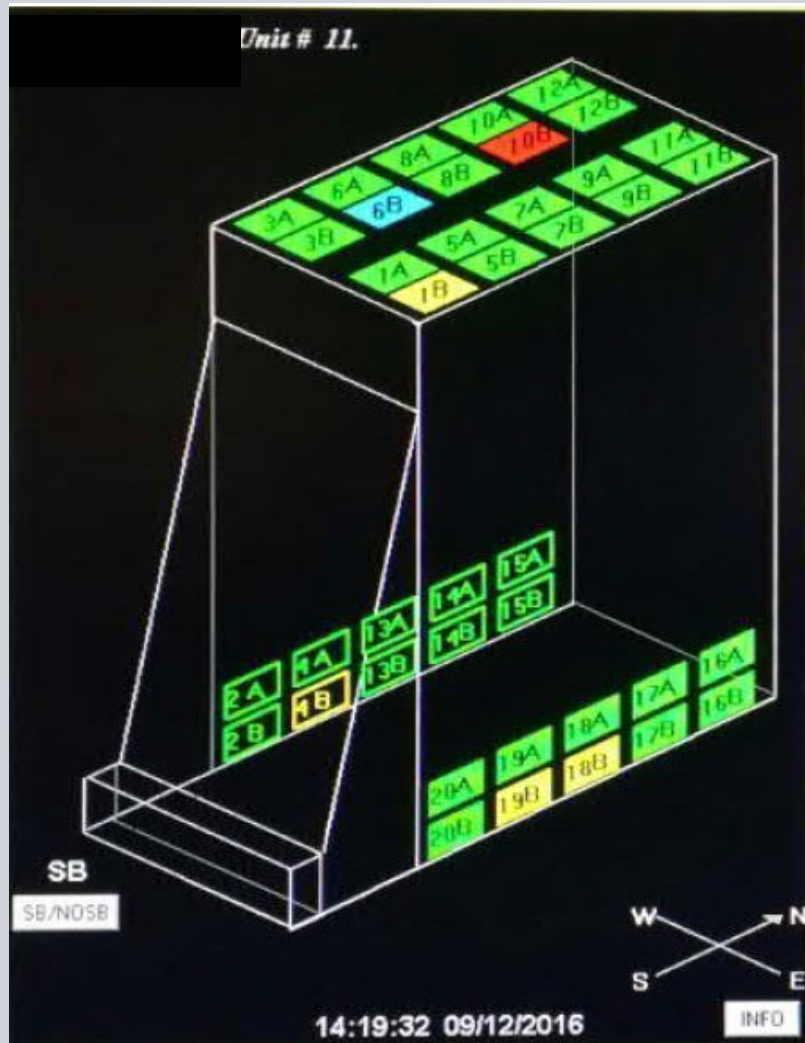
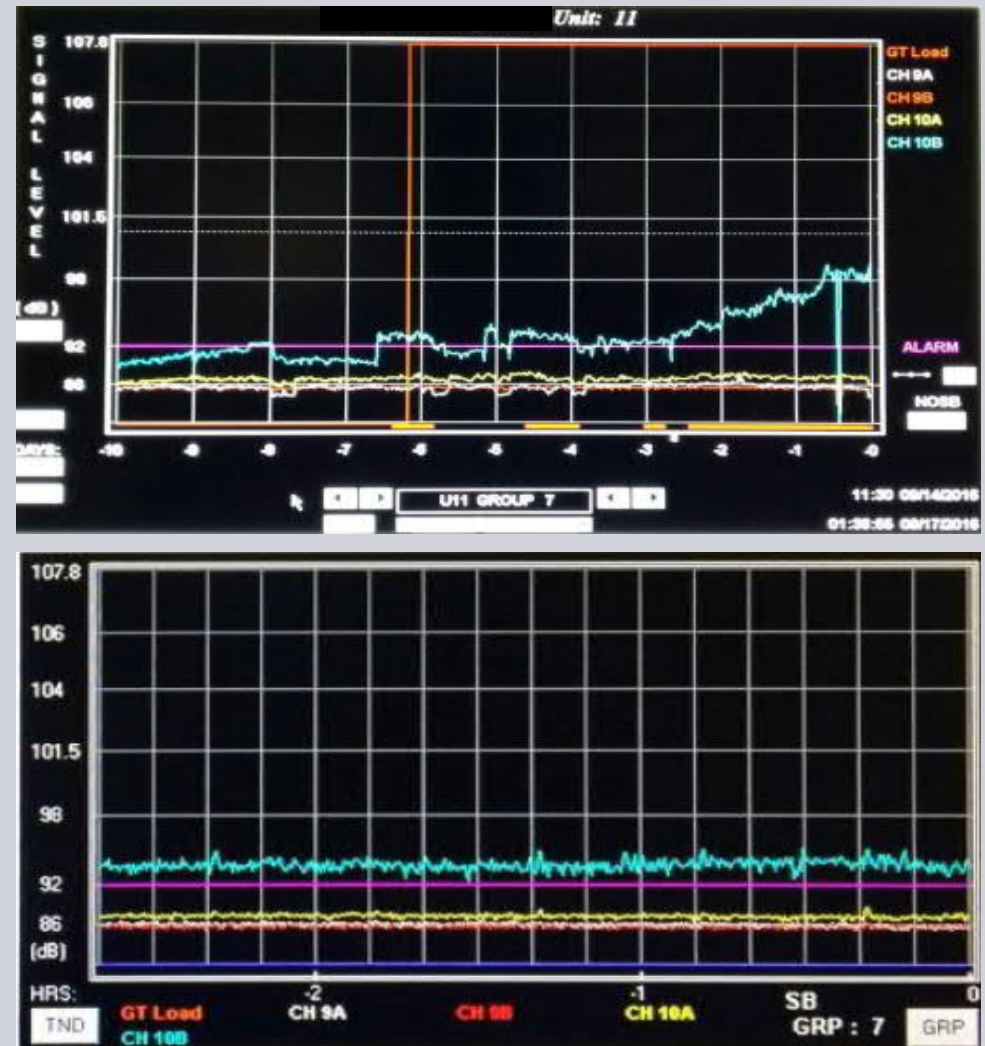
**1ST TUBE LEAK DETECTION BY AMS AFTER 2 MONTHS OF ITS INSTALLATION AT
SUBJECT PLANT (9/12/2016 HP ECON 2-1 TUBE NO. 5 FRONT ROW ON TOP
HEADER 29 – LEAKED FOR 57 HOURS ABOVE ALARM LEVEL)**

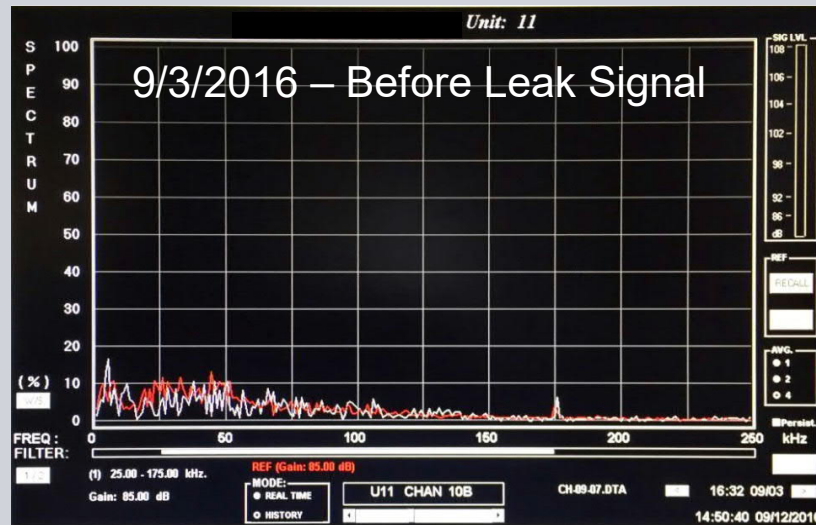
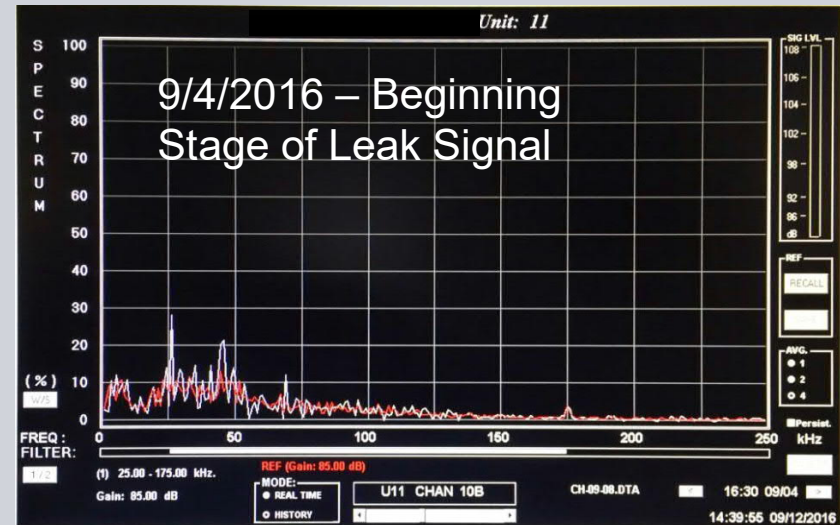
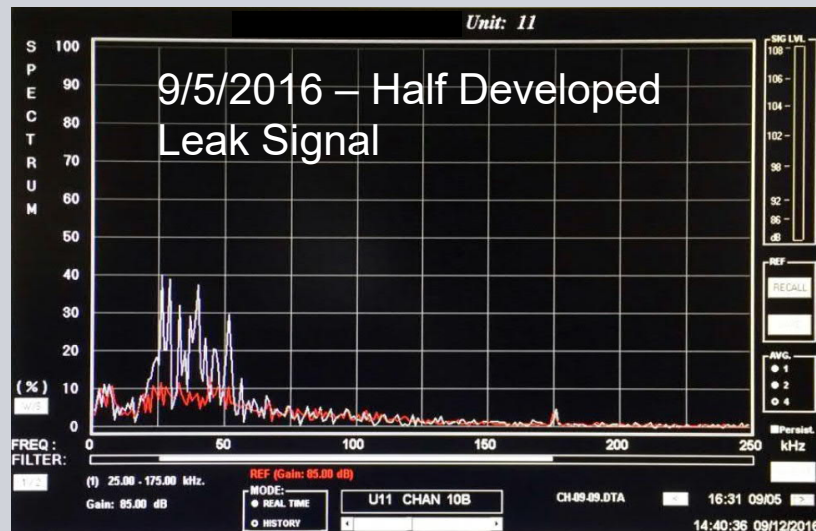
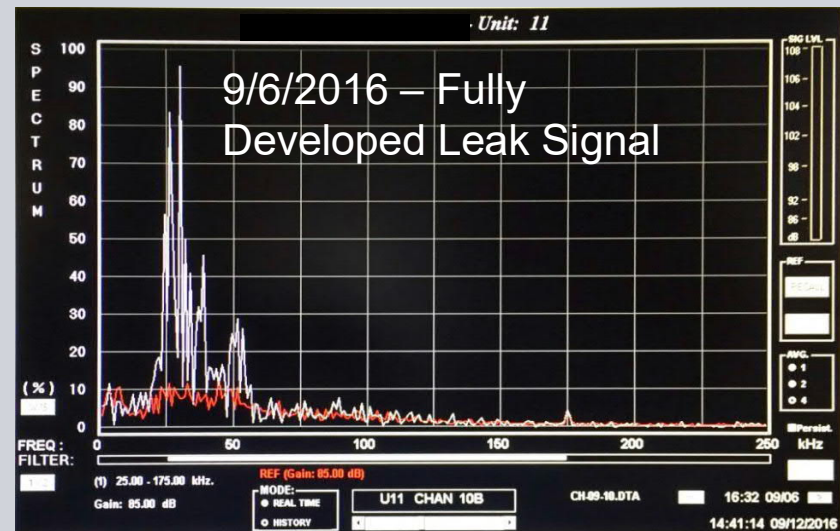
FREQUENCY DISTRIBUTION OF THE ENERGY FOR BEFORE & AFTER THE LEAK EVENT SIGNALS (9/12/2016 HP ECON 2-1 TUBE NO: 5 LEAK REPAIR EVENT) - TRENDS SEVERITY AND PROGRESSION OF LEAK

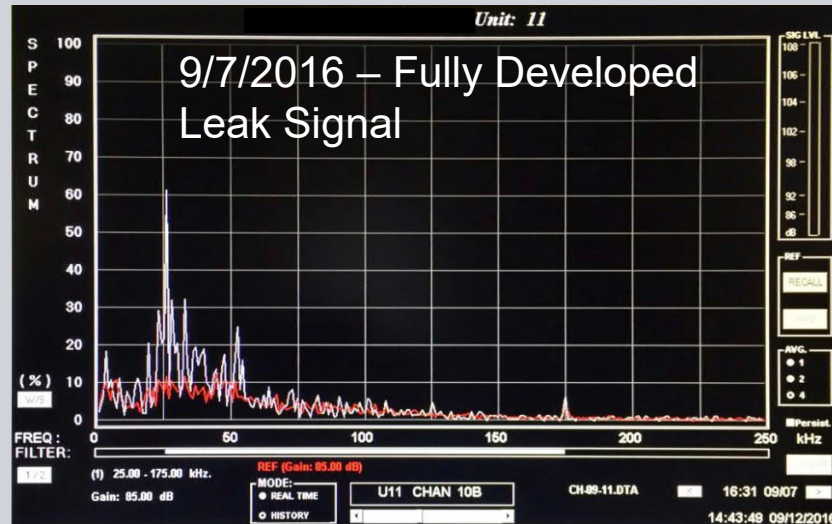
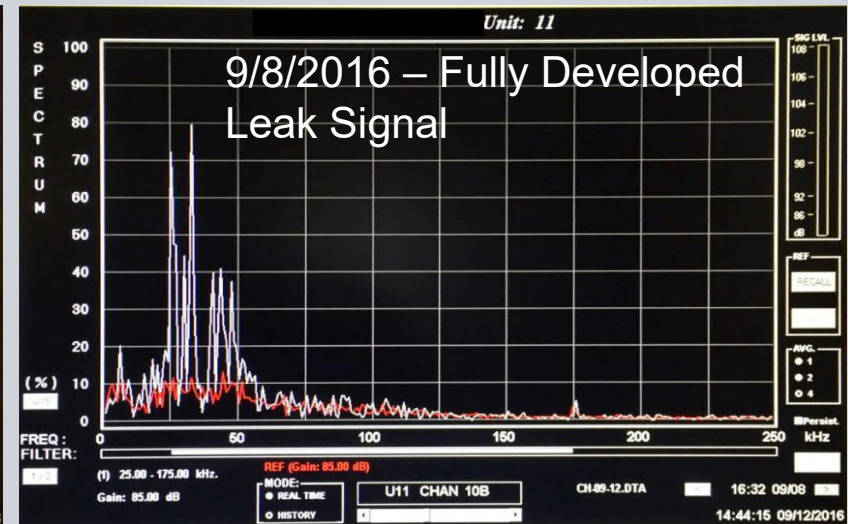
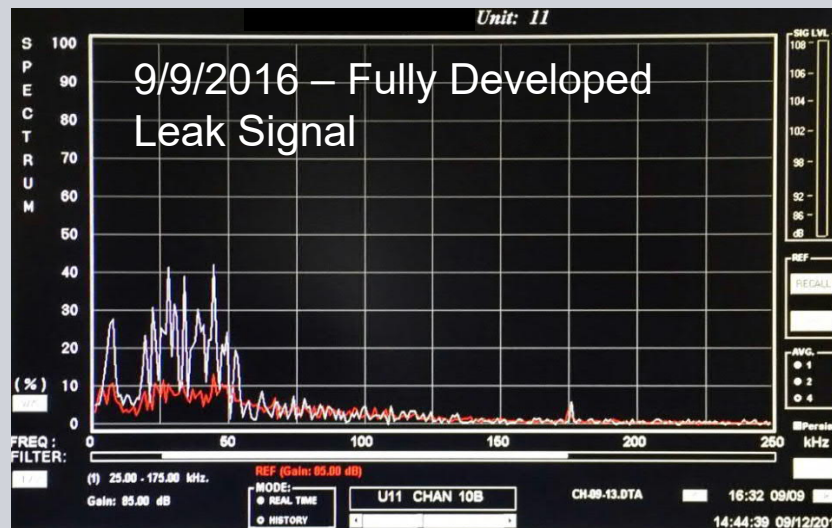
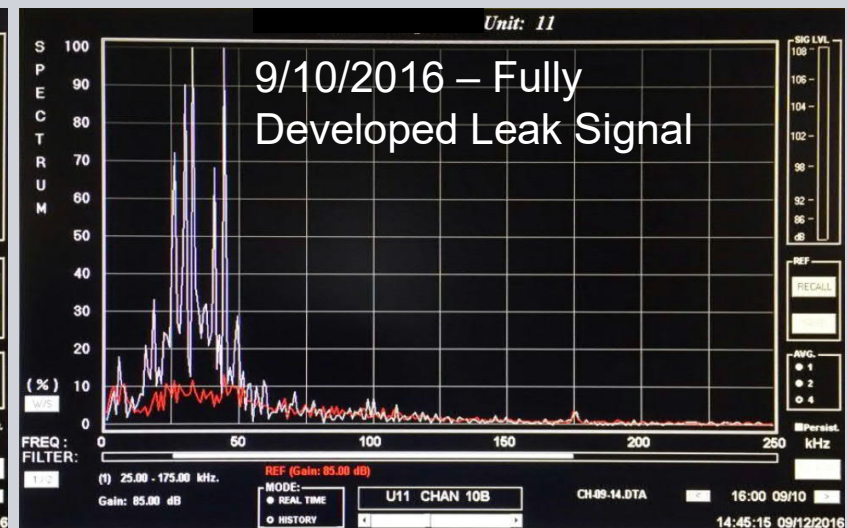
FREQUENCY DISTRIBUTION OF THE ENERGY FOR FULLY DEVELOPED LEAK SIGNALS ON DIFFERENT DAYS (9/12/2016 HP ECON 2-1 TUBE LEAK REPAIR EVENT)

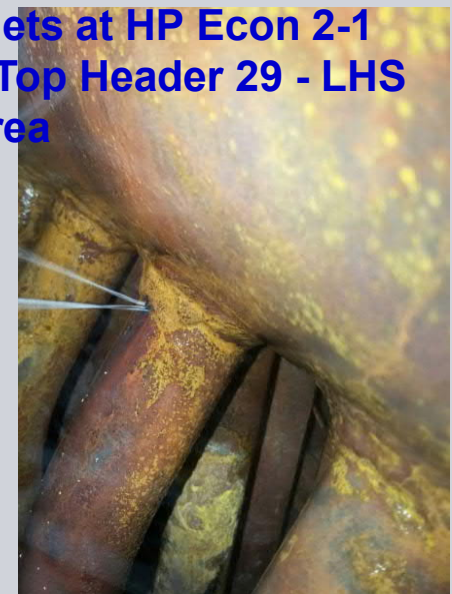
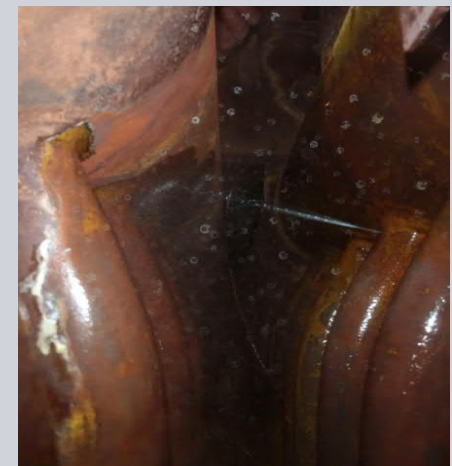
9/12/2016 – Found Leak Jets at HP Econ 2-1
Tube No. 5 Front Row of Top Header 29 - LHS
Module - Channel 10 B Area

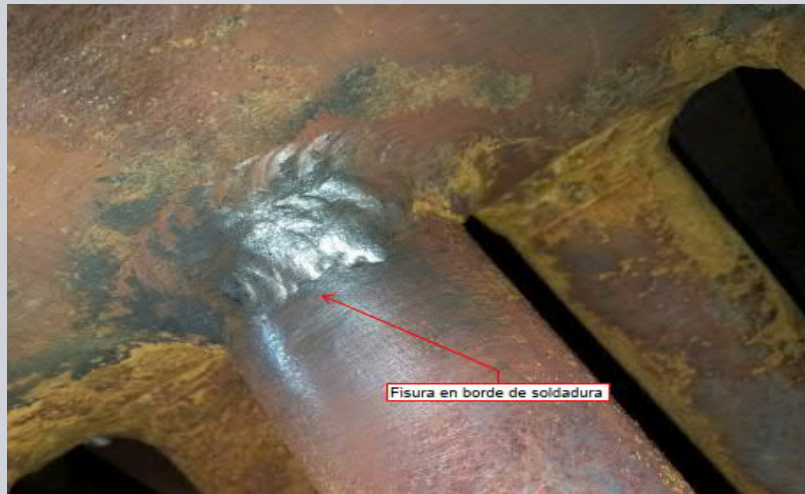
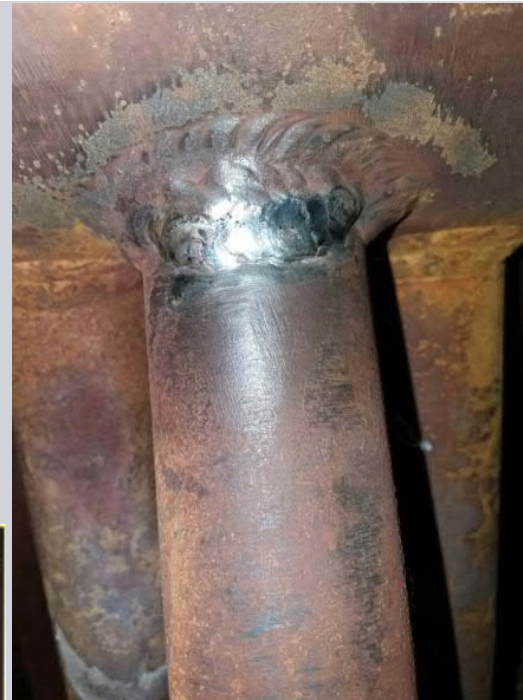
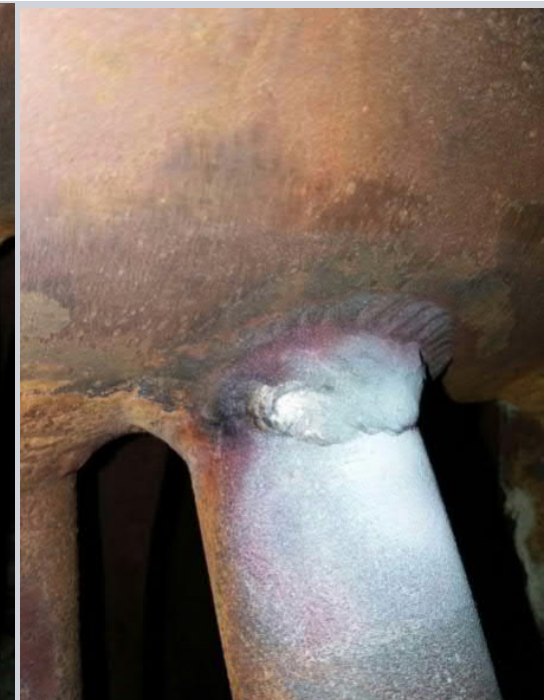
9/12/2016 HP ECON 2-1 TUBE NO. 5 TOP HEADER - AFTER REPAIR WELDING PHOTOS & AFTER REPAIR SIGNALS TREND

After Repair Signals Went Back To Normal Level

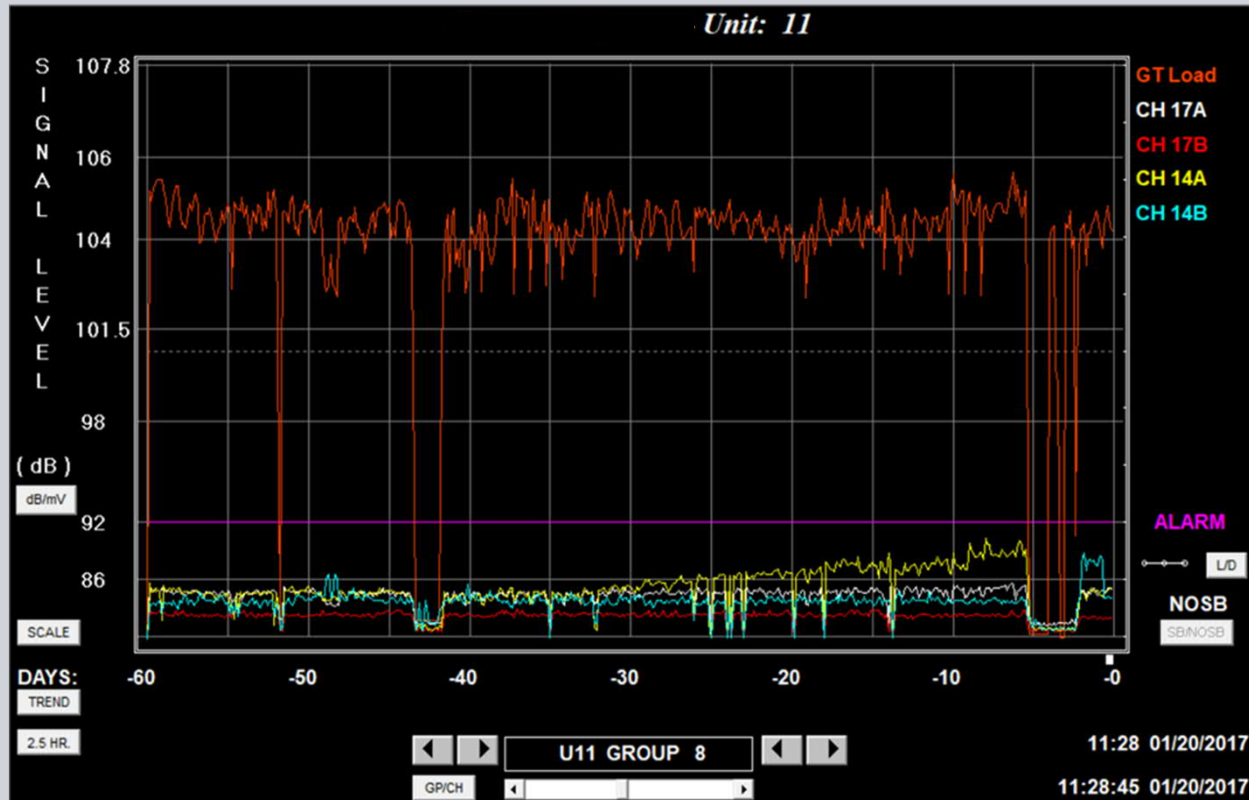
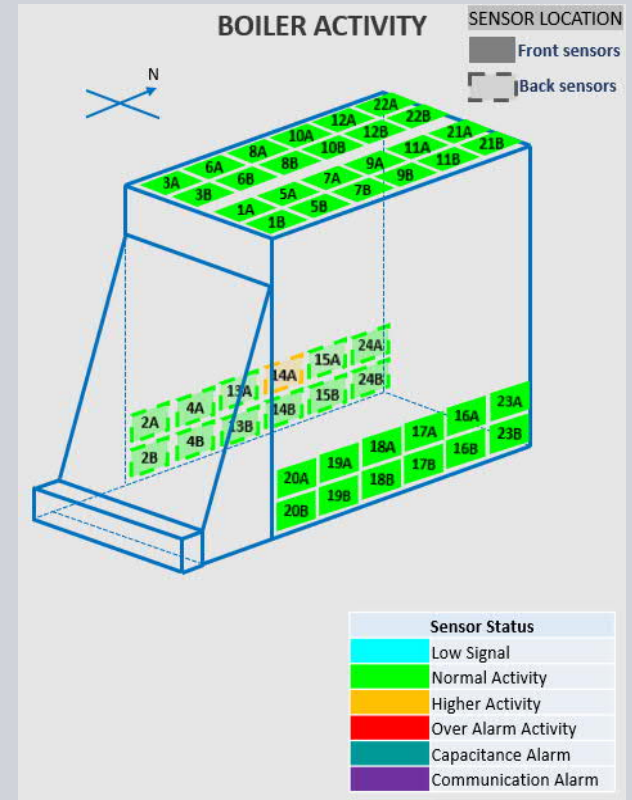
2ND TUBE LEAK DETECTION BY AMS (01/15/2017 HP ECON 2-1 TUBE NO: 5 FRONT ROW AT BOTTOM HEADER 30 LHS MODULE - LEAK SIGNAL TREND)

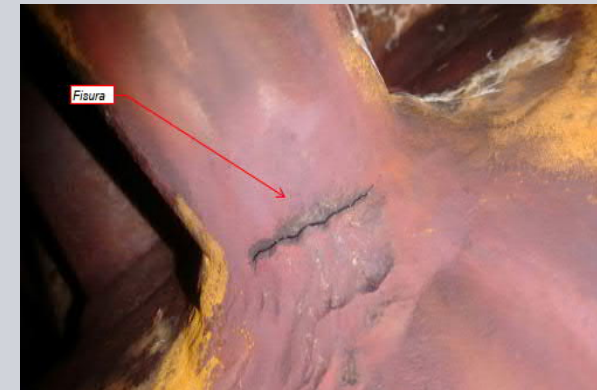
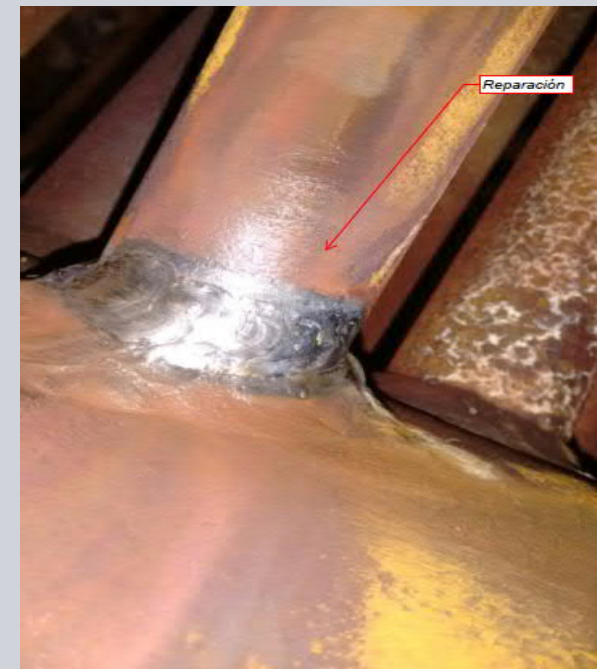
2ND TUBE LEAK DETECTION BY AMS (01/15/2017 HP ECON 2-1 TUBE NO: 5 FRONT ROW AT BOTTOM HEADER 30 LHS MODULE - LEAK LOCATION & REPAIR PHOTO)

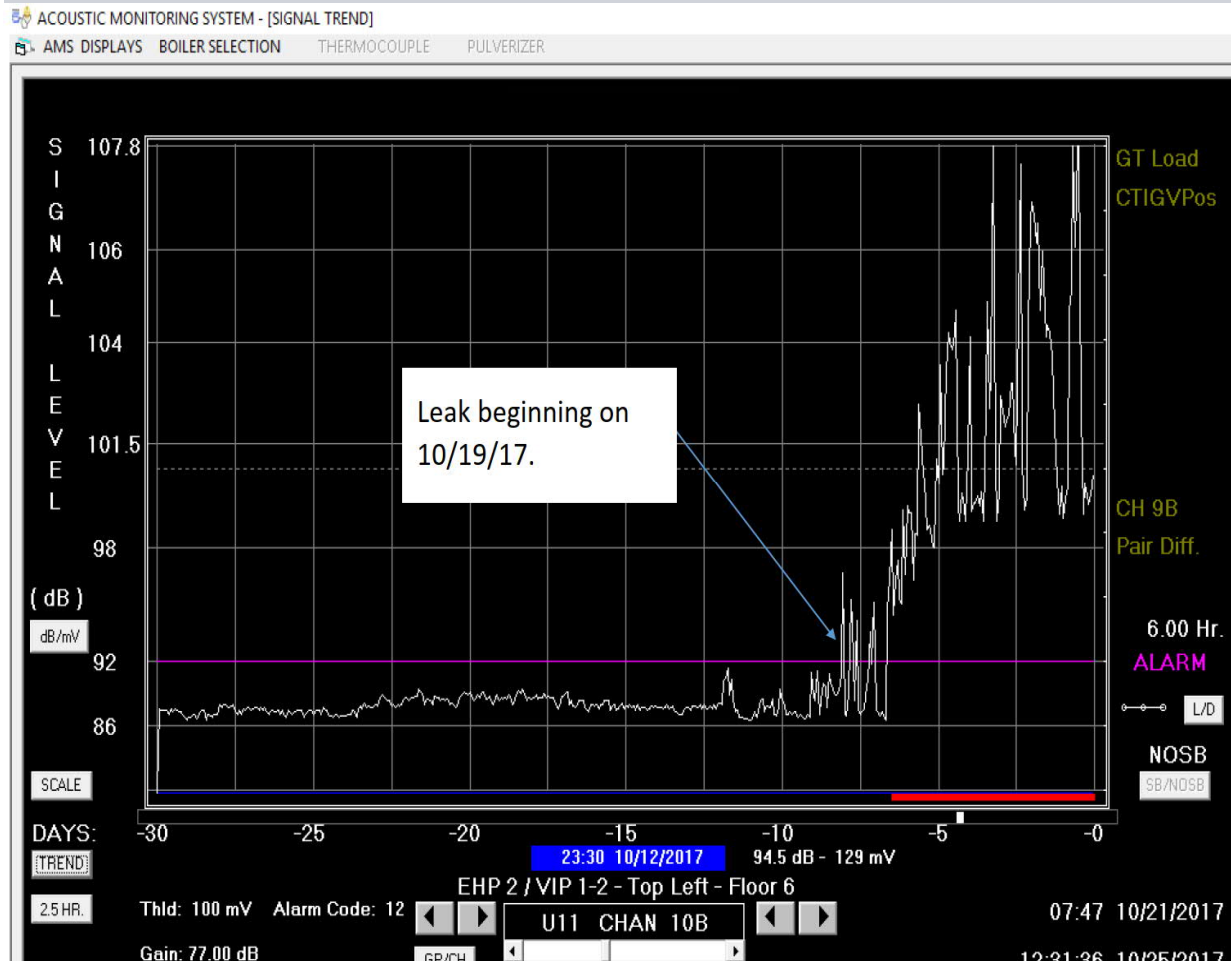
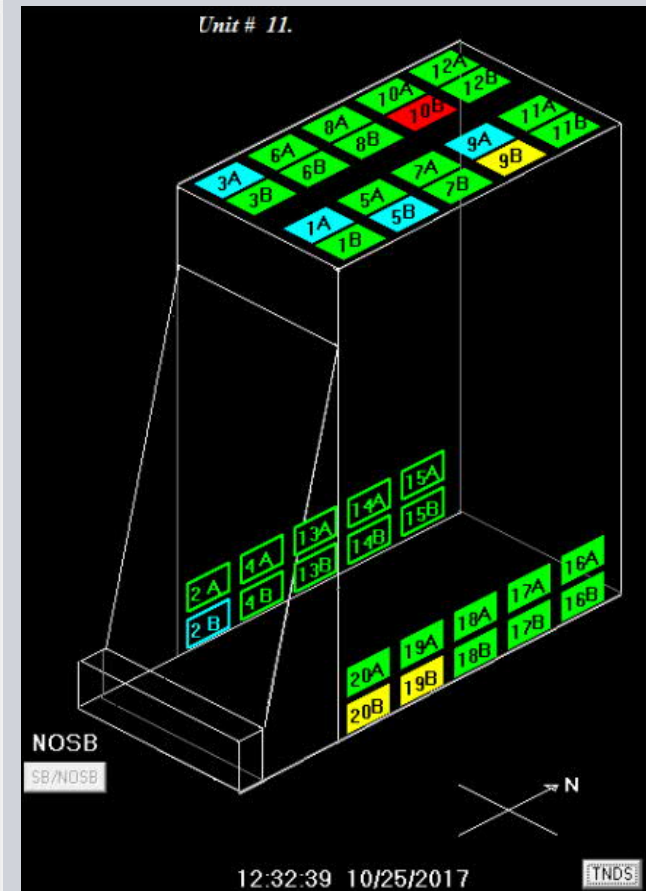
3RD TUBE LEAK DETECTION BY AMS (10/19/2017 HP ECON 2-1 TUBE NO. 4 & 5 FRONT ROW ON TOP HEADER 29 LOCATION – LEAK SIGNAL TREND)

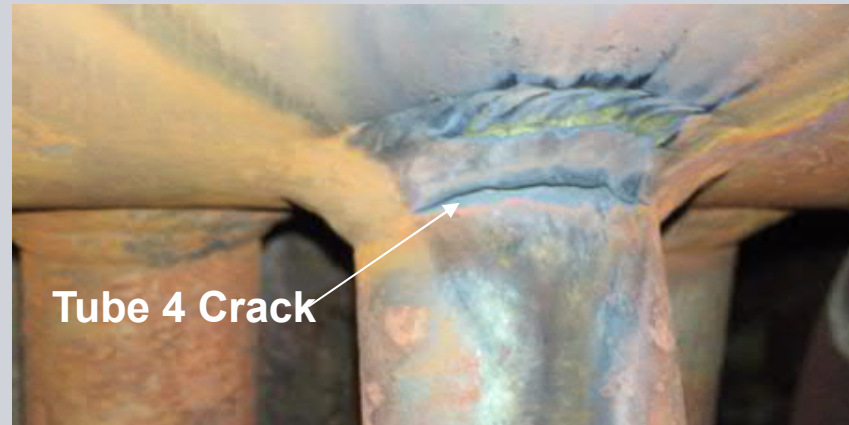
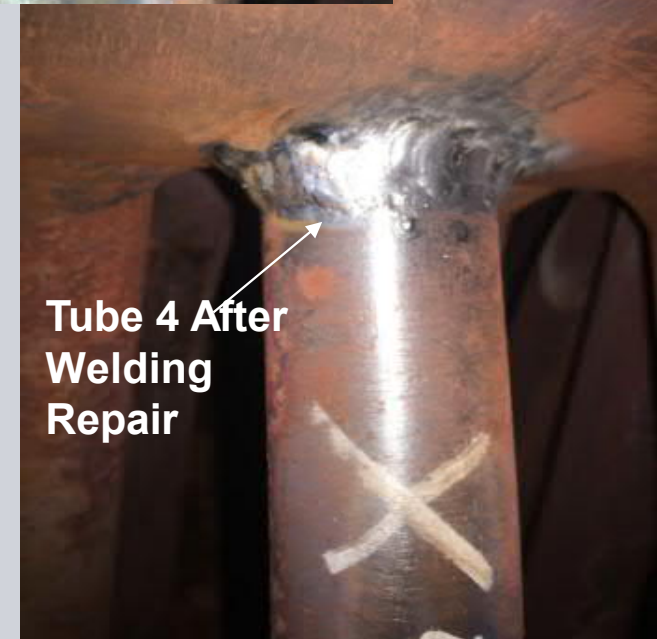
3RD TUBE LEAK DETECTION BY AMS (10/19/2017 HP ECON 2-1 TUBE NO. 4 FRONT ROW ON HEADER 29 LHS MODULE- TUBE LEAK LOCATION & REPAIR PHOTOS)

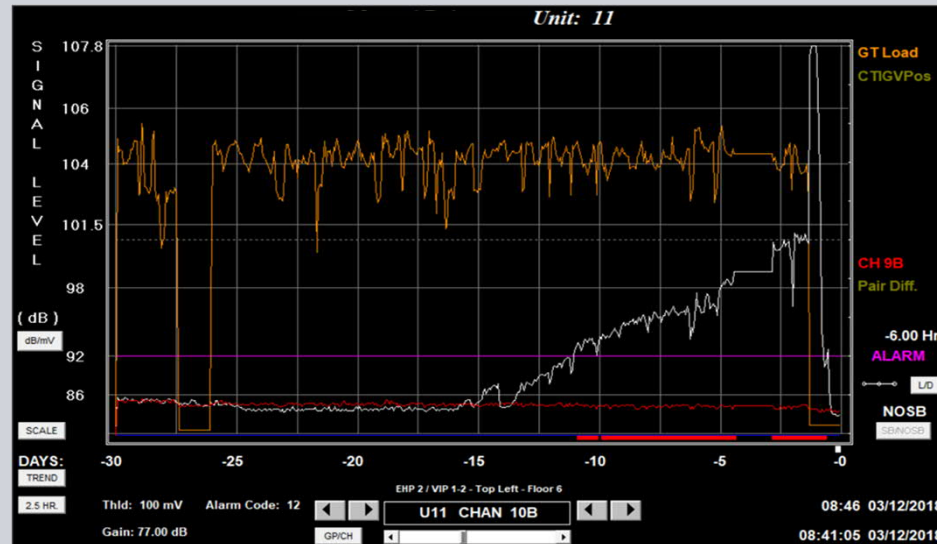
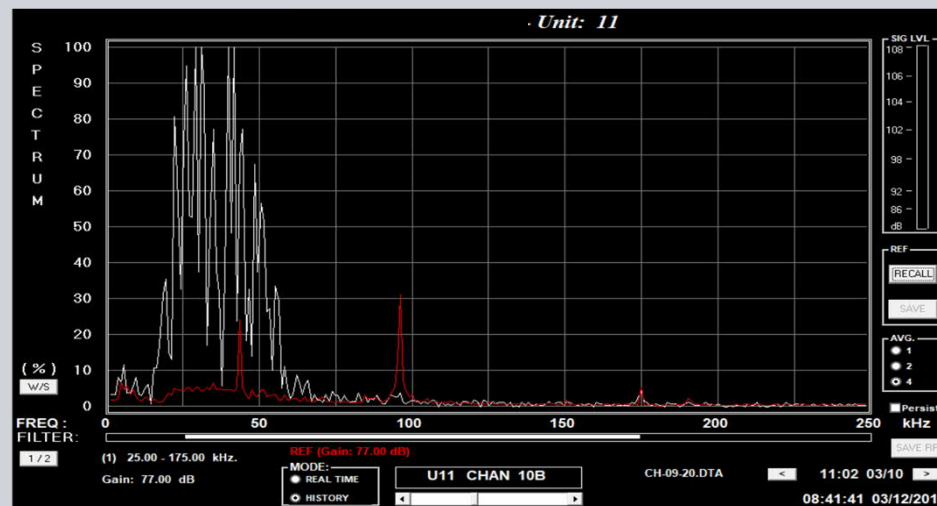
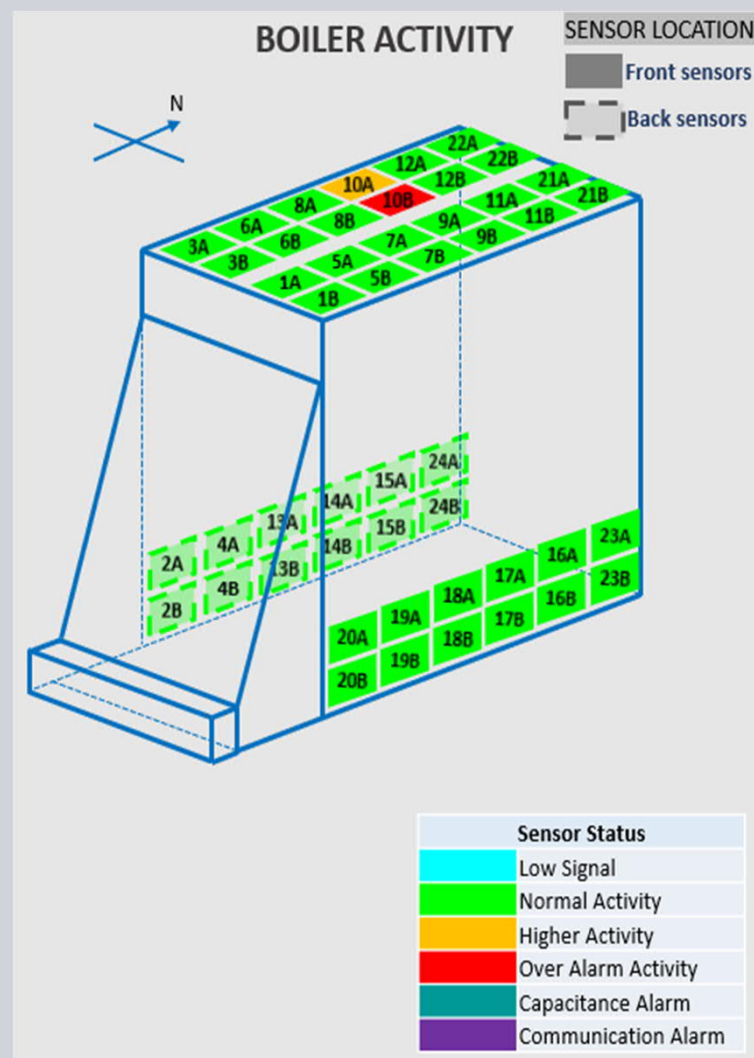
4TH TUBE LEAK DETECTION BY AMS (03/10/2018 HP ECON 2-1 TUBE NO: 6 FRONT ROW ON HEADER 29 LHS MODULE – LEAK SIGNAL TRENDS)

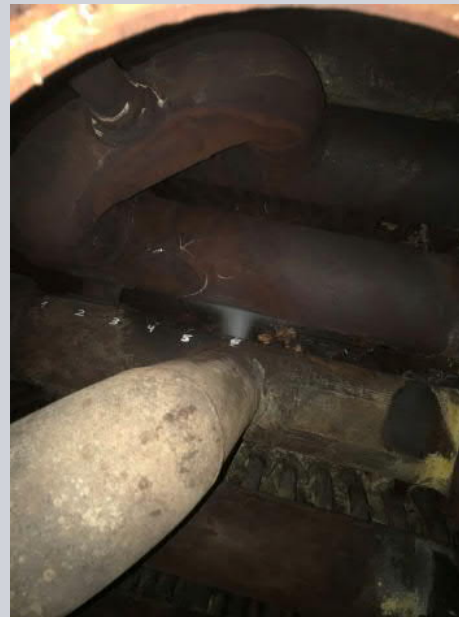
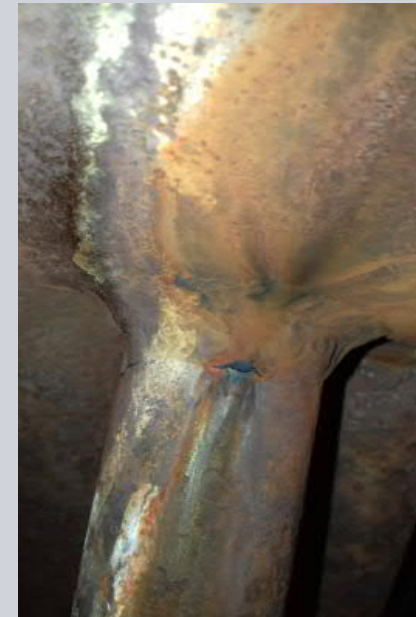
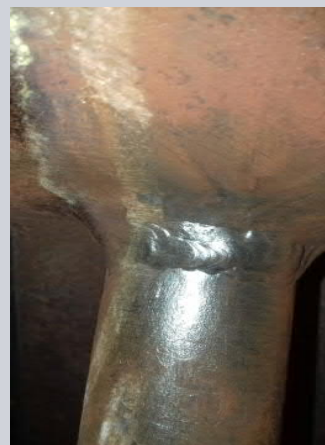
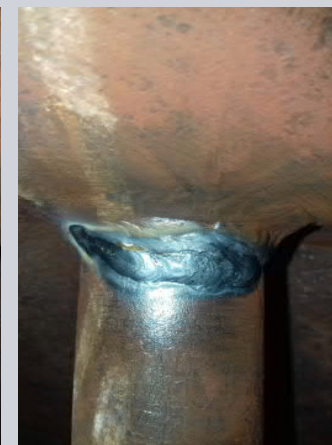
4TH TUBE LEAK DETECTION BY AMS (03/10/2018 HP ECON 2-1 TUBE NO: 6 FRONT ROW ON HEADER 29 LHS MODULE – LEAK LOCATION & REPAIR PHOTOS)

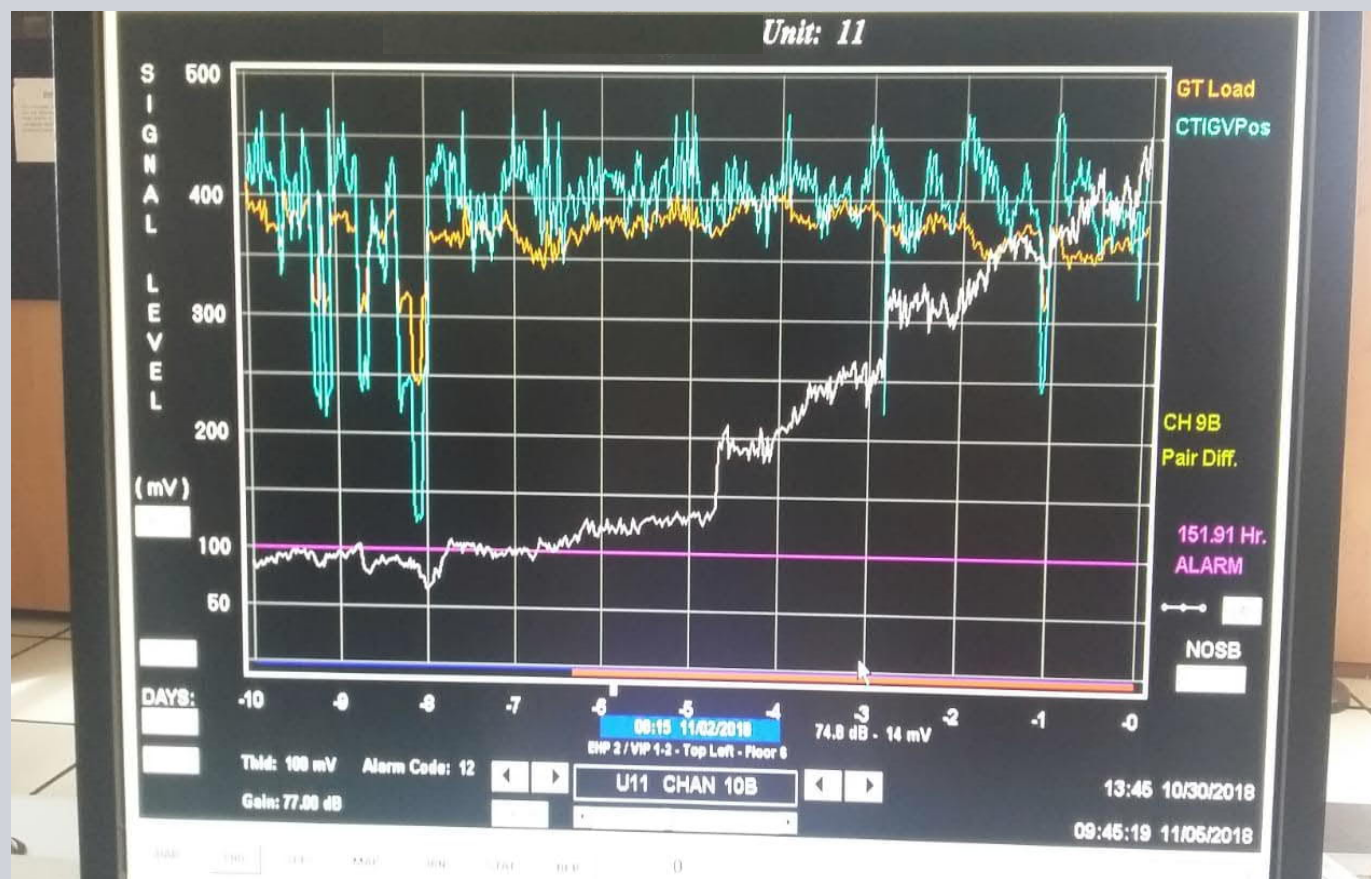
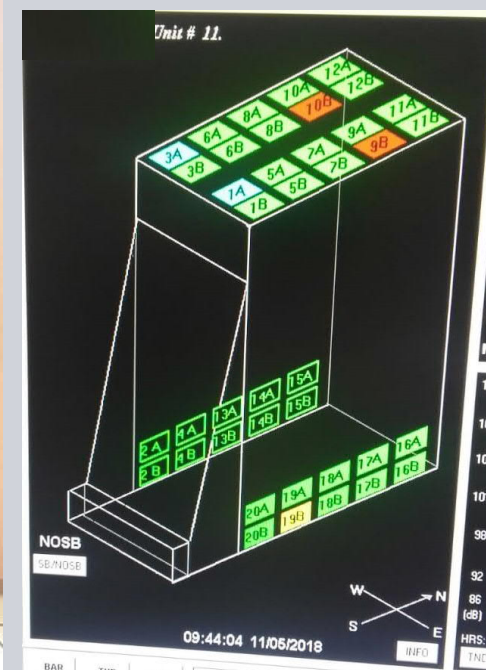
5TH TUBE LEAK DETECTION BY AMS (11/05/2018 IP EVAPORATOR PIN HOLE TUBE LEAK – SIGNAL TRENDS)

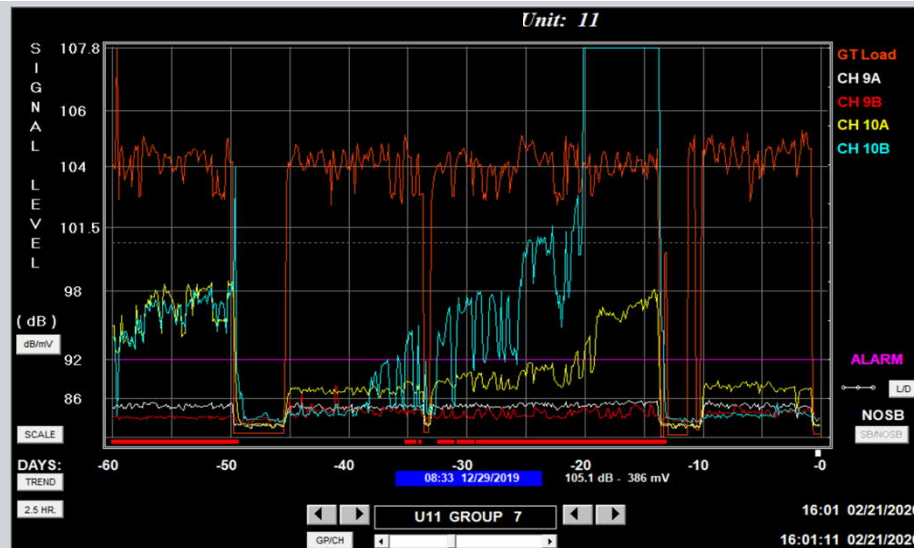
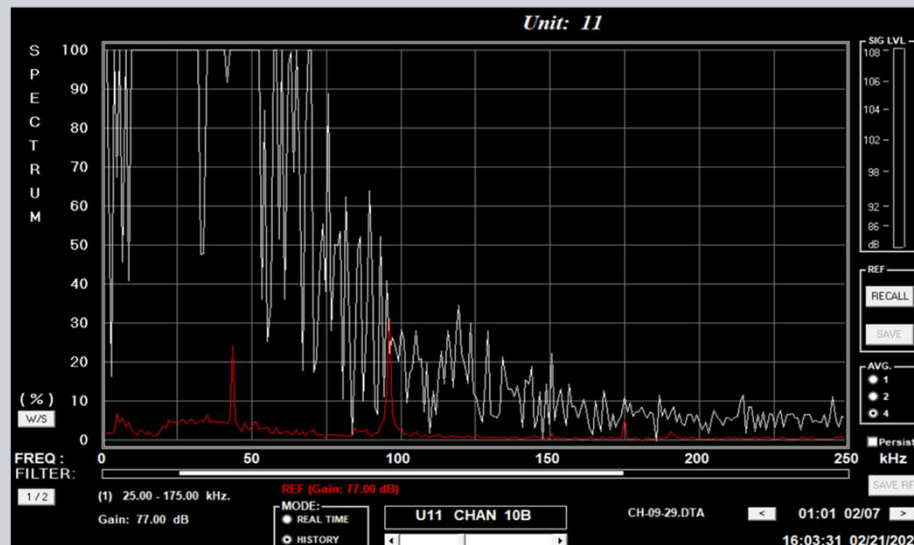
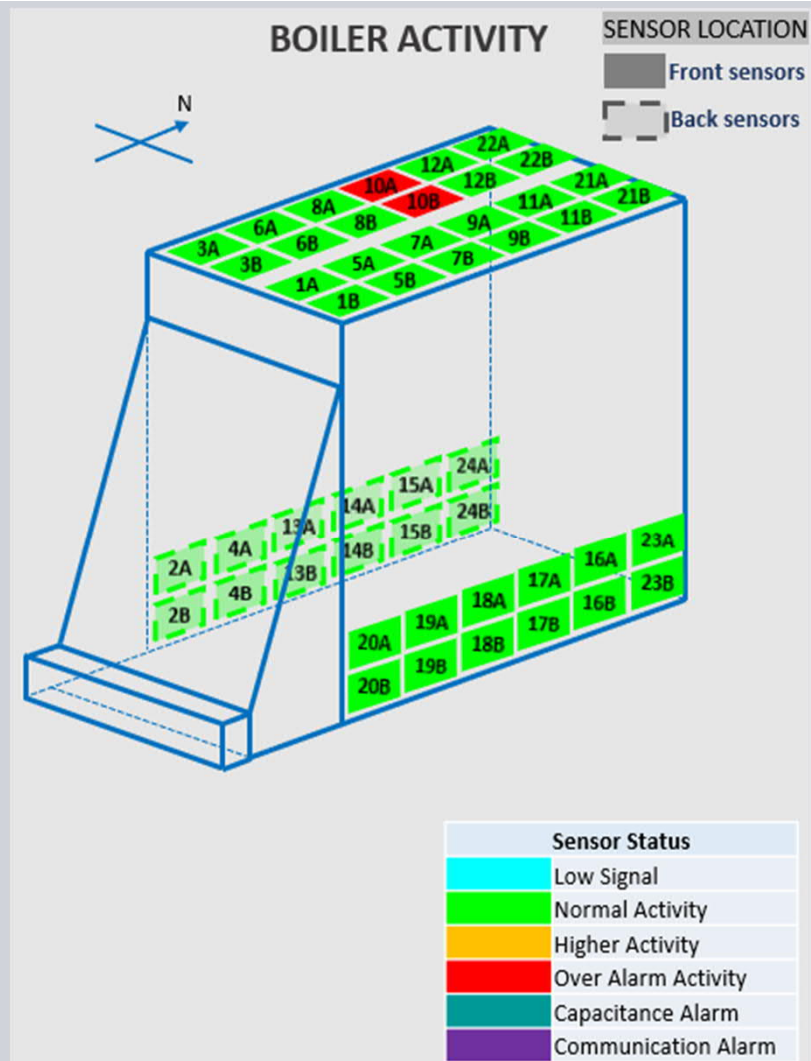
6TH & 7TH TUBE LEAK DETECTION BY AMS (6TH IS FOR HP ECON 2-1 TUBE NO: 5 BOTTOM HEADER NO: 30 & TUBE NO: 37 AT TOP HEADER 29 FRONT ROW TUBES & 7TH IS FOR TUBE NO: 5 & 6 FRONT ROW OF TOP HEADER 29 LHS MODULE – LEAK SIGNAL TRENDS)
