ACTUAL PLANT EXPERIENCE RESULTS OF AN ACOUSTIC MONITORING SYSTEM (AMS) FOR HRSG'S EARLY TUBE LEAK DETECTION

Presented at USA HRSG Forum on 09/24/2021.

(Tham) Thamarai P. Chelvan

UNIT 12 HRSG's FIRST TUBE LEAK EVENT (FEB. 4, 2013) INDICATED BY HIGH MAKE-UP WATER USE AT HP ECON 2-1 AFTER ABOUT 3 YEARS FROM COMMERCIAL OPERATION & ITS IMMEDIATE SHUT DOWN & REPAIR

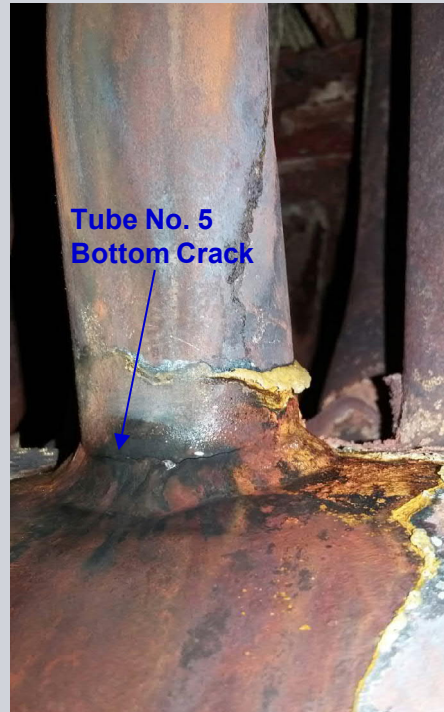
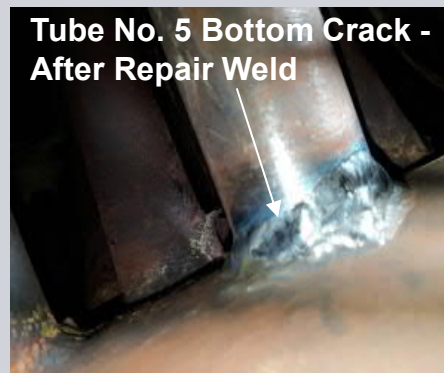
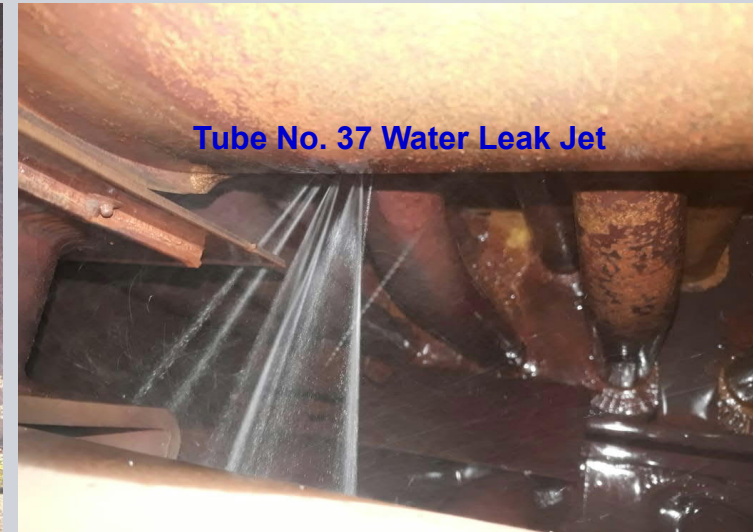
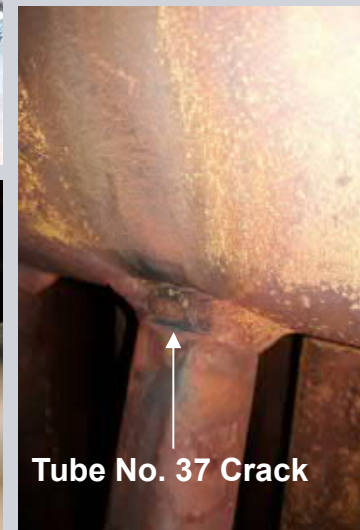
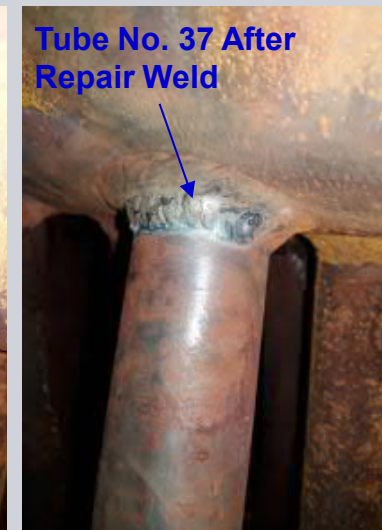
6TH TUBE LEAK DETECTION BY AMS (HP ECON 2-1 TUBE NO: 5 BOTTOM HEADER NO: 30 & TUBE NO: 37 AT TOP HEADER 29 FRONT ROW TUBES – LHS MODULE (01/06/2020) – LEAK LOCATION & REPAIR PHOTOS)

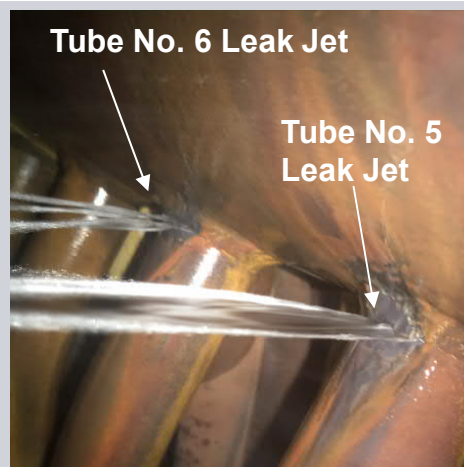
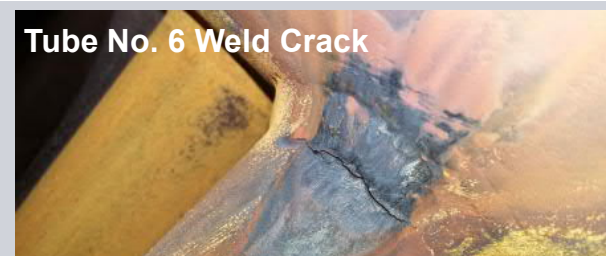
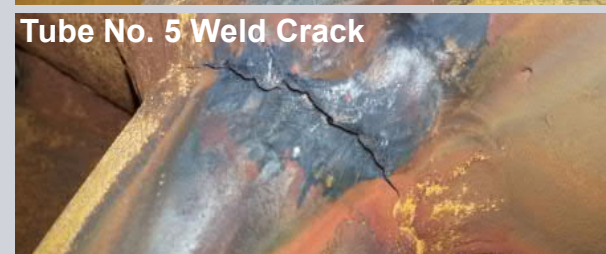
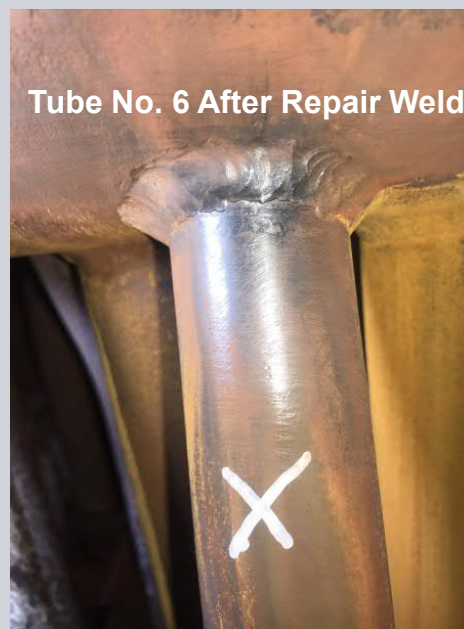
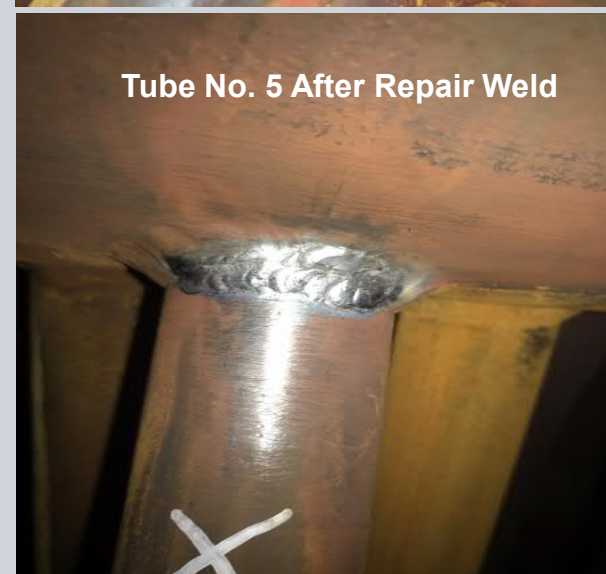
7TH TUBE LEAK DETECTION BY AMS (HP ECON 2-1 TUBE NO: 5 & 6 FRONT ROW OF TOP HEADER 29 LHS MODULE (02/08/2020) – LEAK JET LOCATION & REPAIR PHOTOS – SAME TUBES OF 3RD & 4TH INCIDENCE WELD REPAIRS

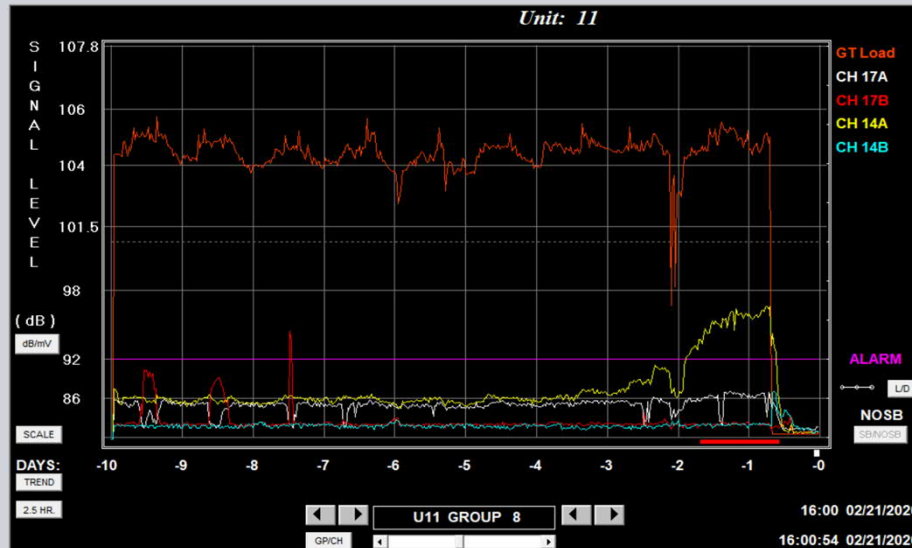
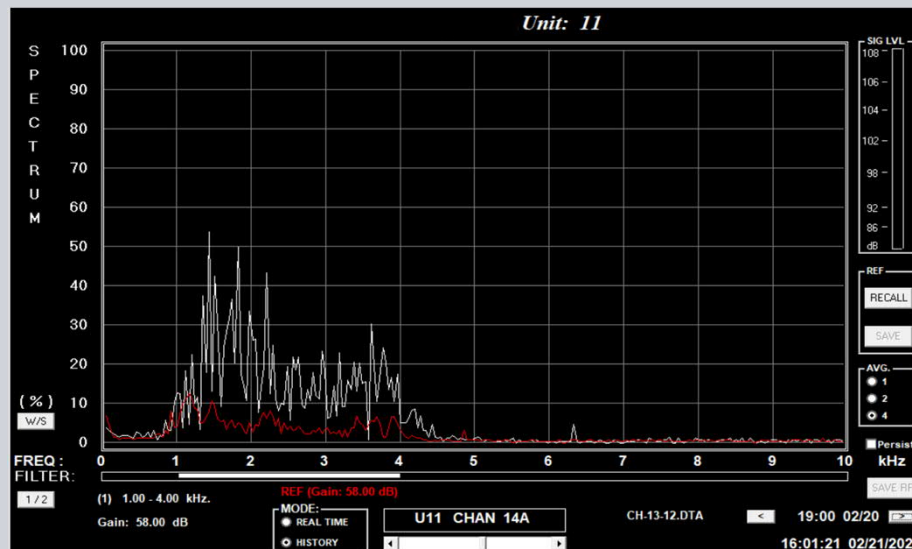
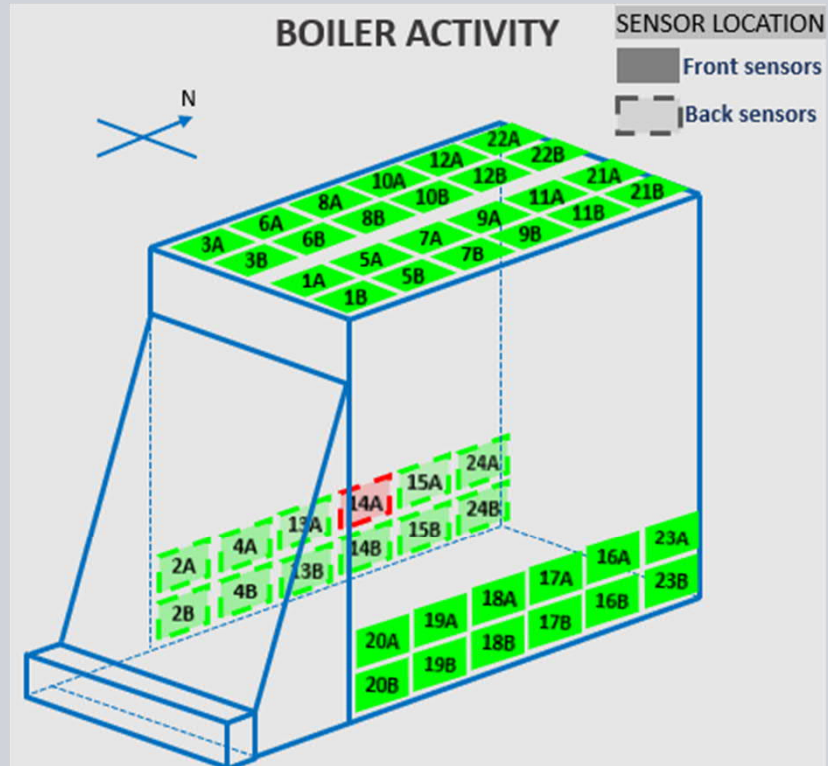
8TH TUBE LEAK DETECTION BY AMS (HP ECON 2-1 TUBE NO: 5 FRONT ROW OF BOTTOM HEADER 30 HAD REPEAT CRACK LEAK ON 02/20/2020 – SAME LOCATION AS THE 2ND INCIDENCE) – LEAK SIGNAL TRENDS)

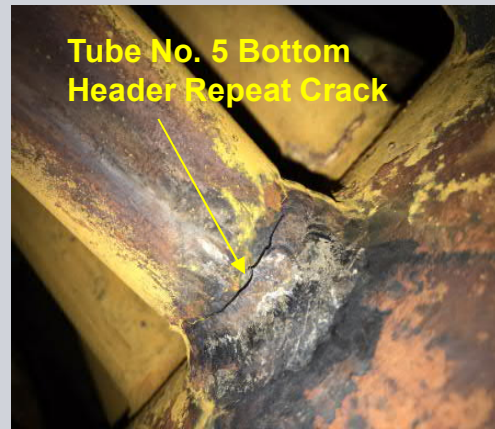
8TH TUBE LEAK DETECTION BY AMS (HP ECON 2-1 TUBE NO: 5 FRONT ROW OF BOTTOM HEADER 30 HAD REPEAT CRACK LEAK ON 02/20/2020 – SAME LOCATION AS THE 2ND INCIDENT) – LEAK LOCATION & REPAIR PHOTO)

Tube No. 5 Bottom Header Repeat Crack

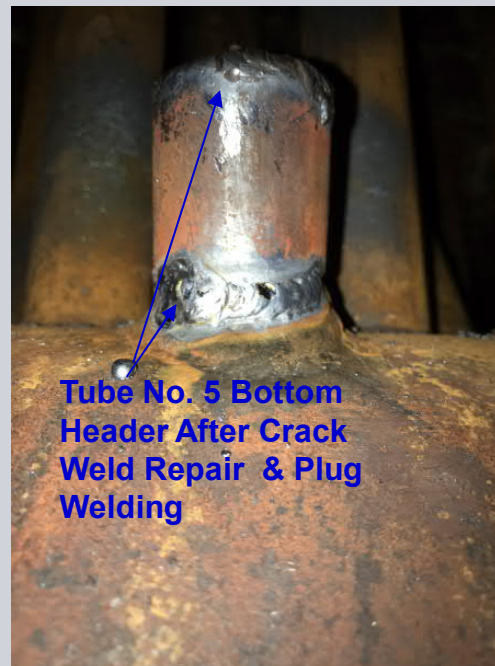
Tube No. 5 Bottom Header After Crack Weld Repair & Plug Welding

DUE TO REPEAT LEAKS AT THE SAME TUBES, BOTH TUBES 5 & 6 WERE PLUGGED AT BOTH TOP & BOTTOM ENDS.

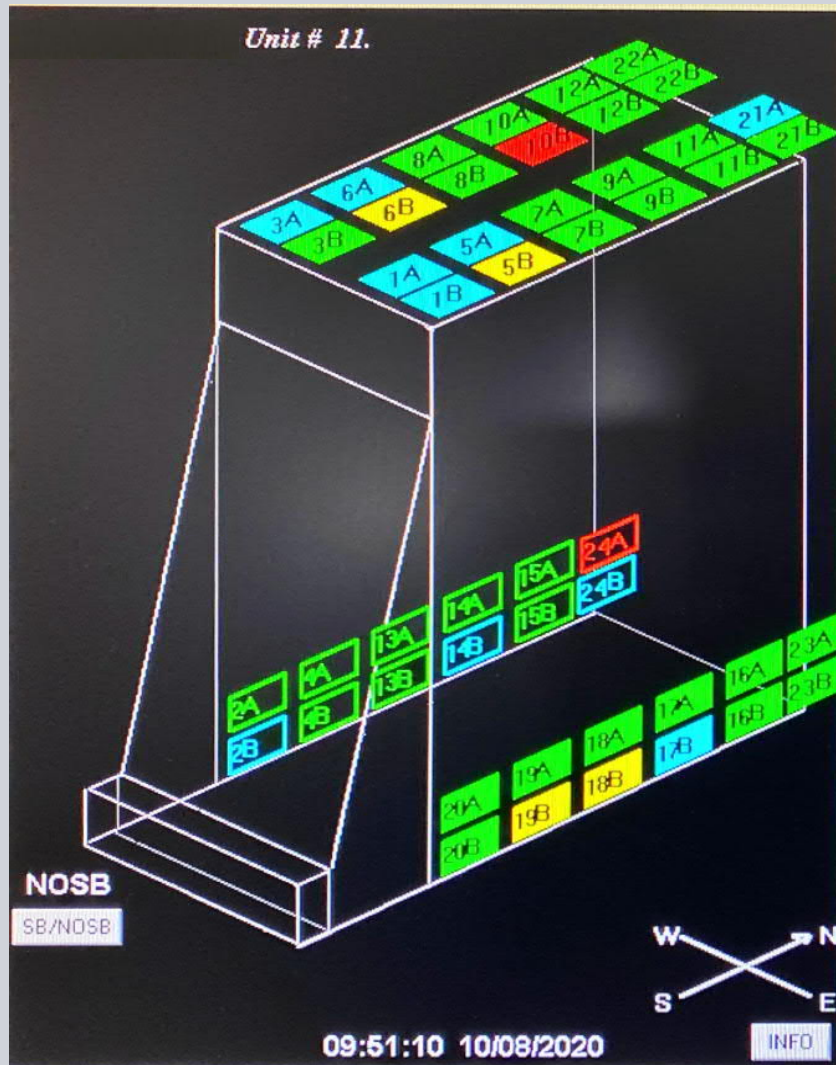
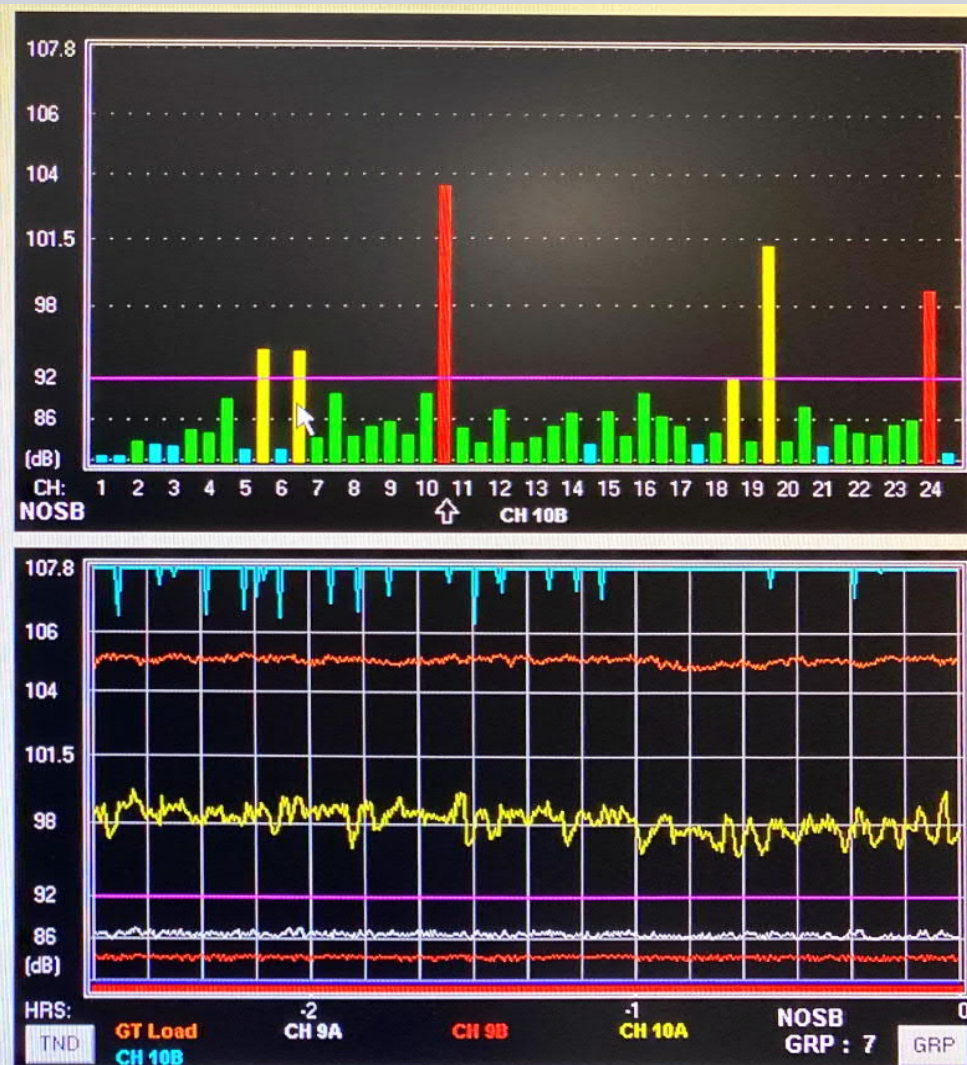
9TH TUBE LEAK DETECTION BY AMS (HP ECON 2-1 TUBE NO: 4 REAR ROW OF TOP HEADER 29 LHS MODULE (10/08/2020) – LEAK SIGNAL TRENDS)

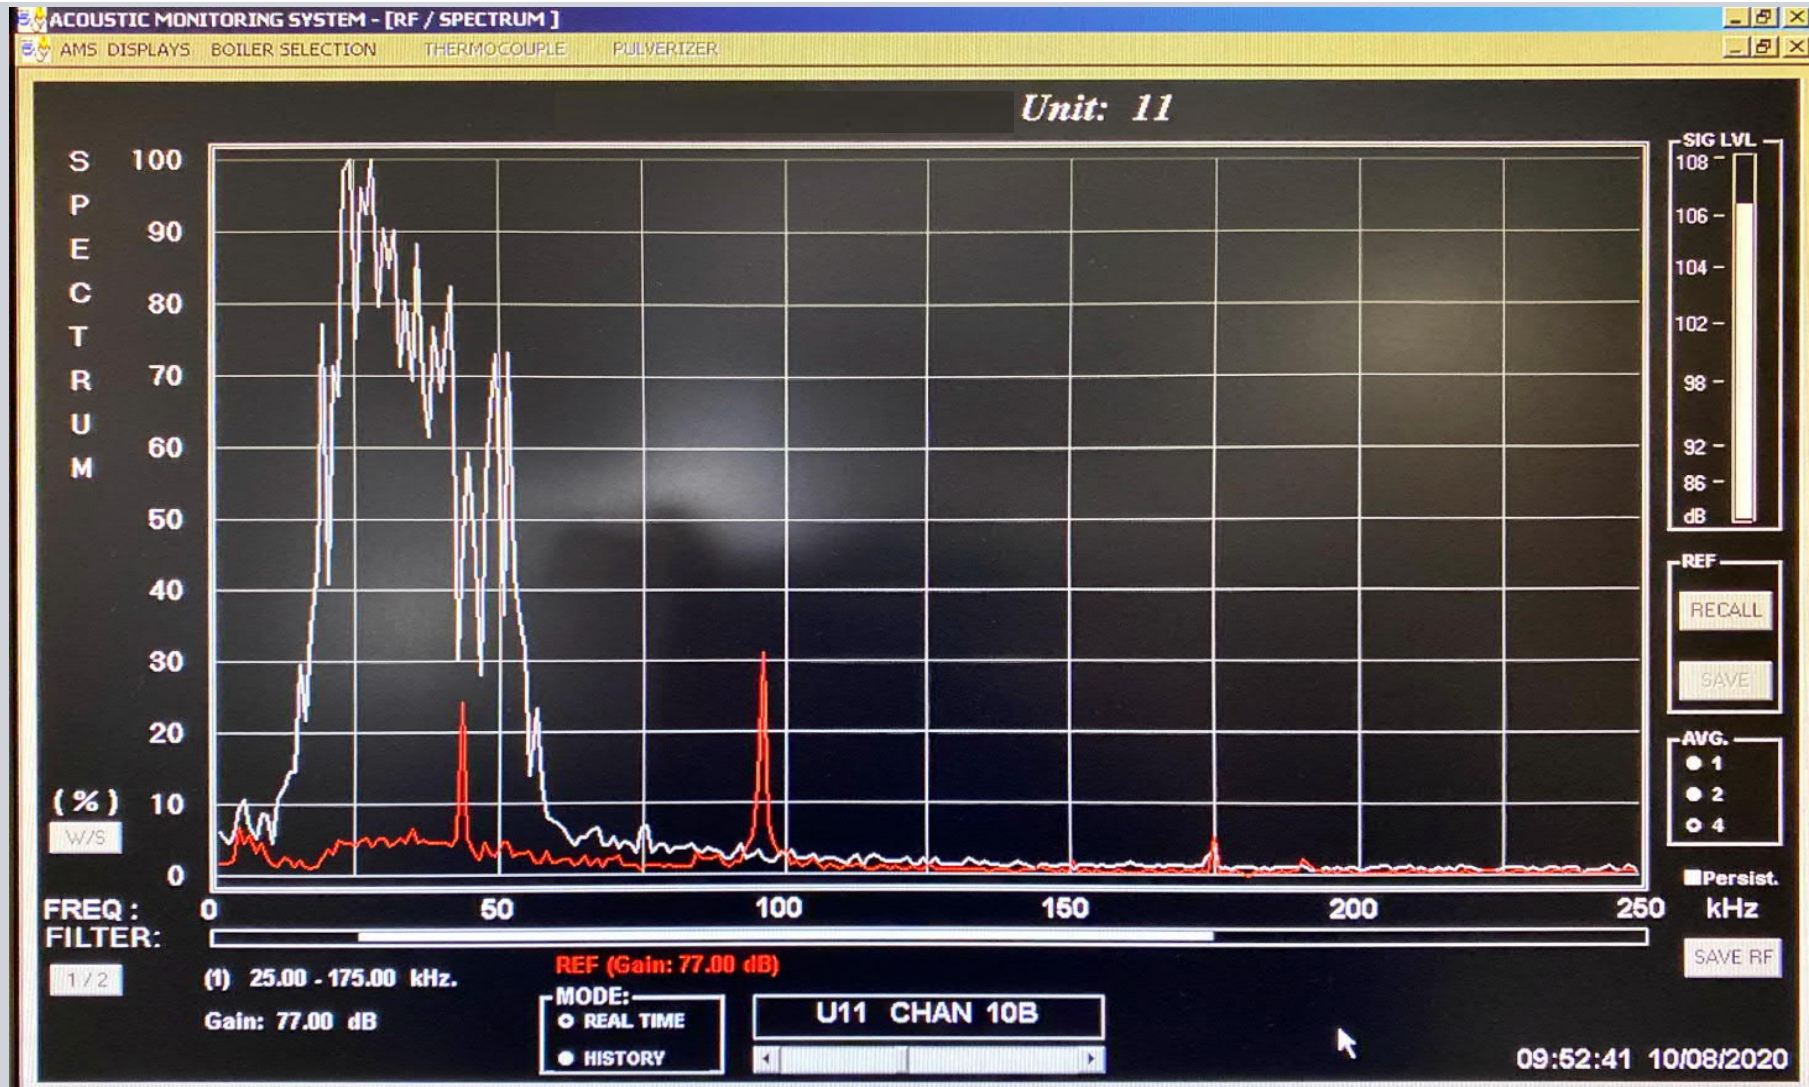
9TH TUBE LEAK DETECTION BY AMS (HP ECON 2-1 TUBE NO: 4 REAR ROW OF TOP HEADER 29 LHS MODULE (10/08/2020) – LEAK SIGNAL TRENDS)

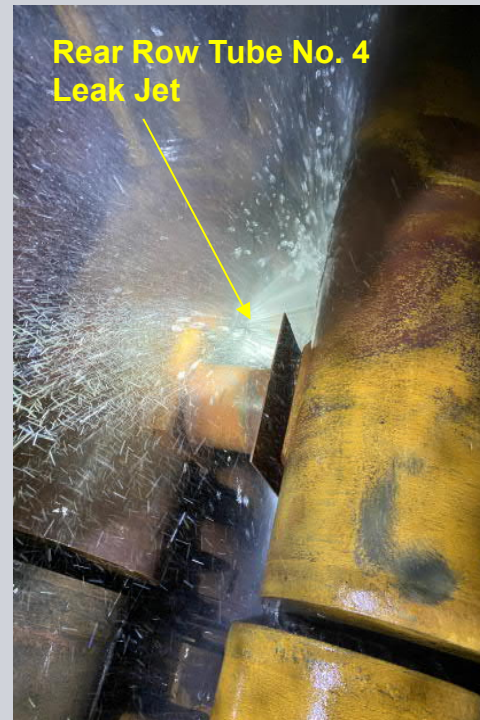
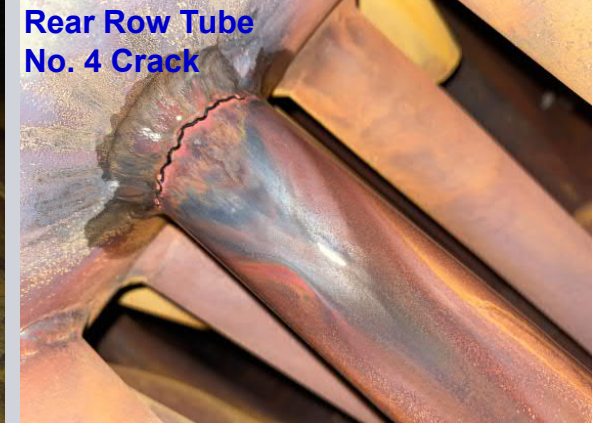
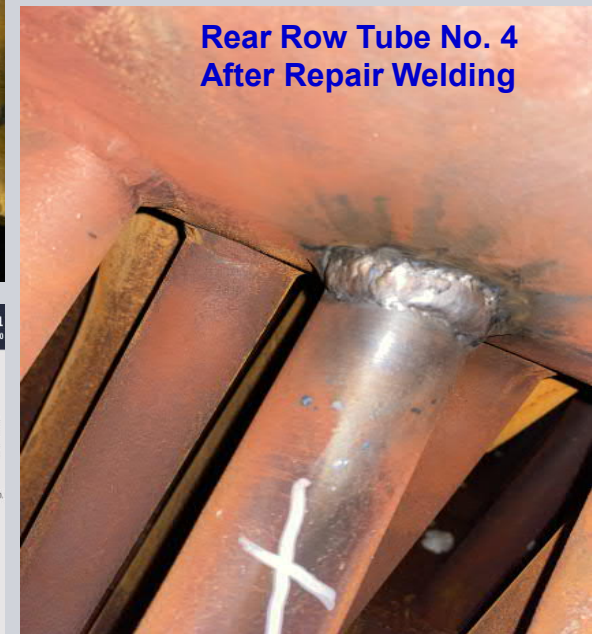
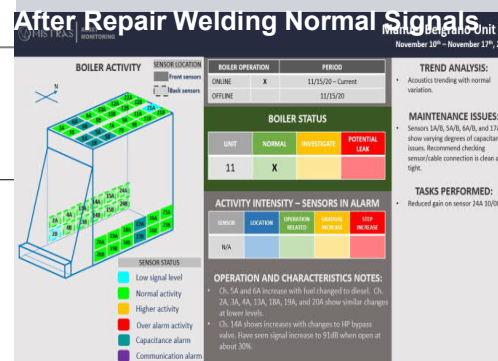
9TH TUBE LEAK DETECTION BY AMS (HP ECON 2-1 TUBE NO: 4 REAR ROW OF TOP HEADER 29 LHS MODULE (10/08/2020) – LEAK LOCATION & REPAIR PHOTOS)

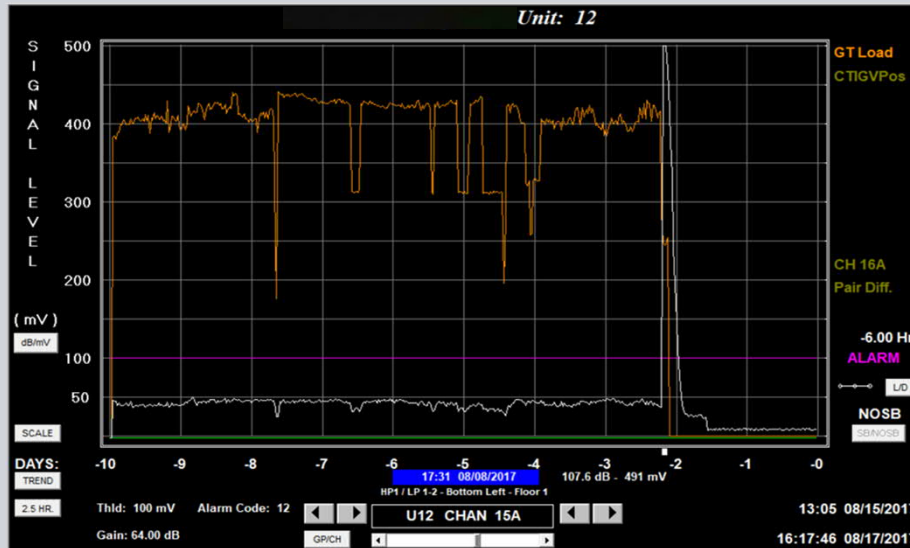
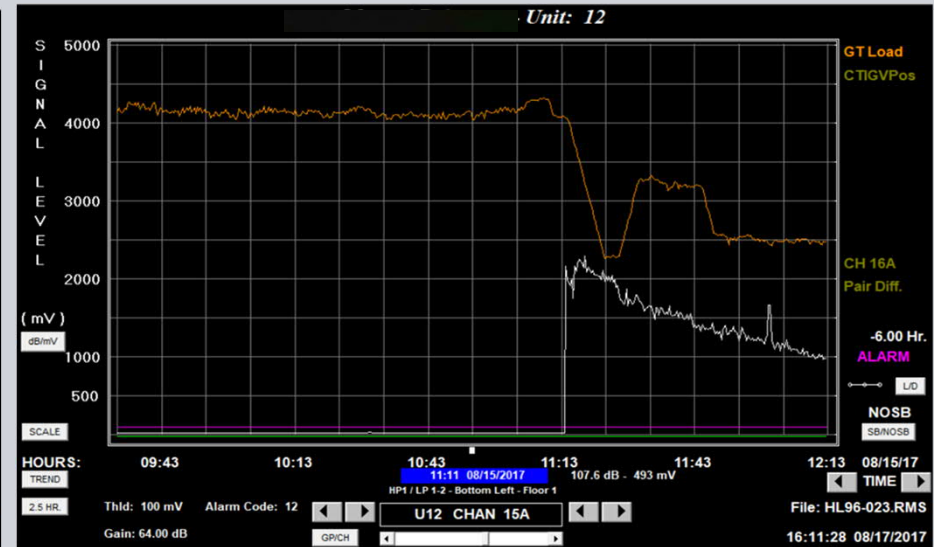
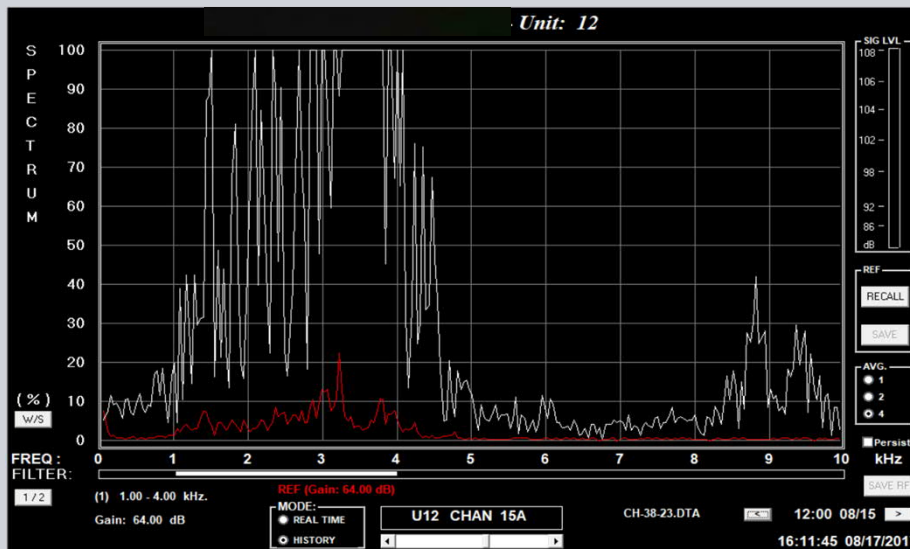
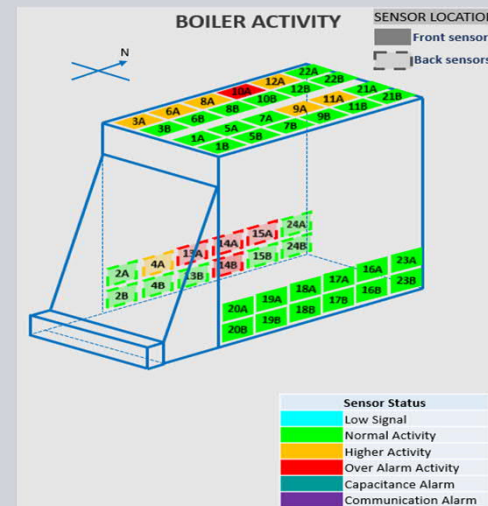
1ST TUBE LEAK DETECTION BY AMS IN UNIT 12 (IP EVAPORATOR 1 TUBE NO:15 FROM RHS OF BOTTOM RHS MODULE HEADER 34 (08/15/2017) – LEAK SIGNAL TRENDS)

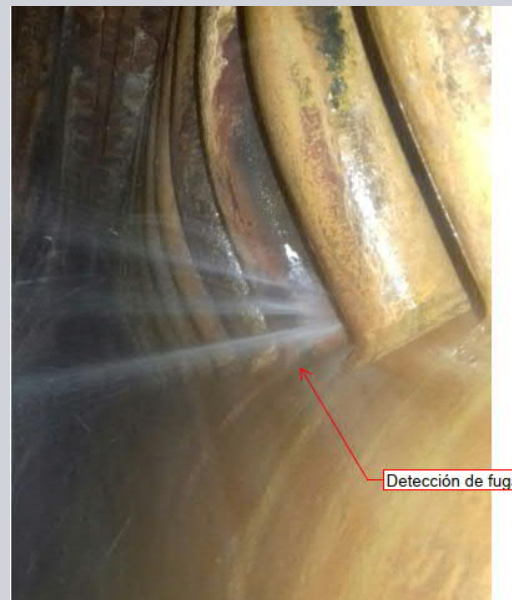
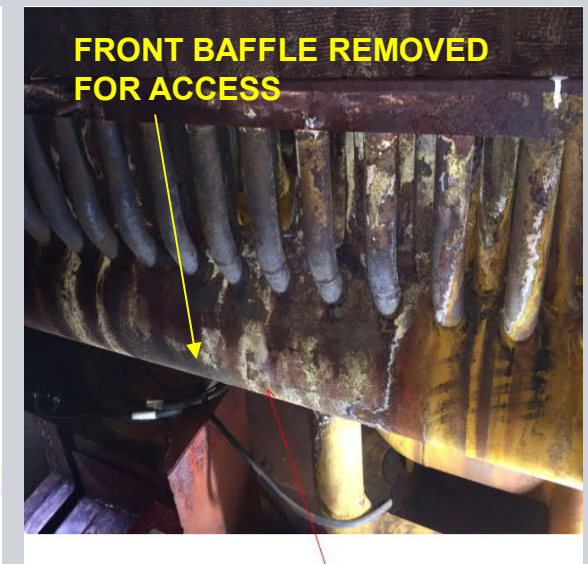
1ST TUBE LEAK DETECTION BY AMS IN UNIT 12 (IP EVAPORATOR 1 TUBE NO:15 FROM RHS OF BOTTOM RHS MODULE HEADER 34 (08/15/2017)– LEAK & REPAIR PHOTOS)
