Storage Tank Floor Inspection

MISTRAS Software & Systems Large Structure Inspection (LSI) System is an automated, programmable, configurable ultrasonic inspection system that provides a 100% scan image of the remaining wall thickness in floor plates in distances as close as 25 mm (1 inch) from the wall.

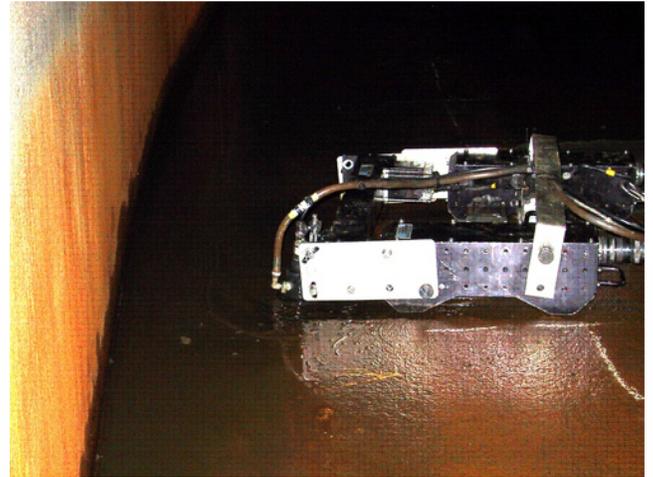
Figure 1: LSI Scanner shown on tank floor, near the outer wall.

collection environment, the use of NDT Automation LSI systems' unique integrated squirter/bubbler scanning head coupled with a highly focused transducer can significantly enhance ultrasonic performance.

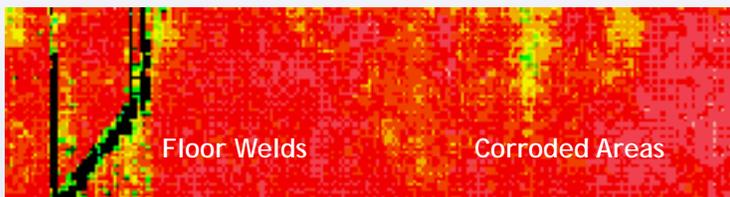
TANK WALL

Figure 2: Floor scan showing corroded areas

Scan data is easily interpreted through color-coded thickness "maps" as shown in Figure 2. In this example showing 2 meters of scan length, nominal floor thickness is in red, while corroded areas are shown in shades of yellow and green. In addition to the thickness data, all scan location data has also been recorded as an integral part of the filing system. *These rates are for comparison purposes; higher or lower resolutions may be appropriate for differing conditions.
