Testing Power Transformers with Acoustic Emission

Acoustic Emission (AE) is a well-known technique that is used to detect and locate acoustic sources in power transformers.

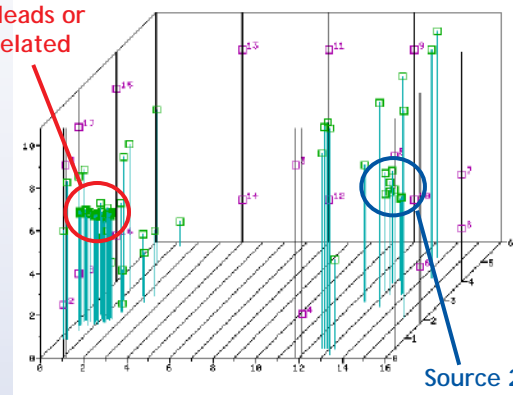
Source 1

NLTC leads or core related

Source 2 Series Autotransformer

Three-dimensional plot showing the location of two different sources.

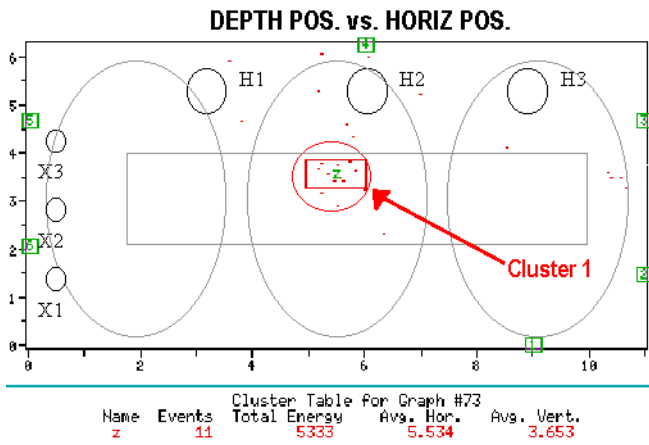
Location of one source in a two-dimensional view.
