WIND TURBINE SHAFT INSPECTION

Application Brief

Phased Array Ultrasonic Testing (PAUT) for Automated Wind Turbine Shaft Inspection

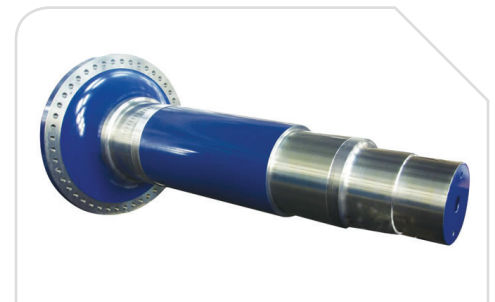
The engineer delivered detailed inspections and reports on a turbine-by-turbine basis. These NDT inspections help assess the condition of turbine shafts and the reports provide the evidence to justify the continued operation of the wind turbine or identify defects that require repair and/or monitoring.

The turbine shaft testing was carried out using an MX2 with TomoView software, 5Mhz Compressional wave probe, and a Phoenix

Bi-axial encoded scanner to record the completed scan, verify test coverage, and capture data prior to de-mobbing from the site.
