Guided Wave Ultrasonic (GUL) Inspection Services

CASE STUDY: REFINERY PIPING INSPECTION

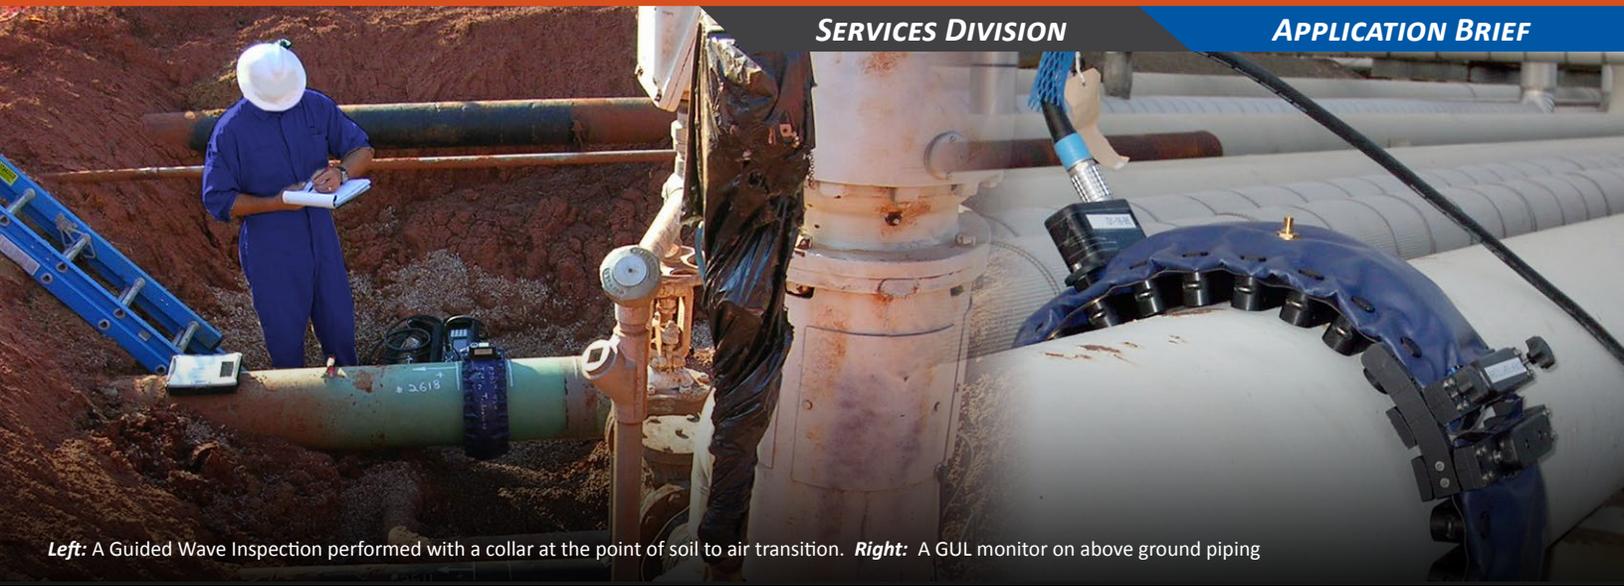
Left: A Guided Wave Inspection performed with a collar at the point of soil to air transition. **Right:** A GUL monitor on above ground piping

A Guided Wave inspection is performed by placing a collar around the pipe section, including stripping an area approximately 24" wide if the system is insulated, and then performing the test. Each of these individual scans is termed a "shot". During this project MISTRAS performed over 2000 shots looking for various damage mechanisms.
